# **Phase 1 Milestone Inspection Report**

**On Top of the World Clearwater**

**Building 15**

**ESi Project No: 98508**

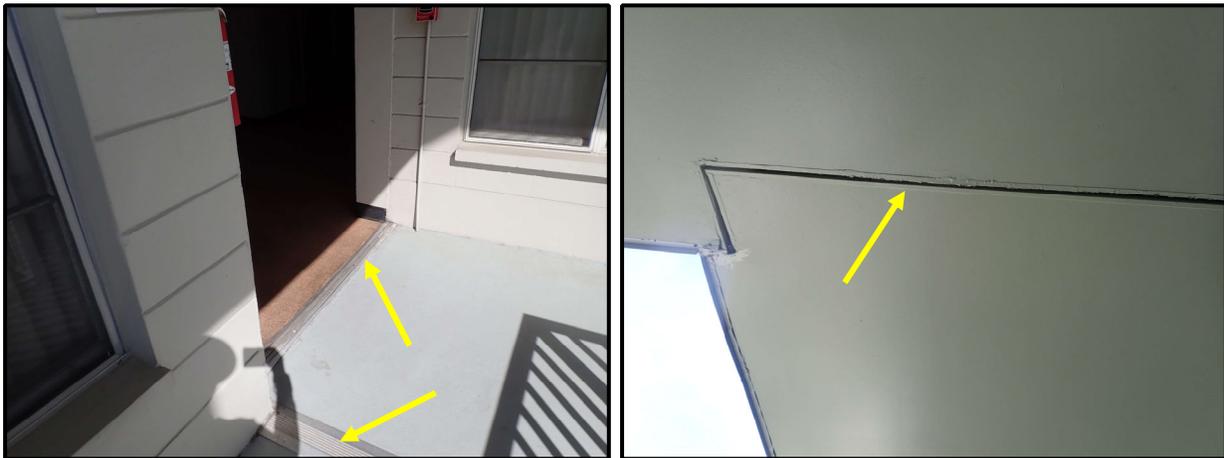
**Figure 5. Representative photographs of building expansion joints at exterior corridor at top and bottom of slab.**

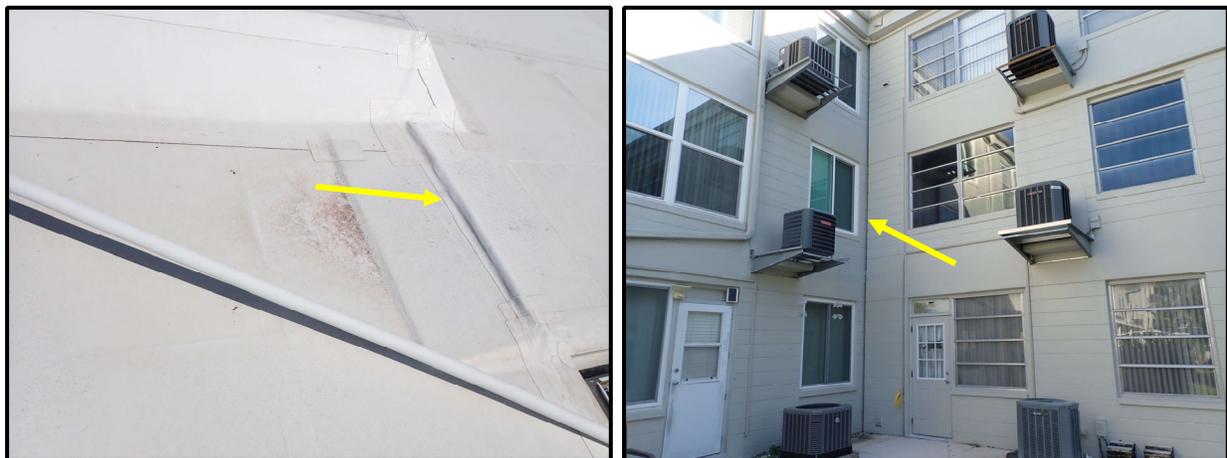
**Figure 6. Representative photographs of building expansion joints at roof and rear wall.**

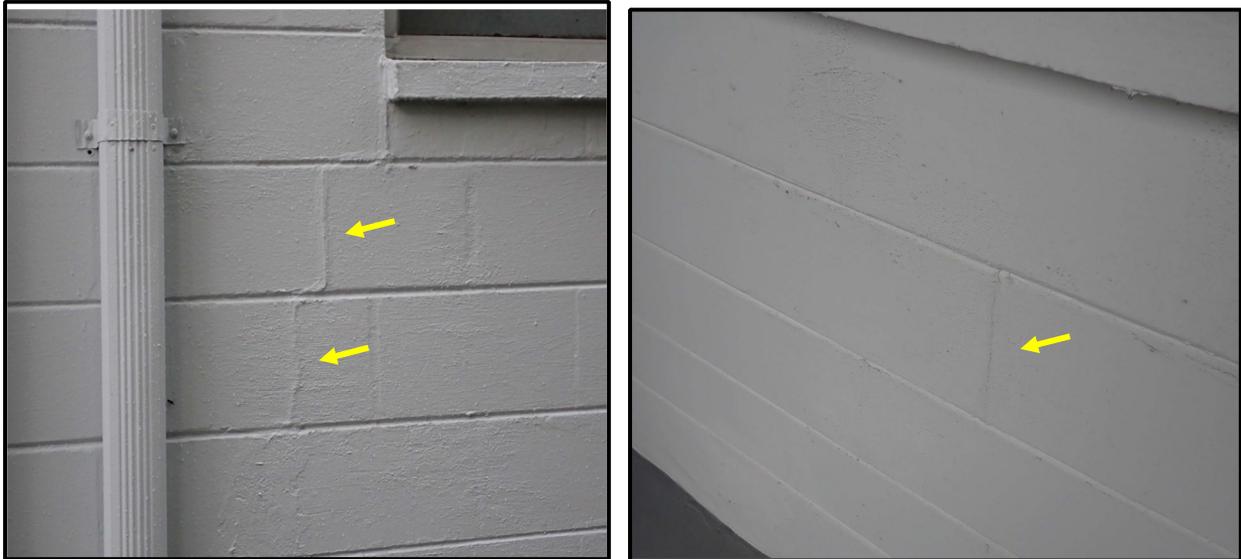
Stairstep cracks, both previously repaired and those appearing to be recent, on the CMU bearing walls of the wings particularly below windows and near the core were typically observed throughout the elevations of the building. Stairstep cracks are cracks in the mortar joints and form due to the movement of the structure, as mortar is a brittle material. The observed width and location of the cracks represent typical movement from a structure (commonly due to soil settlement) and do not appear to be indicative of structural damage. Recommendation for repairs and monitoring of the cracks is provided in Exhibit A. Representative photographs of this observation are shown below in **Figure 5**.

**Figure 5. Representative photographs of step stair cracks at CMU walls.**

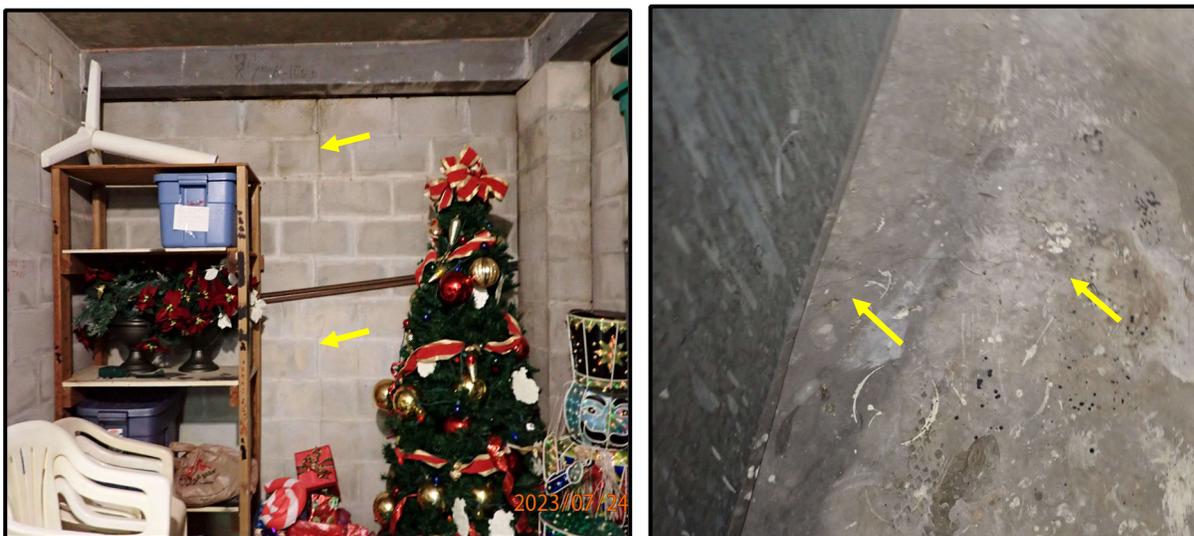
Vertical and horizontal cracking was observed on the building's core on the CMU walls of the storage rooms. CMU and mortar are brittle materials and are likely to crack when subjected to expansion and contraction and differential movement. The observed cracks are due to the movement of the core throughout its life. Similarly observed, were cracks on the concrete slab on grade on the first-floor electrical and storage rooms. The observed cracks are due to the expansion and contraction of the slab and typical settlement of the soils below the structure. Recommendations for repairs and monitoring of the cracks is provided in Exhibit A. Representative photographs of this observation are shown below in **Figure 7**.

**Figure 7. Representative photographs of cracks on CMU walls and concrete slabs at common rooms in Core building.**

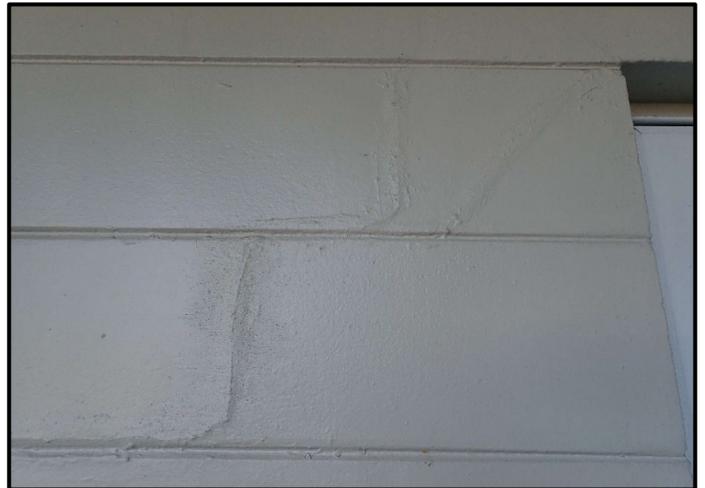
Photograph 04 - View of a previous repair to a stair step crack.

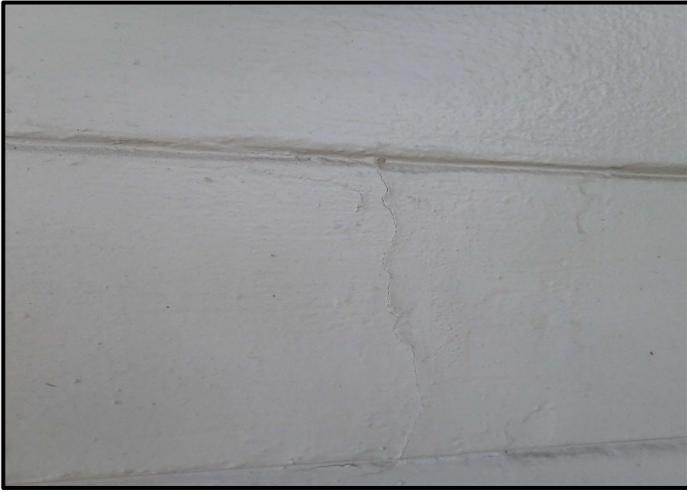
Photograph 05 - View of a re-opened vertical crack.

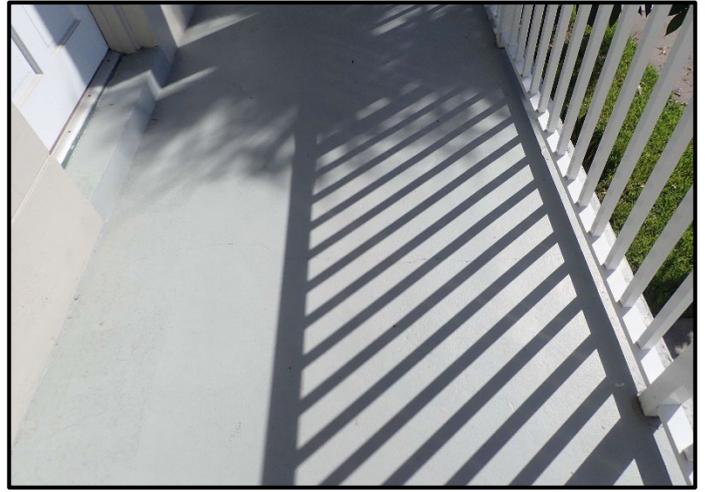
Photograph 06 - View of a crack in the walkway slab.

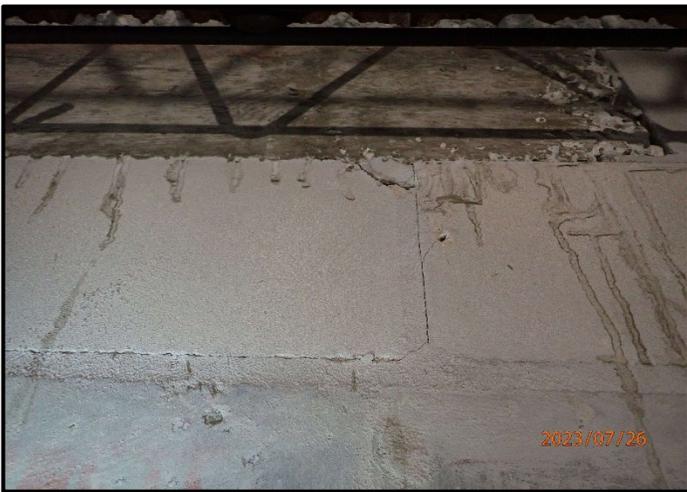
Photograph 07 - View of cracked mortar joint and block corner.

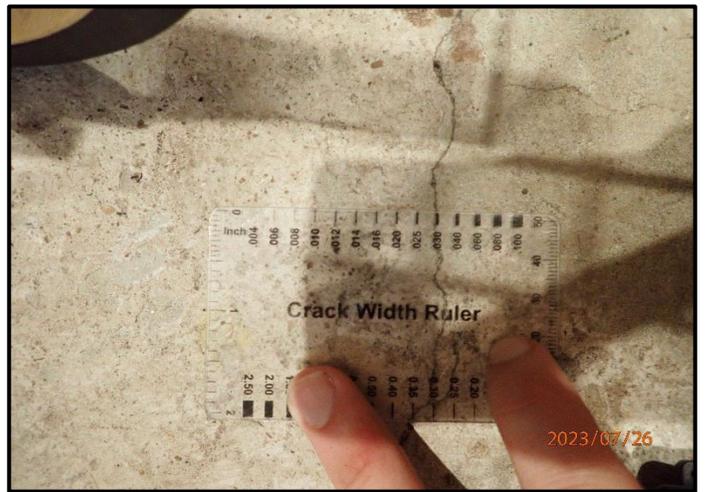
Photograph 08 - Close up view of cracked slab in storage room.

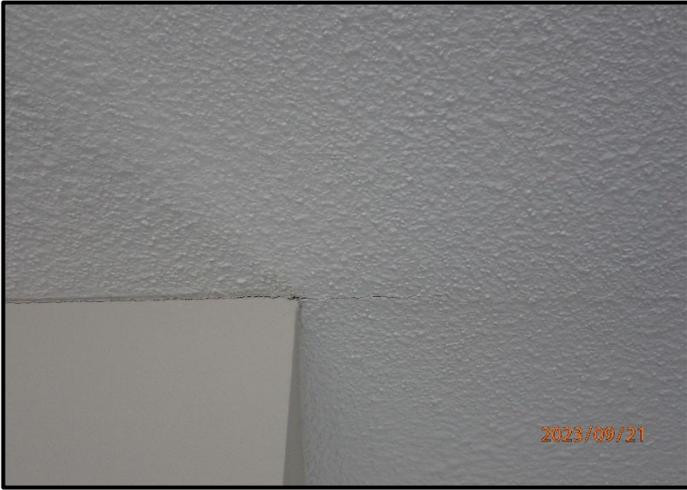
B15:60	Hairline ceiling drywall crack at living room/kitchen entry. Hairline drywall crack at Florida room window corners.	No	As noted in observation.	No	Monitor cracks.

Photograph 09 - Crack on ceiling in unit 60.

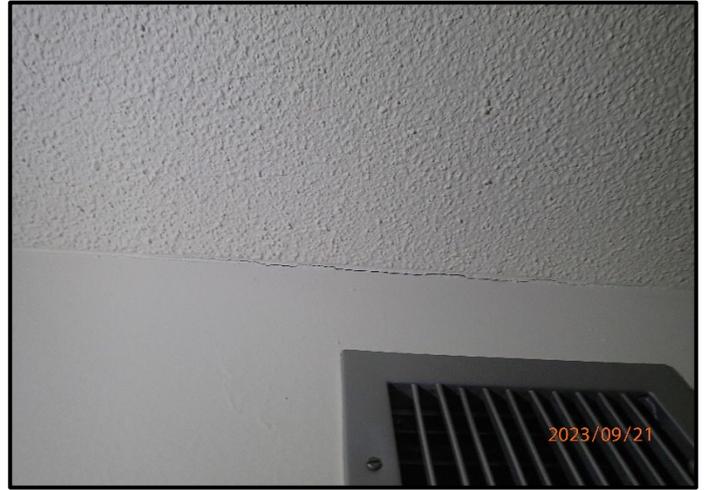
Photograph 10 - Cracking at ceiling and wall joint in unit 49.

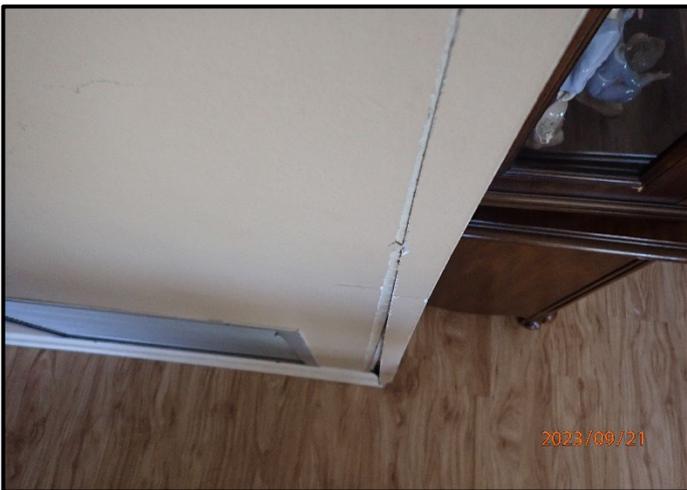
B15:24	Vertical hairline drywall crack below Florida room window. One door tile with cracked corner in Florida room. High point in master bedroom flooring near closet, feels like <6" wide object below flooring at this location. Crack on edge of living room corner, frame exposed. Tiles in kitchen cracked.	No	As noted in observation.	No	Monitor crack and floor level. repair crack in living room.
B15:39	No evidence of structural damage or surface imperfections observed.	No	No	No	No action.
B15:49	Corner bead separation on living room/kitchen wall. Hairline horizontal drywall crack at top corner of Florida room window. Hairline crack above closet, length of closet. Separation between wall and ceiling above bedroom door, about 5' length, 0.03" max width. Moisture stains under AC vent in bathroom, along shower, and on wall in laundry room.	No	As noted in observation.	No	Monitor cracks. Repair wall/ceiling separation. Verify if moisture damage is due to active leak and if so, repair damage and source.

Photograph 11 - Vertical crack on wall in unit 24.
