Phase 1 Milestone Inspection Report

On Top of the World Clearwater

Building 17

ESi Project No: 98508

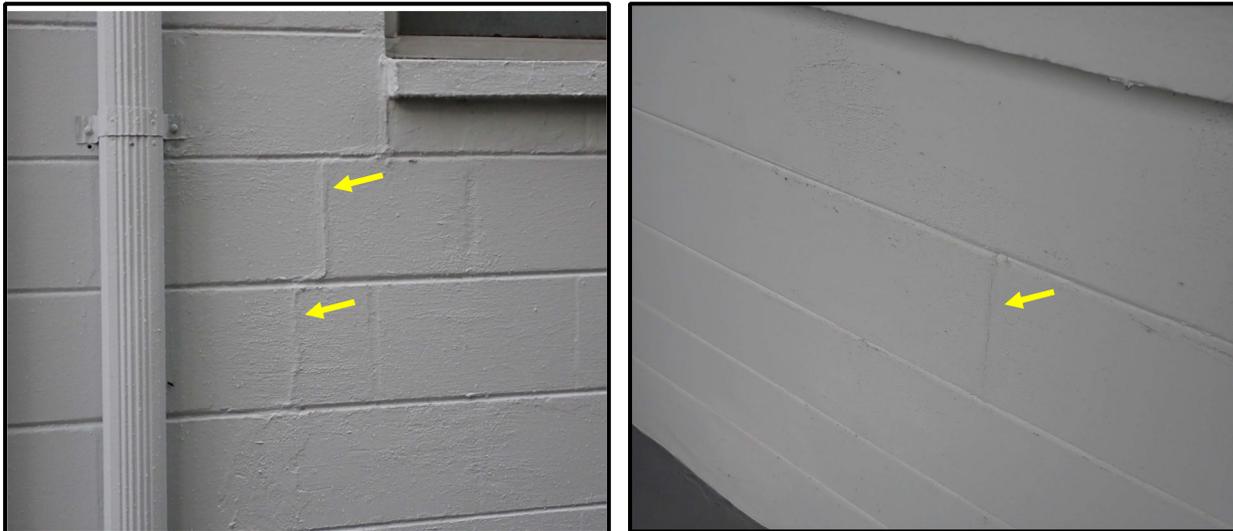
Stairstep cracks, both previously repaired and those appearing to be recent, on the CMU bearing walls of the wings particularly below windows and near the core were typically observed throughout the elevations of the building. Stairstep cracks are cracks in the mortar joints and form due to the movement of the structure, as mortar is a brittle material. The observed width and location of the cracks represent typical movement from a structure (commonly due to soil settlement) and do not appear to be indicative of structural damage. Recommendation for repairs and monitoring of the cracks is provided in Exhibit A. Representative photographs of this observation are shown below in **Figure 7**.

Figure 7. Representative photographs of step stair cracks at CMU walls.

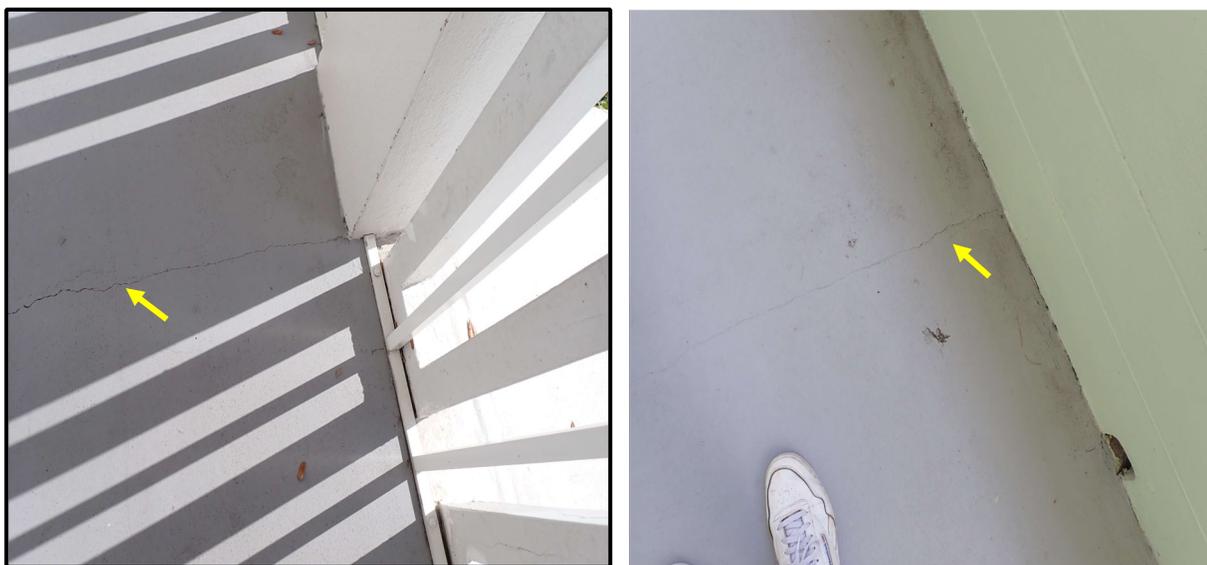
Cracks on the exterior hallway floor slabs were observed perpendicular to the length of the slab and the supporting wall. The observed cracks were typically hairline cracks and shallow. The cracks had weathered edges and dirt on the inside, representing they are historical in nature. The frequency and spacing of these cracks were not uniform. The observed cracks in the subject building are likely due to the expansion and contraction of the materials where control joints were not observed or due to the deflection of the slab at support locations and do not represent a structural damage or substantial deterioration. Recommendation for repairs and monitoring of the cracks is provided in Exhibit A. Representative photographs of this observation are shown below in **Figure 8**.

Figure 8. Representative photographs of shallow cracks at top surface of the exterior hallway.

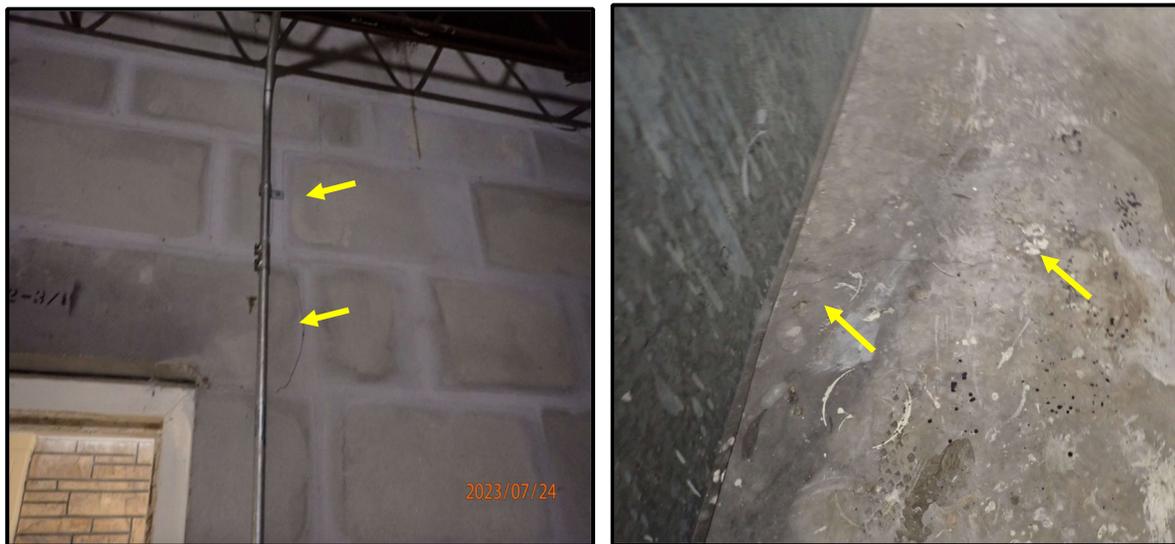
Vertical and horizontal cracking was observed on the building's core on the CMU walls of the storage rooms. CMU and mortar are brittle materials and are likely to crack when subjected to expansion and contraction and differential movement. The observed cracks are due to the movement of the core throughout its life. Similarly observed, were cracks on the concrete slab on grade on the first-floor electrical and storage rooms. The observed cracks are due to the expansion and contraction of the slab and typical settlement of the soils below the structure. Recommendations for repairs and monitoring of the cracks is provided in Exhibit A. Representative photographs of this observation are shown below in **Figure 9**.

Figure 9. Representative photographs of cracks on CMU walls and concrete slabs at common rooms in Core building.

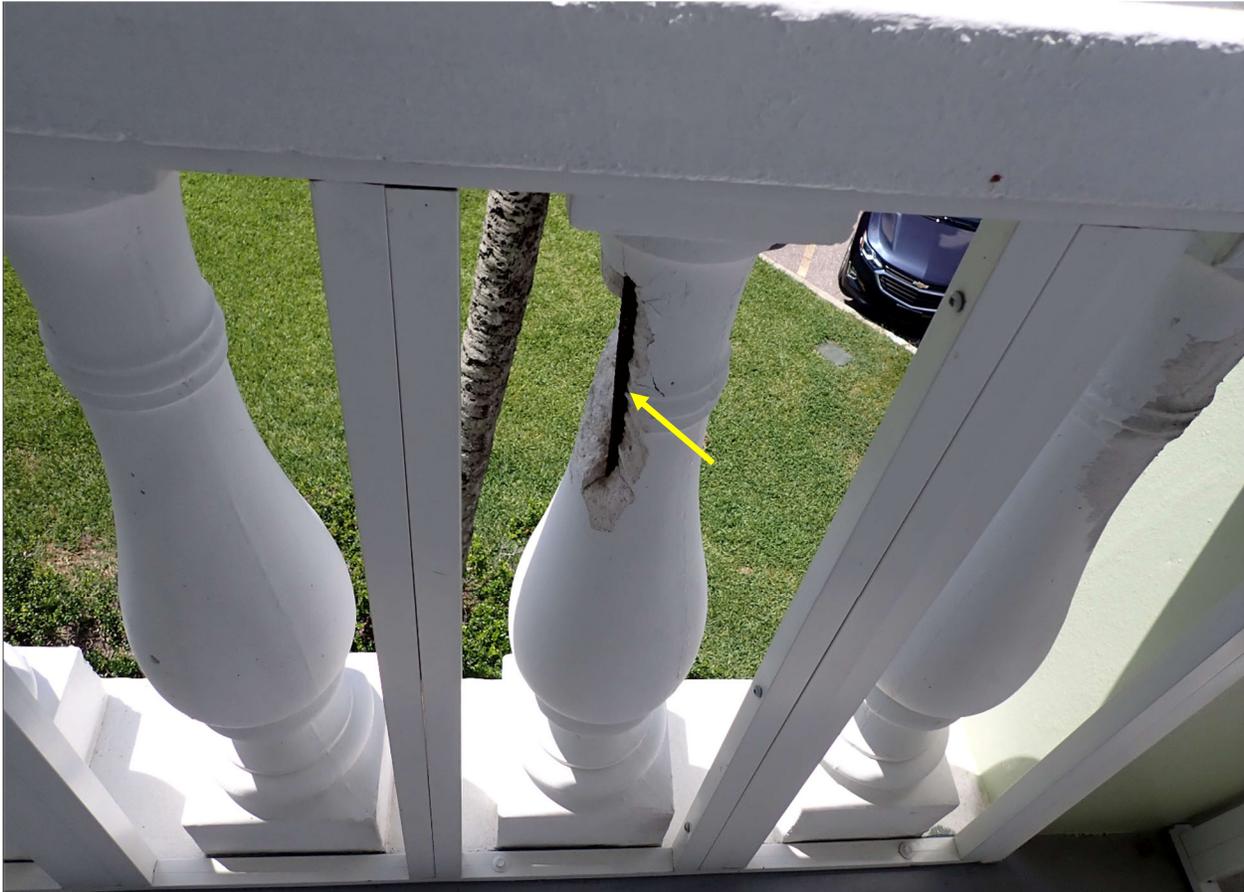
The building's exterior architectural features consisted of a decorative railing with exposed columns which extended from the roof to the slab. The railings and columns were constructed of a painted cementitious material. A secondary metal railing was installed in the interior of the decorative railing, which was in good condition. Evidence of deterioration of the decorative railings in the form of cracking was observed throughout the building (Figure 10). This is not structural damage, yet it is recommended that the decorative railing be repaired to prevent spalled pieces from detaching and falling.

Figure 10. Representative photograph of cracking of decorative railing

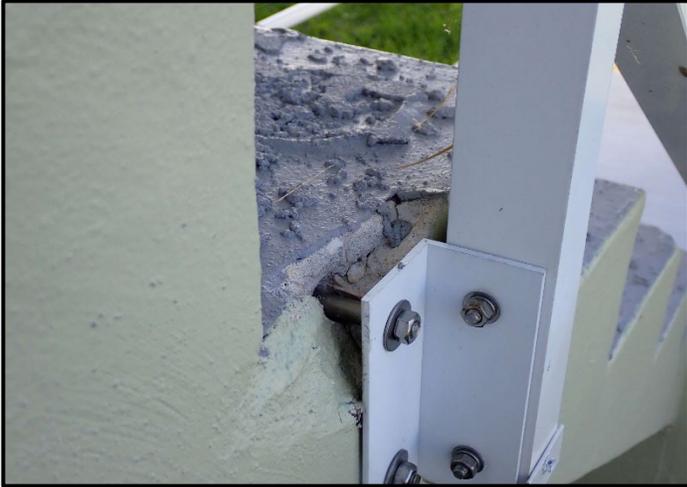
Photograph 09 - P7190011 - stair SW wing.

17	Vertical, diagonal and/or horizontal cracks and few areas of spalling/missing concrete on the concrete railing.	End of SW wing at top of stair landing.	No	No	Y - Localized as noted in the location column.	Yes	Consider full replacement of decorative concrete railings. Perform temporary spot patches until replacement.	No
17	Series of concrete divots across exterior walkway. 6 divots of between 1/2" and 1 1/2" by 1/4" deep.	2nd floor exterior walkway NW wing outside unit 43.	No	No	Y - Localized as noted in the location column.	No	Imperfections have been sealed/painted over. Monitor for growth or spreading of cracks.	No
17	Spalled concrete where stair railing bracket connected to side of concrete stairs; one of 4 concrete anchors not fully engaged with concrete.	first run of stairs from grade to intermediate landing, SW wing stairs.	No	No	Y - Localized as noted in the location column.	No	Unknown depth of anchors; Remove existing paint from exposed concrete, fill with a waterproof grout to keep water from entering poured concrete, reseal/paint with an exterior paint.	No

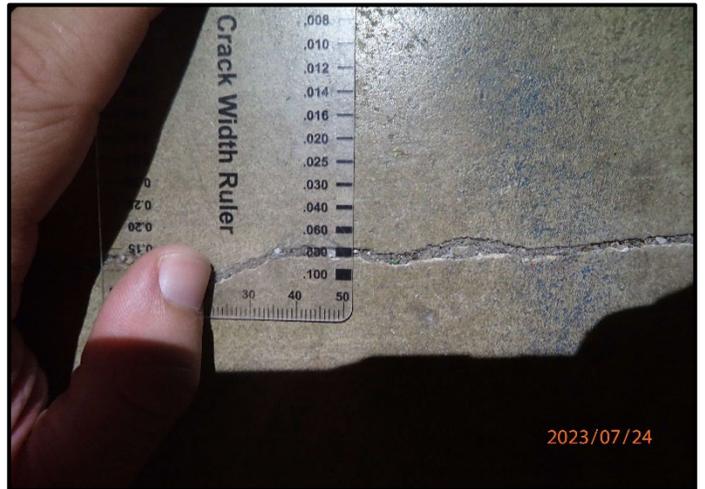
Photograph 12 - P7240428 - EMR floor.

17	Filled 0.08" crack in slab.	1st floor elevator machine room floor.	No	No	Y - Localized as noted in the location column.	No	Repair - Seal crack with high-strength epoxy. Paint and then monitor for evidence of growth or opening.	No
17	Stair step crack thru mortar joints.	1st floor elevator machine room, right side end of concrete door lintel.	No	No	Y - Localized as noted in the location column.	No	Repair - Seal crack with high-strength epoxy. Paint and then monitor for evidence of growth or opening.	No
17	Divot/spall in concete slab, approx. 2" dia.	1st floor electrical room floor.	No	No	Y - Localized as noted in the location column.	No	Remove loose concrete and clean divot; fill with a haigh strength grout. Paint/seal over repair and crack.	No
17	Crack through door lintel.	1st floor electrical room floor.	No	No	Y - Localized as noted in the location column.	No	Repair - Seal crack with high-strength epoxy. Paint and then monitor for evidence of growth or opening.	No

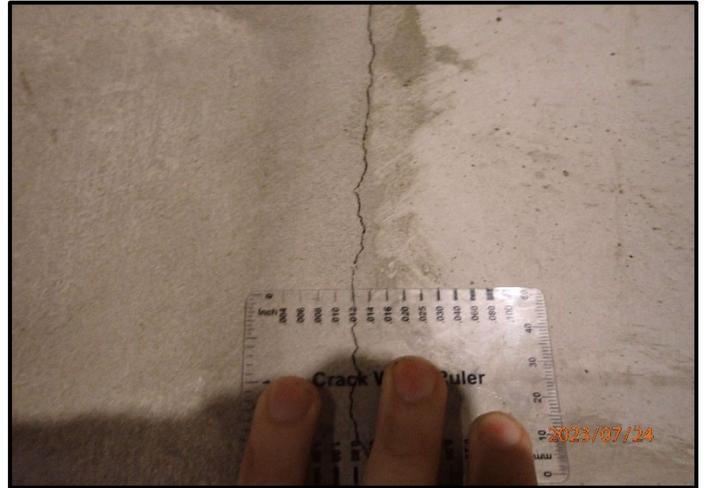
Photograph 22 - P7240478 - 2nd flr large storage room.

17	hairline cracks in slab.	2nd floor large storage room at door lintel.	No	No	Y - Localized as noted in the location column.	No	Repair - seal cracks with a high strength epoxy. Paint and monitor for growth or opening of crack.	No
17	Stair step crack thru mortar joints.	2nd floor large storage room at door lintel.	No	No	Y - Localized as noted in the location column.	No	Repair - Seal crack with high-strength epoxy. Paint and then monitor for evidence of growth or opening.	No
17	Hairline cracks in slab.	3rd floor roof access storage room floor.	No	No	Y - Localized as noted in the location column.	No	Monitor for evidence of growth or opening.	No

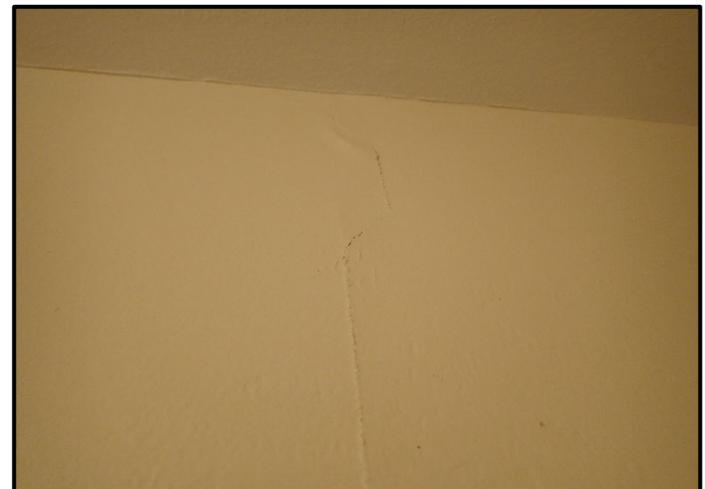
Photograph 24 - P8171774 - vertical hairline crack in unit 6.

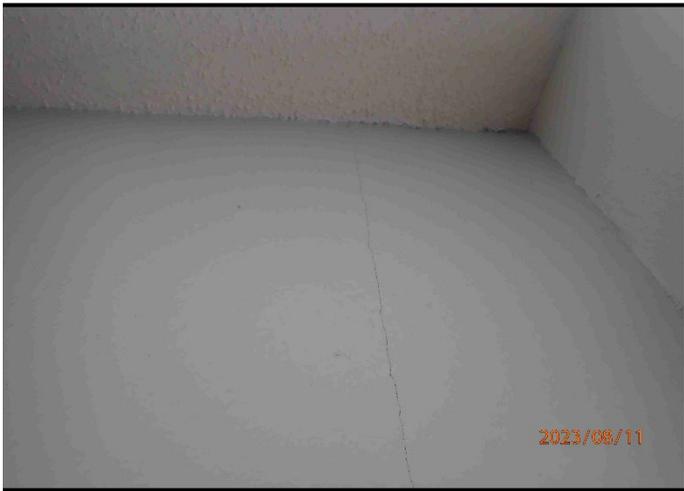
Photograph 25 - P8110231 - vertical hairline crack in unit 17.

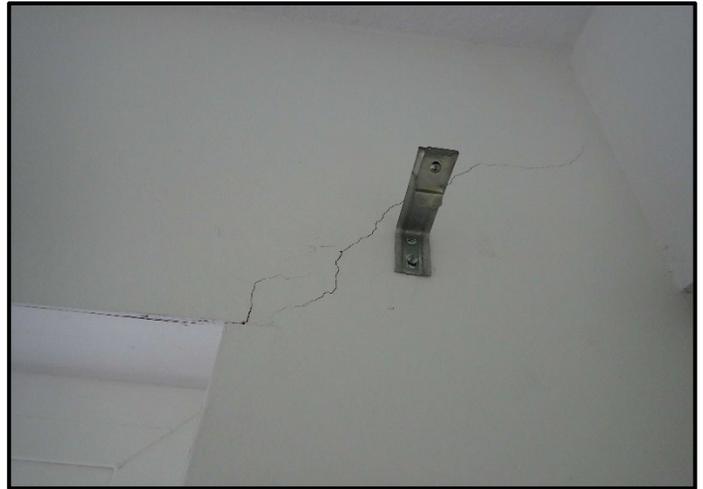
Photograph 26 - P8100069 - vertical hairline crack in unit 53.
