Phase 1 Milestone Inspection Report

On Top of the World Clearwater

Building 17

ESi Project No: 98508

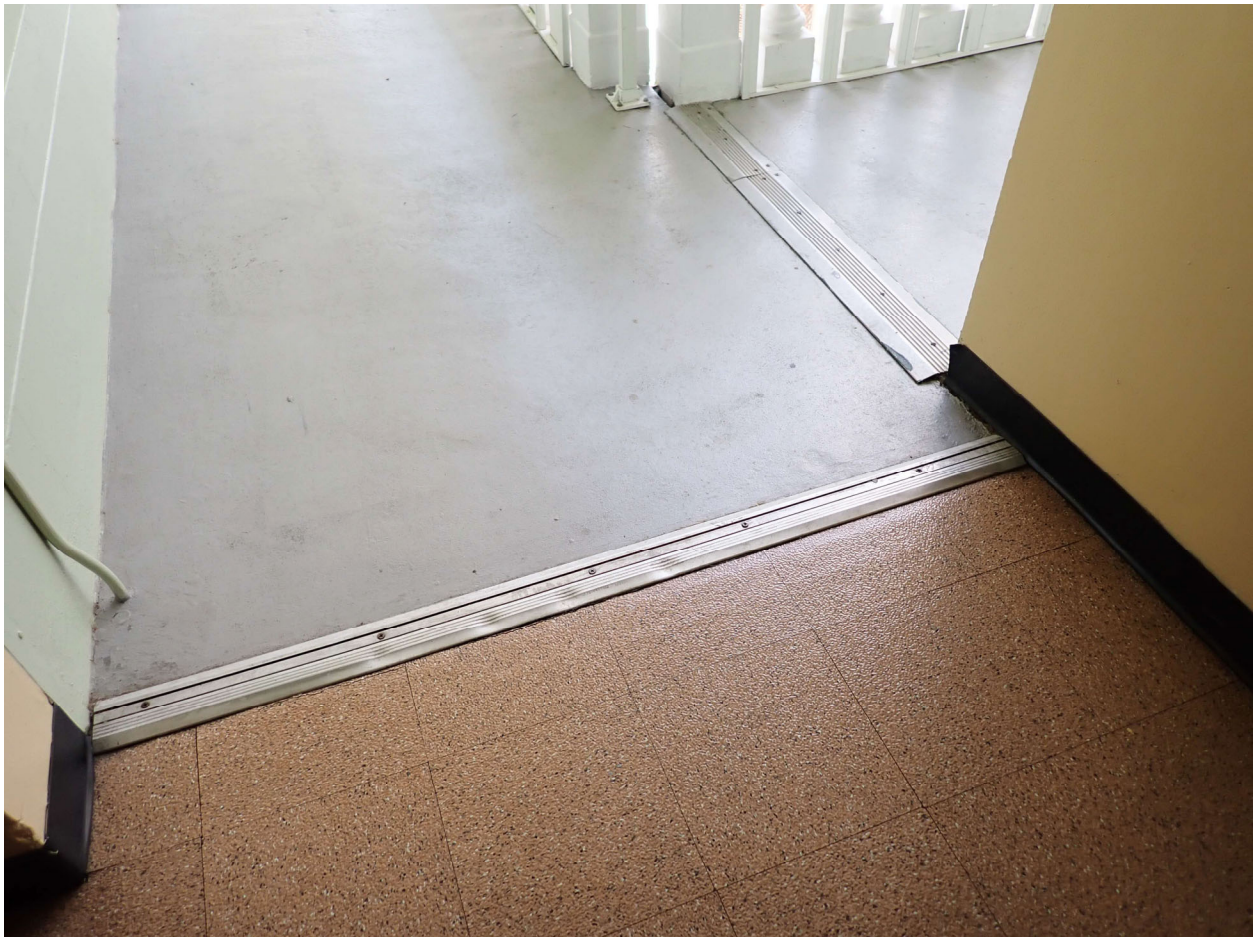
Figure 5. Representative expansion joint at wing/core intersection.

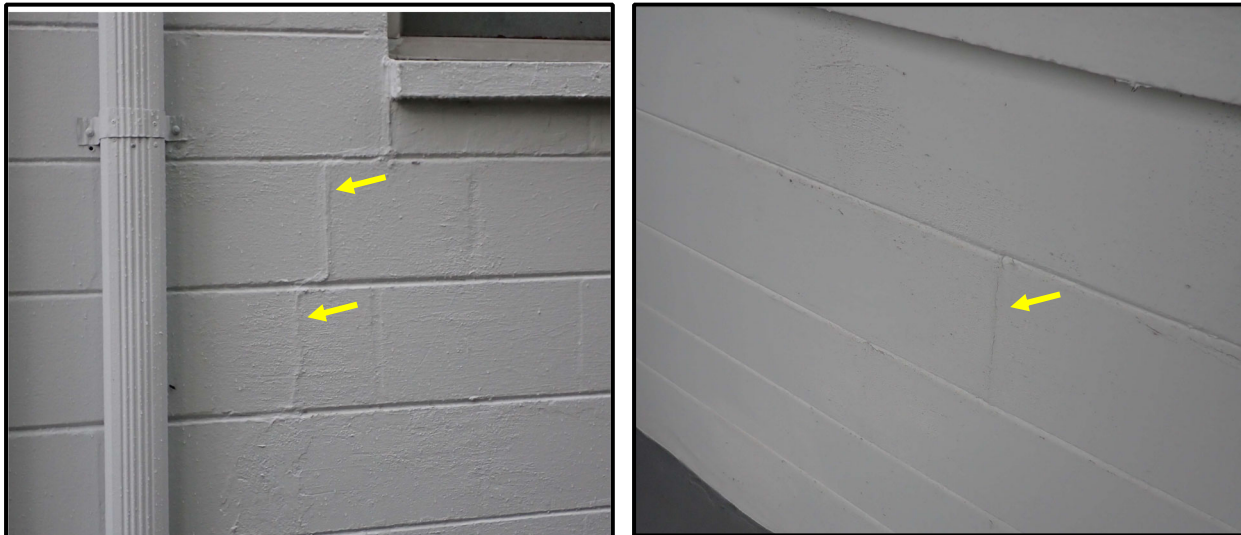
Stairstep cracks, both previously repaired and those appearing to be recent, on the CMU bearing walls of the wings particularly below windows and near the core were typically observed throughout the elevations of the building. Stairstep cracks are cracks in the mortar joints and form due to the movement of the structure, as mortar is a brittle material. The observed width and location of the cracks represent typical movement from a structure (commonly due to soil settlement) and do not appear to be indicative of structural damage. Recommendation for repairs and monitoring of the cracks is provided in Exhibit A. Representative photographs of this observation are shown below in **Figure 7**.

Figure 7. Representative photographs of step stair cracks at CMU walls.

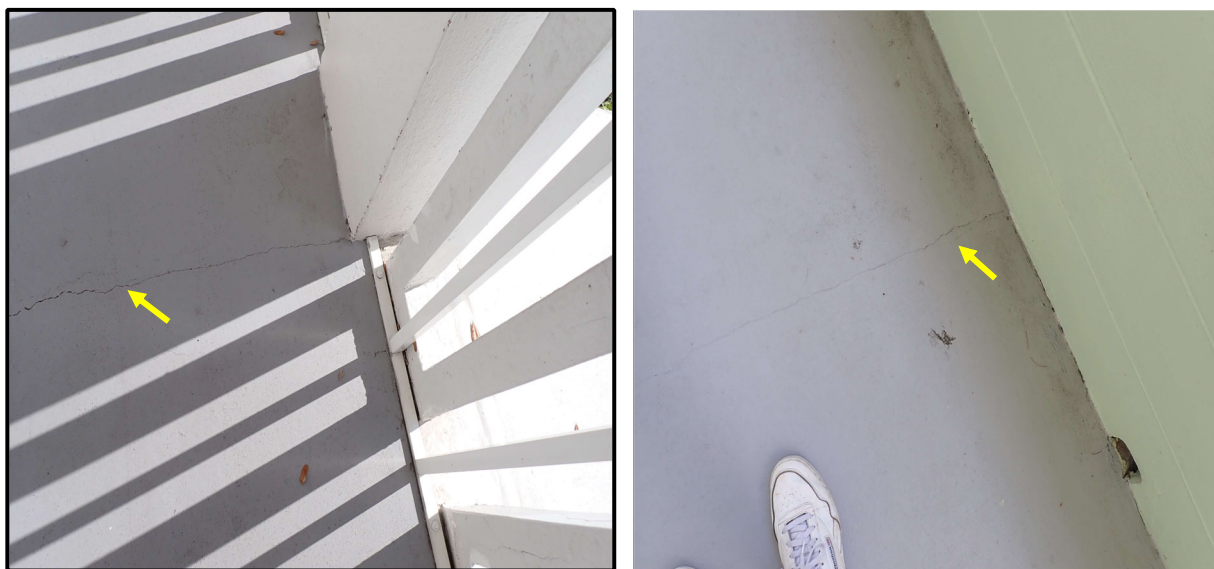
Cracks on the exterior hallway floor slabs were observed perpendicular to the length of the slab and the supporting wall. The observed cracks were typically hairline cracks and shallow. The cracks had weathered edges and dirt on the inside, representing they are historical in nature. The frequency and spacing of these cracks were not uniform. The observed cracks in the subject building are likely due to the expansion and contraction of the materials where control joints were not observed or due to the deflection of the slab at support locations and do not represent a structural damage or substantial deterioration. Recommendation for repairs and monitoring of the cracks is provided in Exhibit A. Representative photographs of this observation are shown below in **Figure 8**.

Figure 8. Representative photographs of shallow cracks at top surface of the exterior hallway.

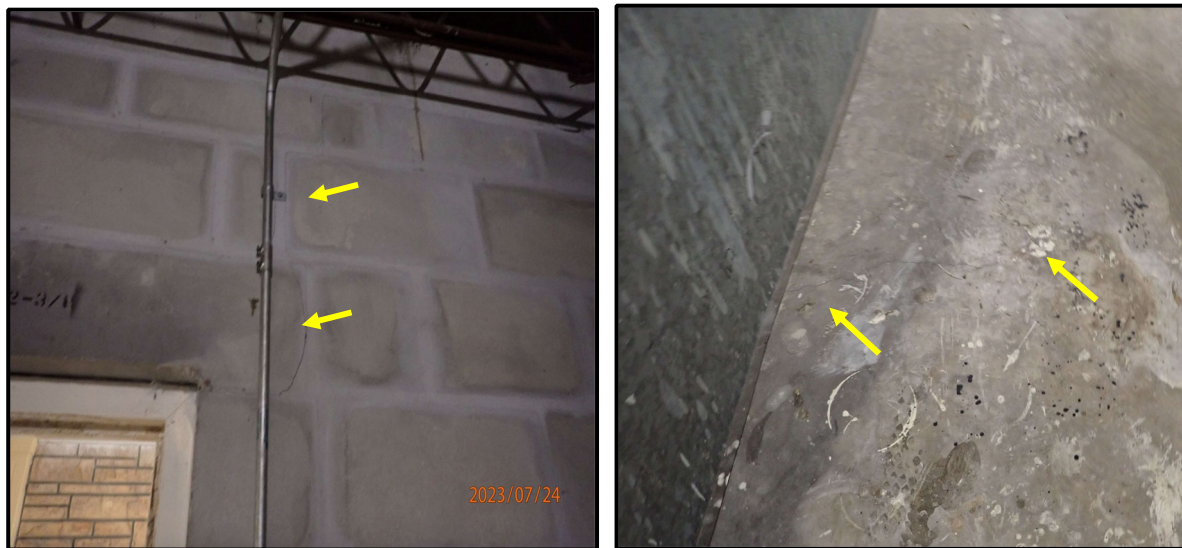
Vertical and horizontal cracking was observed on the building's core on the CMU walls of the storage rooms. CMU and mortar are brittle materials and are likely to crack when subjected to expansion and contraction and differential movement. The observed cracks are due to the movement of the core throughout its life. Similarly observed, were cracks on the concrete slab on grade on the first-floor electrical and storage rooms. The observed cracks are due to the expansion and contraction of the slab and typical settlement of the soils below the structure. Recommendations for repairs and monitoring of the cracks is provided in Exhibit A. Representative photographs of this observation are shown below in **Figure 9**.

Figure 9. Representative photographs of cracks on CMU walls and concrete slabs at common rooms in Core building.

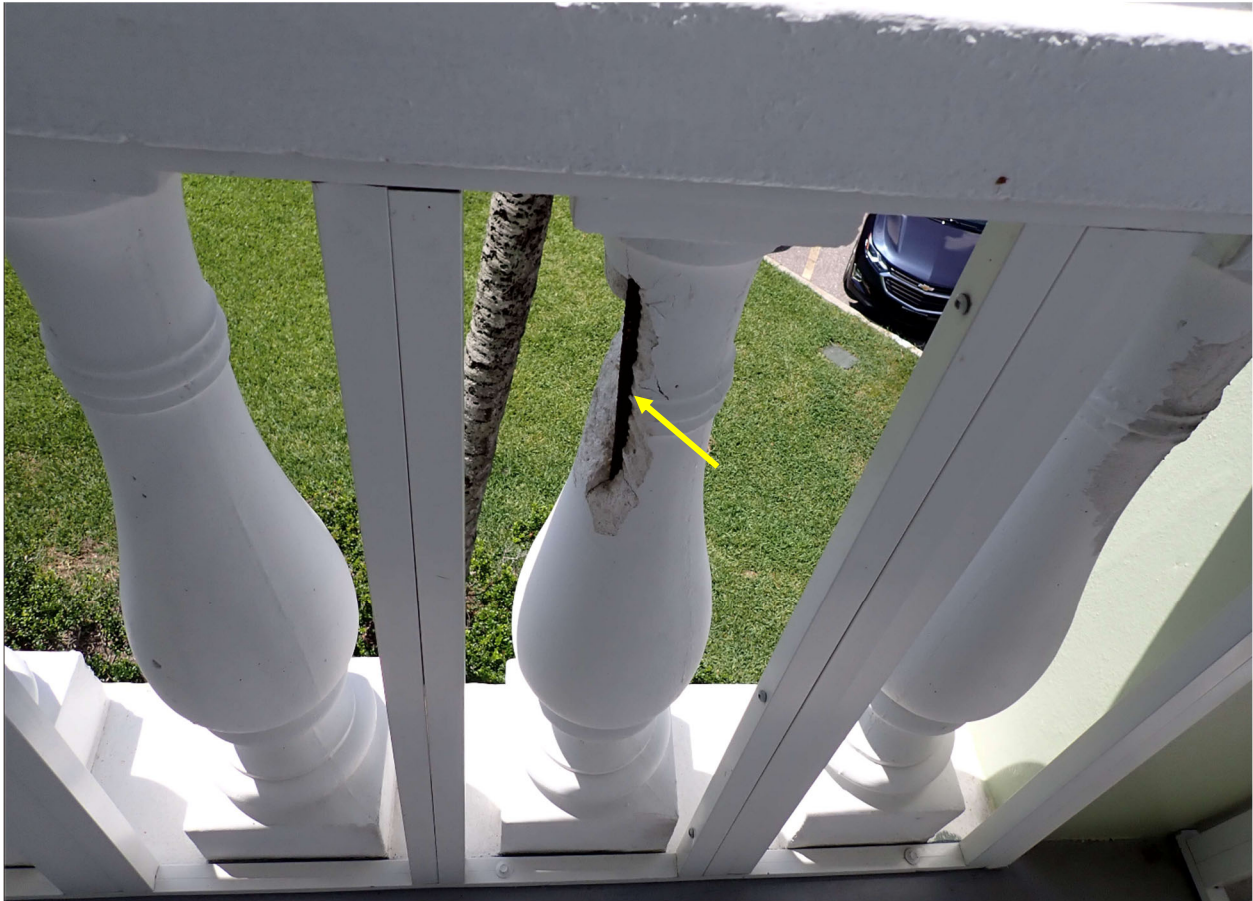
The building's exterior architectural features consisted of a decorative railing with exposed columns which extended from the roof to the slab. The railings and columns were constructed of a painted cementitious material. A secondary metal railing was installed in the interior of the decorative railing, which was in good condition. Evidence of deterioration of the decorative railings in the form of cracking was observed throughout the building (Figure 10). This is not structural damage, yet it is recommended that the decorative railing be repaired to prevent spalled pieces from detaching and falling.

Figure 10. Representative photograph of cracking of decorative railing

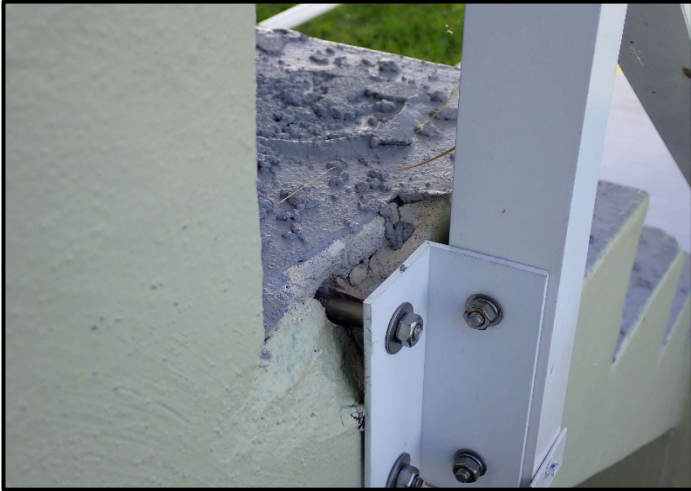
Photograph 09 - P7190011 - stair SW wing.

17	Vertical, diagonal and/or horizontal cracks and few areas of spalling/missing concrete on the concrete railing.	End of SW wing at top of stair landing.	No	No	Y - Localized as noted in the location column.	Yes	Consider full replacement of decorative concrete railings. Perform temporary spot patches until replacement.	No
17	Series of concrete divots across exterior walkway. 6 divots of between 1/2" and 1 1/2" by 1/4" deep.	2nd floor exterior walkway NW wing outside unit 43.	No	No	Y - Localized as noted in the location column.	No	Imperfections have been sealed/painted over. Monitor for growth or spreading of cracks.	No
17	Spalled concrete where stair railing bracket connected to side of concrete stairs; one of 4 concrete anchors not fully engaged with concrete.	first run of stairs from grade to intermediate landing, SW wing stairs.	No	No	Y - Localized as noted in the location column.	No	Unknown depth of anchors; Remove existing paint from exposed concrete, fill with a waterproof grout to keep water from entering poured concrete, reseal/paint with an exterior paint.	No

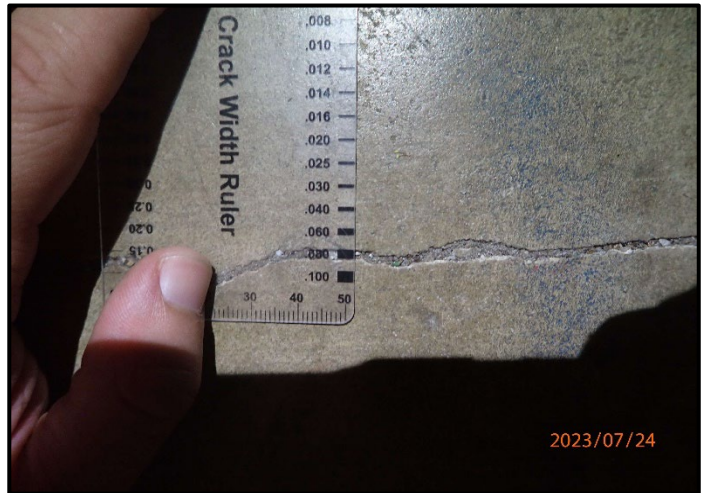
Photograph 12 - P7240428 - EMR floor.

17	Filled 0.08" crack in slab.	1st floor elevator machine room floor.	No	No	Y - Localized as noted in the location column.	No	Repair - Seal crack with high-strength epoxy. Paint and then monitor for evidence of growth or opening.	No
17	Stair step crack thru mortar joints.	1st floor elevator machine room, right side end of concrete door lintel.	No	No	Y - Localized as noted in the location column.	No	Repair - Seal crack with high-strength epoxy. Paint and then monitor for evidence of growth or opening.	No
17	Divot/spall in concete slab, approx. 2" dia.	1st floor electrical room floor.	No	No	Y - Localized as noted in the location column.	No	Remove loose concrete and clean divot; fill with a haigh strength grout. Paint/seal over repair and crack.	No
17	Crack through door lintel.	1st floor electrical room floor.	No	No	Y - Localized as noted in the location column.	No	Repair - Seal crack with high-strength epoxy. Paint and then monitor for evidence of growth or opening.	No

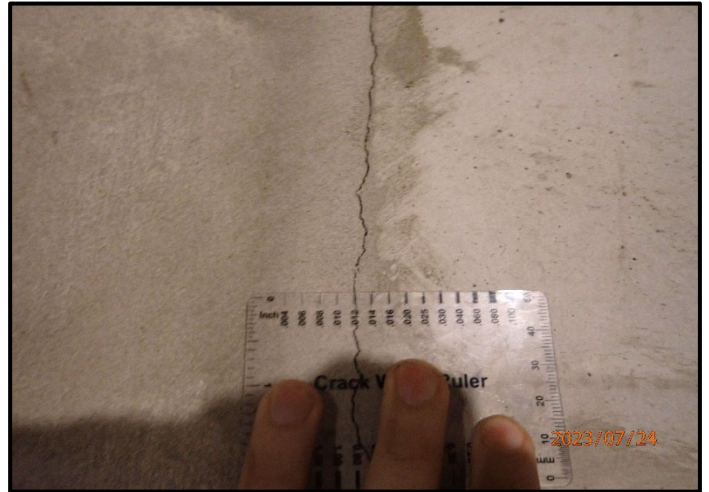
Photograph 22 - P7240478 - 2nd flr large storage room.

17	hairline cracks in slab.	2nd floor large storage room at door lintel.	No	No	Y - Localized as noted in the location column.	No	Repair - seal cracks with a high strength epoxy. Paint and monitor for growth or opening of crack.	No
17	Stair step crack thru mortar joints.	2nd floor large storage room at door lintel.	No	No	Y - Localized as noted in the location column.	No	Repair - Seal crack with high-strength epoxy. Paint and then monitor for evidence of growth or opening.	No
17	Hairline cracks in slab.	3rd floor roof access storage room floor.	No	No	Y - Localized as noted in the location column.	No	Monitor for evidence of growth or opening.	No

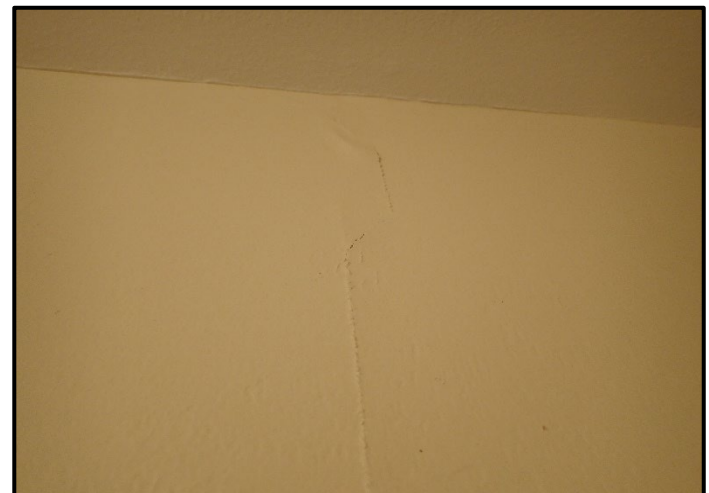
Photograph 24 - P8171774 - vertical hairline crack in unit 6.

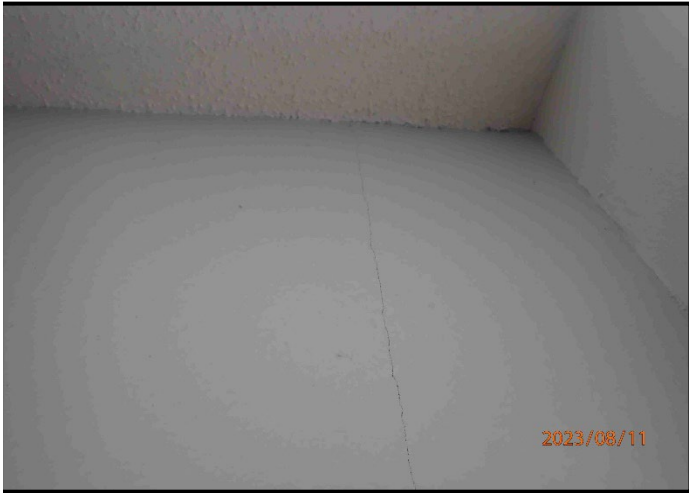
Photograph 25 - P8110231 - vertical hairline crack in unit 17.

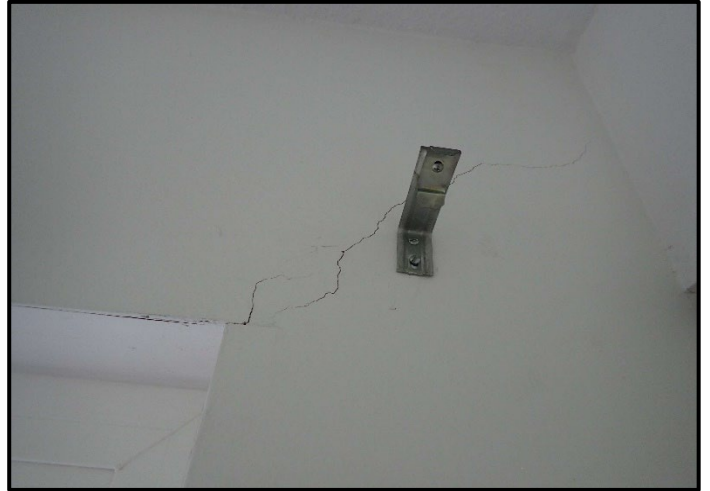
Photograph 26 - P8100069 - vertical hairline crack in unit 53.
