Phase 1 Milestone Inspection Report

On Top of the World Clearwater

Building 21

ESi Project No: 98508

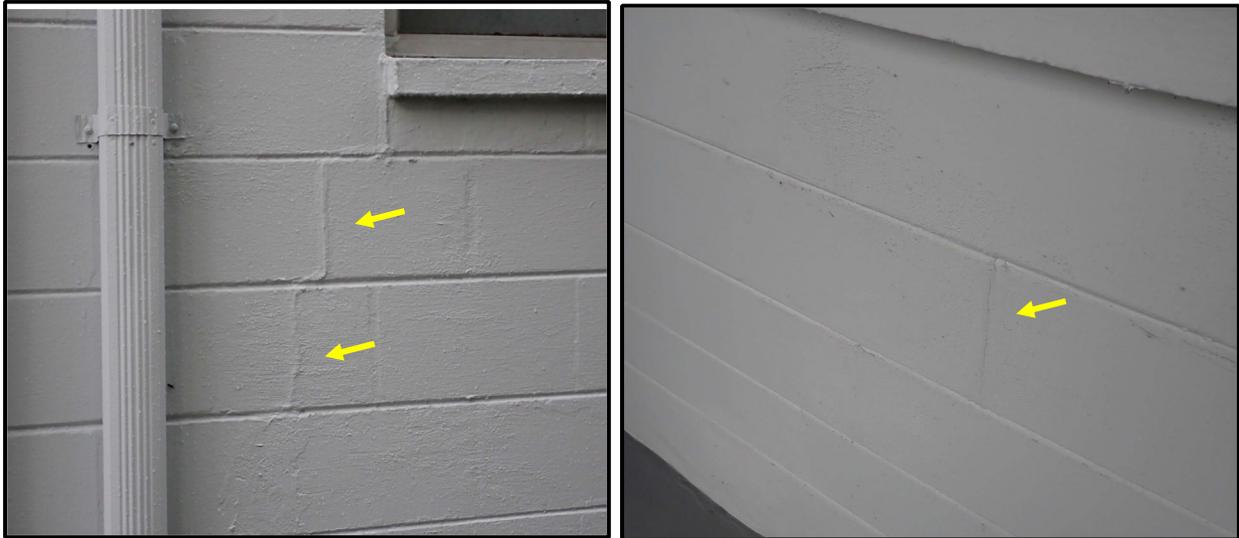
Stairstep cracks, both previously repaired and those appearing to be recent, on the CMU bearing walls of the wings particularly below windows and near the core were typically observed throughout the elevations of the building. Stairstep cracks are cracks in the mortar joints and form due to the movement of the structure, as mortar is a brittle material. The observed width and location of the cracks represent typical movement from a structure (commonly due to soil settlement) and do not appear to be indicative of structural damage. Recommendation for repairs and monitoring of the cracks is provided in Exhibit A. Representative photographs of this observation are shown below in **Figure 7**.

Figure 7. Representative photographs of step stair cracks at CMU walls.

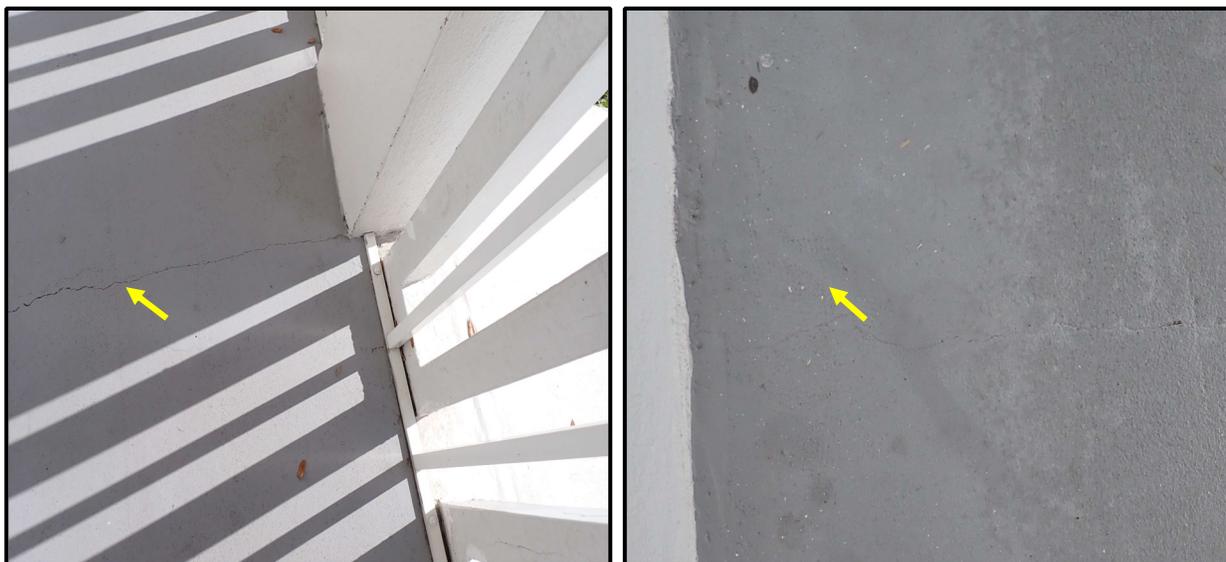
Cracks on the exterior hallway floor slabs were observed perpendicular to the length of the slab and the supporting wall. The observed cracks were typically hairline cracks and shallow. The cracks had weathered edges and dirt on the inside, representing they are historical in nature. The frequency and spacing of these cracks were not uniform. The observed cracks in the subject building are likely due to the expansion and contraction of the materials where control joints were not observed or due to the deflection of the slab at support locations and do not represent a structural damage or substantial deterioration. Recommendation for repairs and monitoring of the cracks is provided in Exhibit A. Representative photographs of this observation are shown below in **Figure 8**.

Figure 8. Representative photographs of shallow cracks at top surface of the exterior hallway.

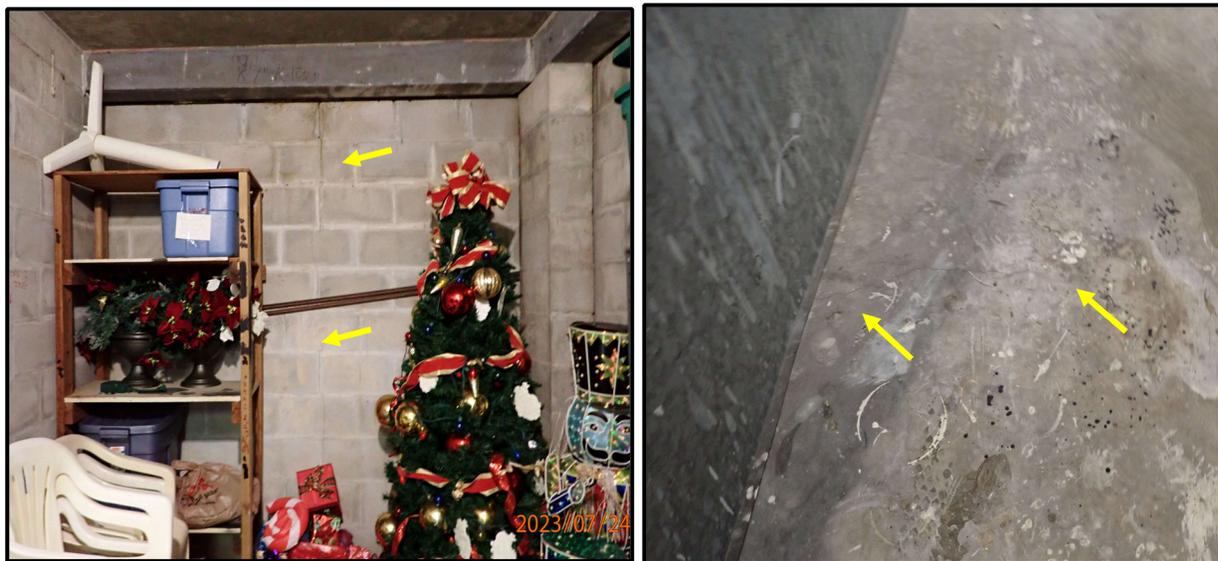
Vertical and horizontal cracking was observed on the building's core on the CMU walls of the storage rooms. CMU and mortar are brittle materials and are likely to crack when subjected to expansion and contraction and differential movement. The observed cracks are due to the movement of the core throughout its life. Similarly observed, were cracks on the concrete slab on grade on the first-floor electrical and storage rooms. The observed cracks are due to the expansion and contraction of the slab and typical settlement of the soils below the structure. Recommendations for repairs and monitoring of the cracks is provided in Exhibit A. Representative photographs of this observation are shown below in Figure 9.

Figure 9. Representative photographs of cracks on CMU walls and concrete slabs at common rooms in Core building.

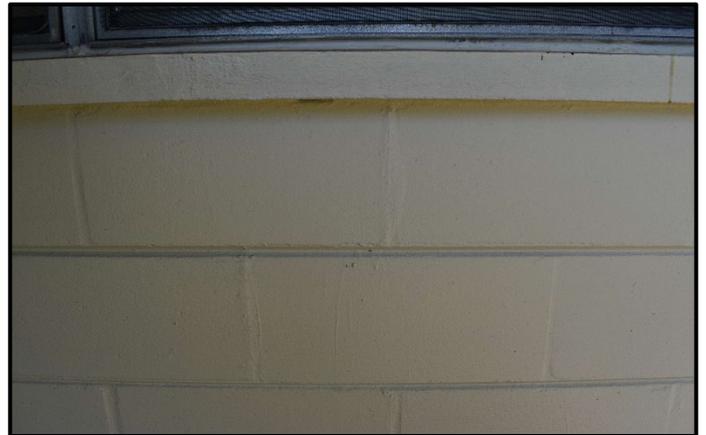
Photograph 04 - Previous repair to stair step crack.

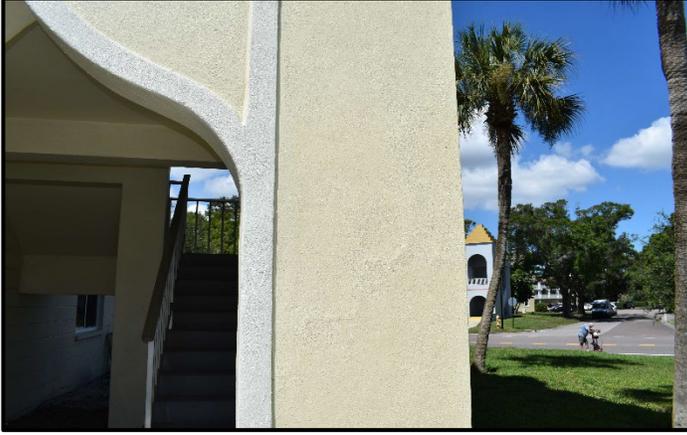
Photograph 05 - Previous repair to stair step crack.

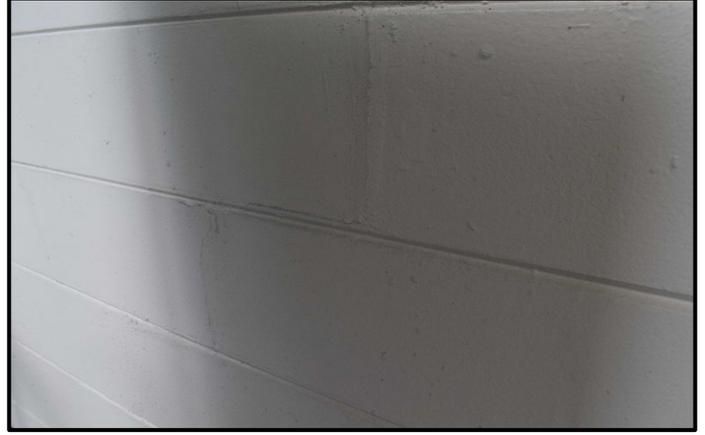
Photograph 06 - Hairline crack re-opened in previous repair.

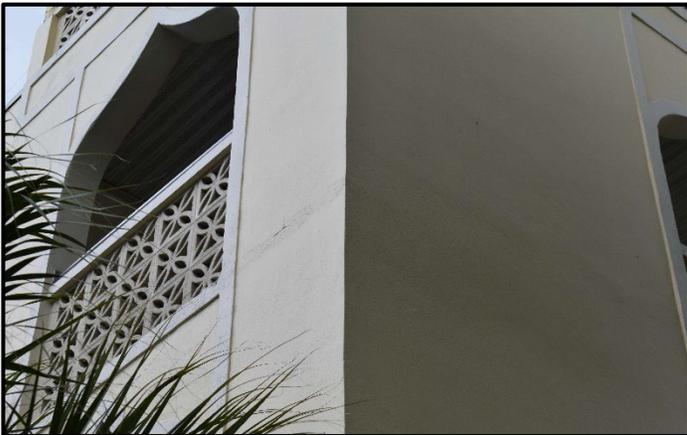
Photograph 07 - Previous repair to horizontal crack.

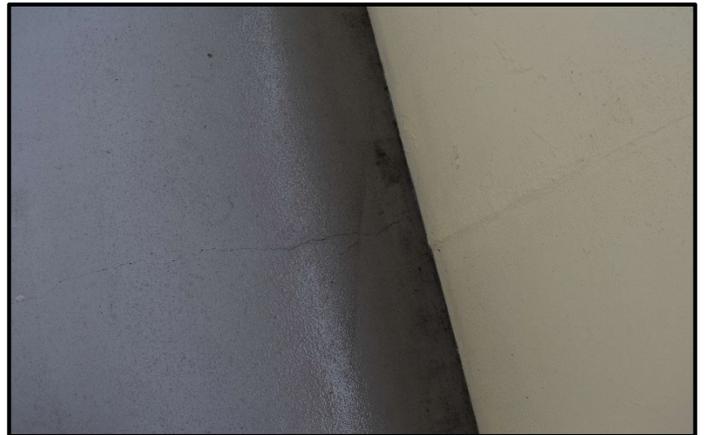
Photograph 08 - Crack in elevated concrete walkway.

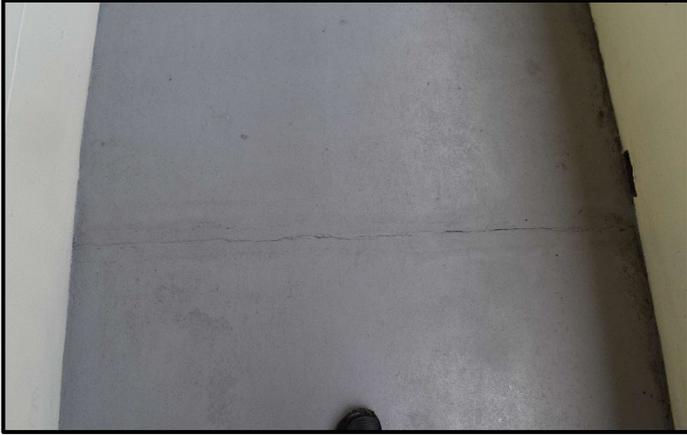
Photograph 09 - Crack in elevated concrete walkway.

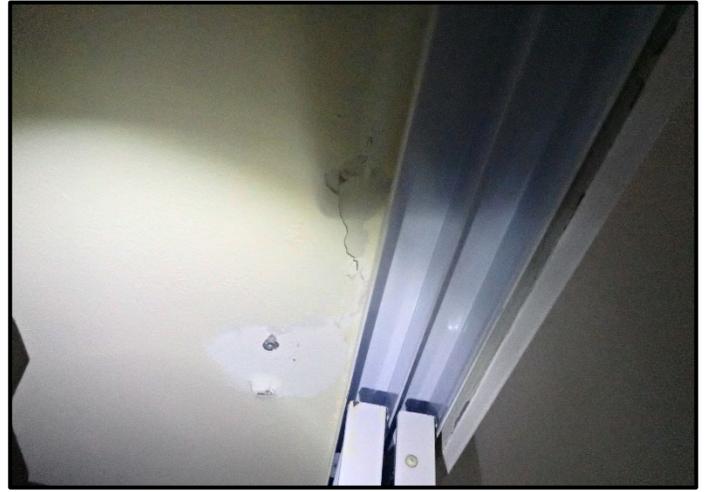
Photograph 14 - Cracking in ceiling of unit 16.

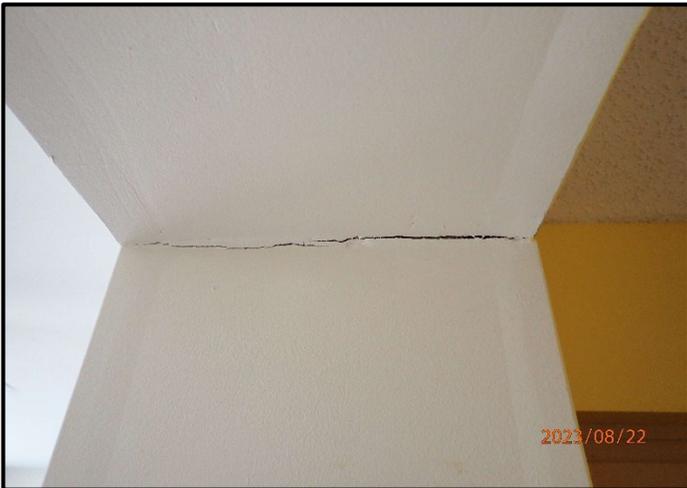
Photograph 15 - Horizontal crack at ceiling intersection with wall in unit 17.
