Phase 1 Milestone Inspection Report

On Top of the World Clearwater

Building 30

ESi Project No: 98508

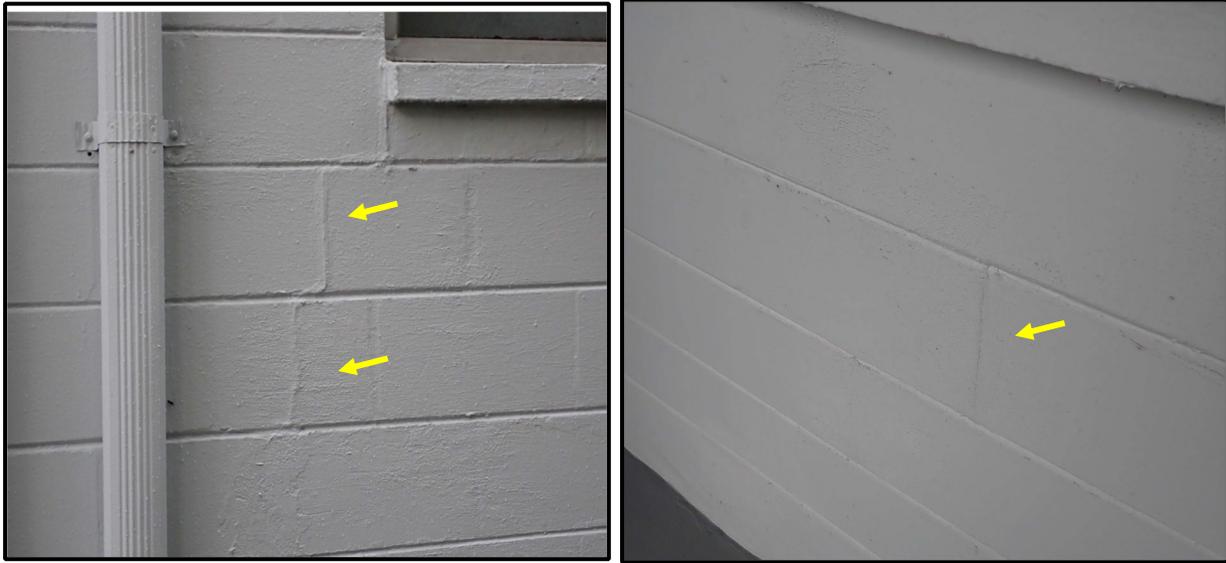
Stairstep cracks, both previously repaired and those appearing to be recent, on the CMU bearing walls of the wings particularly below windows and near the core were typically observed throughout the elevations of the building. Stairstep cracks are cracks in the mortar joints and form due to the movement of the structure, as mortar is a brittle material. The observed width and location of the cracks represent typical movement from a structure (commonly due to soil settlement) and do not appear to be indicative of structural damage. Recommendation for repairs and monitoring of the cracks is provided in Exhibit A. Representative photographs of this observation are shown below in **Figure 7**.

Figure 7. Representative photographs of step stair cracks at CMU walls.

30	Re-opened mortar shallow hairline crack at previous repair to stair step mortar crack in exterior face of CMU wall.	Front elevation of units: 3rd story - 54, 56, 58, 60, 50, 48, 42, 55, 59, 61, 49 and 43. 2nd story - 25, 27, 29, 35, 41, 38, 40, 30, 26, 24 and 22. 1st story - 18, 1 and 19.	N	N	Y - Localized as noted in the location column.	N	Repair - Seal hairline cracks with high-strength epoxy or mortar.	N

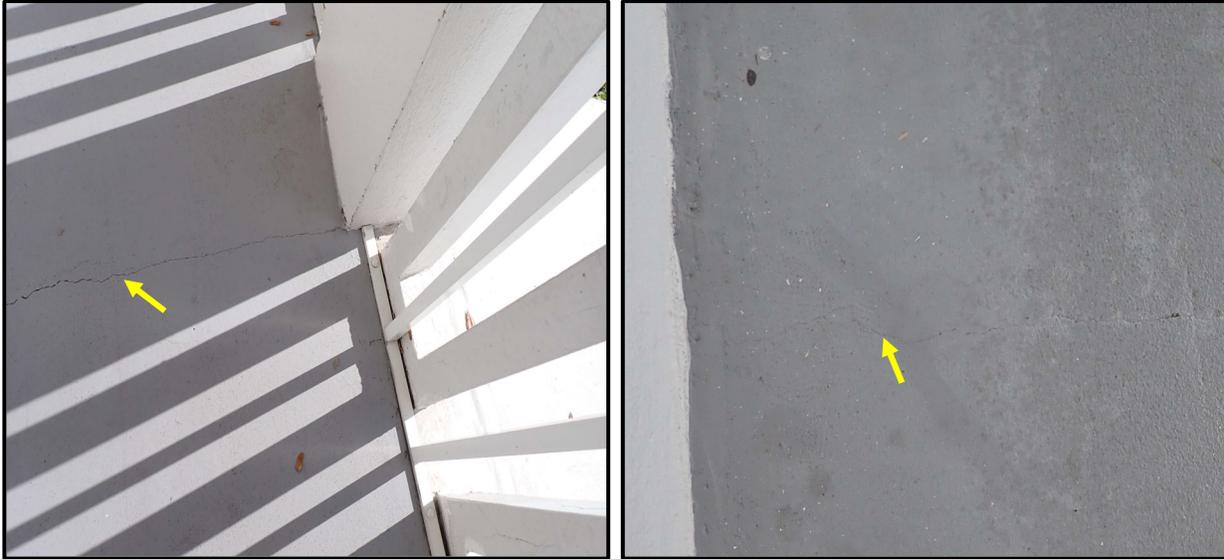
Cracks on the exterior hallway floor slabs were observed perpendicular to the length of the slab and the supporting wall. The observed cracks were typically hairline cracks and shallow. The cracks had weathered edges and dirt on the inside, representing they are historical in nature. The frequency and spacing of these cracks were not uniform. The observed cracks in the subject building are likely due to the expansion and contraction of the materials where control joints were not observed or due to the deflection of the slab at support locations and do not represent a structural damage or substantial deterioration. Recommendation for repairs and monitoring of the cracks is provided in Exhibit A. Representative photographs of this observation are shown below in **Figure 8**.

Figure 8. Representative photographs of shallow cracks at top surface of the exterior hallway.

Building Number	Observation	Location	Structural damage (Y/N) If yes - extent	Substantial Structural Damage (Y/N) If yes - extent	Surface imperfection* (Y/N) If yes - extent	Dangerous as defined by the Florida Building Code? (Y/N)	Recommendations (maintenance, repair, replace, or monitor)	Further (Phase 2) inspection required? (Y/N)
30	Stair step mortar shallow hairline crack in CMU wall.	Front elevation of units: 3rd story - 52 and 47. 2nd story - 23, 33 and 39. 1st story - 4, 3 and 7.	N	N	Y - Localized as noted in the location column.	N	Monitor or Repair - Seal hairline cracks with high-strength epoxy or mortar, if possible.	N
30	Shallow line cracks at the top face of the concrete slab of the exterior walkway perpendicular to the wall, consistently throughout all walkways. In some locations hairline cracks perpendicular to the walkway observed on the bottom face of the concrete slab..	Exterior walkways in 2nd and 3rd story.	N	N	Y - Perpendicular single cracks throughout the walkways in 2nd and 3rd story.	N	Repair - Seal hairline cracks with high-strength epoxy.	N

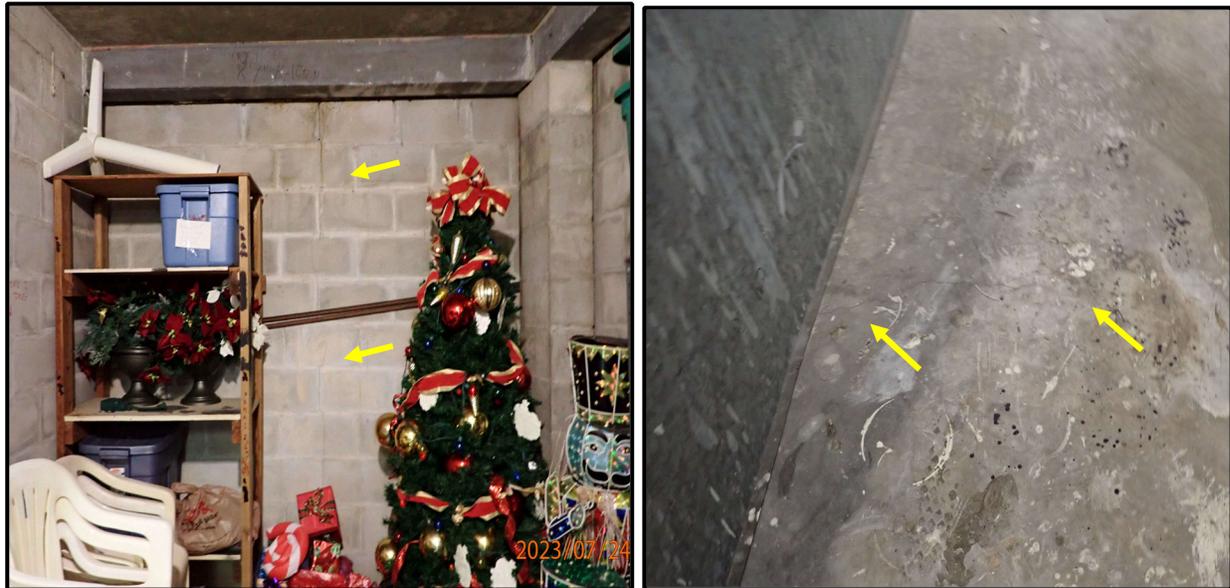
Vertical and stair step cracking was observed on the building's core on the CMU walls of the storage rooms. CMU and mortar are brittle materials and are likely to crack when subjected to expansion and contraction and differential movement. The observed cracks are due to the movement of the core throughout its life. Similarly observed, were cracks on the concrete slab on grade on the first-floor electrical and storage rooms. The observed cracks are due to the expansion and contraction of the slab and typical settlement of the soils below the structure. Recommendations for repairs and monitoring of the cracks is provided in Exhibit A. Representative photographs of this observation are shown below in **Figure 9**.

Figure 9. Representative photographs of cracks on CMU walls and concrete slabs at common rooms in Core building.

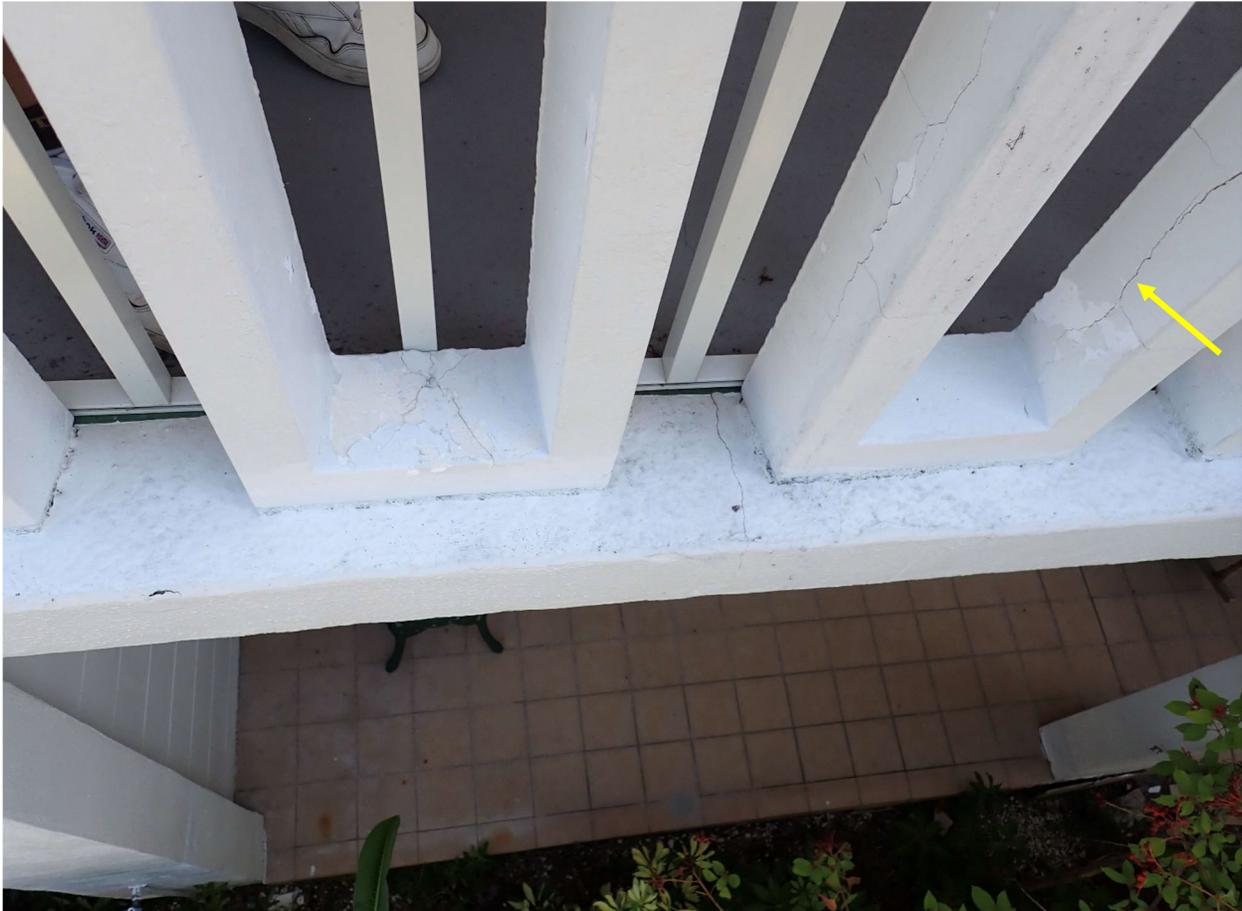
The building's exterior architectural features consisted of a decorative railing with exposed columns which extended from the roof to the slab. The railings and columns were constructed of a painted cementitious material. A secondary metal railing was installed in the interior of the decorative railing, which was in good condition. Evidence of deterioration of the decorative railings in the form of cracking was observed throughout the building (Figure 10). This is not structural damage, yet it is recommended that the decorative railing be repaired to prevent spalled pieces from detaching and falling.

Figure 10. Representative photograph of cracking of decorative railing

30	Surface patch (previous repair) to vertical and horizontal cracks on the concrete railing, with evidence of re-opened cracks in few areas of the concrete railing..	Front elevation of units in 2nd and 3rd story.	N	N	Y - Sporadically throughout the 2nd and 3rd story.	Y	Repair - Seal cracks with high-strength epoxy.	N
30	Surface patch (previous repair) to ceiling finish above stairways.	Stairways located near Unit 60.	N	N	Y - Localized as noted in the location column.	N	Monitor.	N

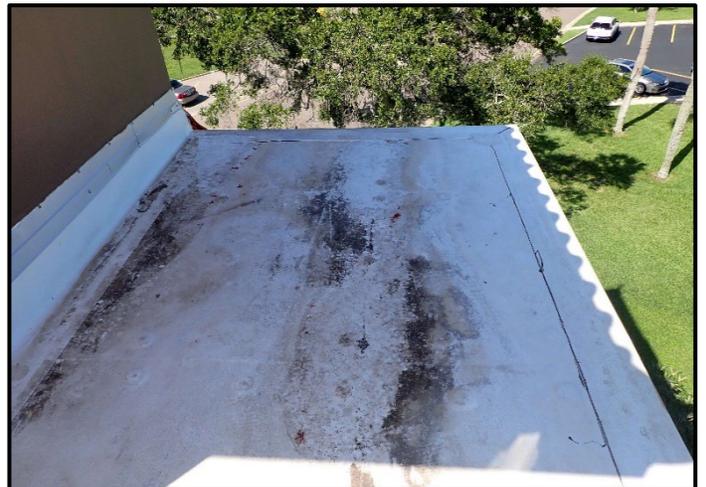
Photograph 04 - View of water stains on the membrane in southwest wing roof.

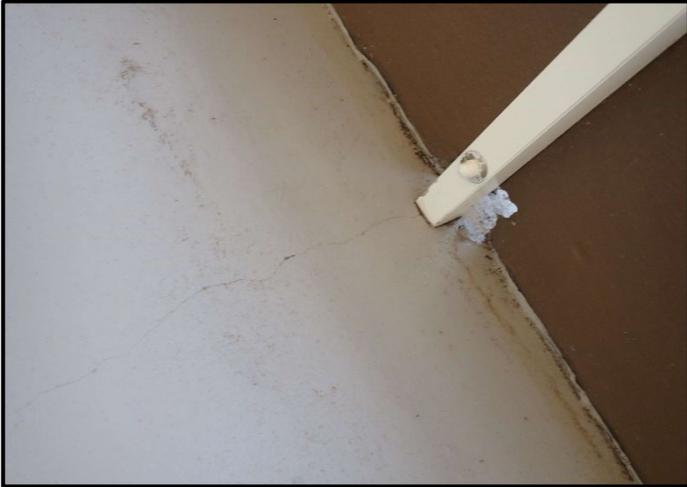
Photograph 05 - View of a crack in the elevated walkway surface perpendicular to the building near Unit 23.

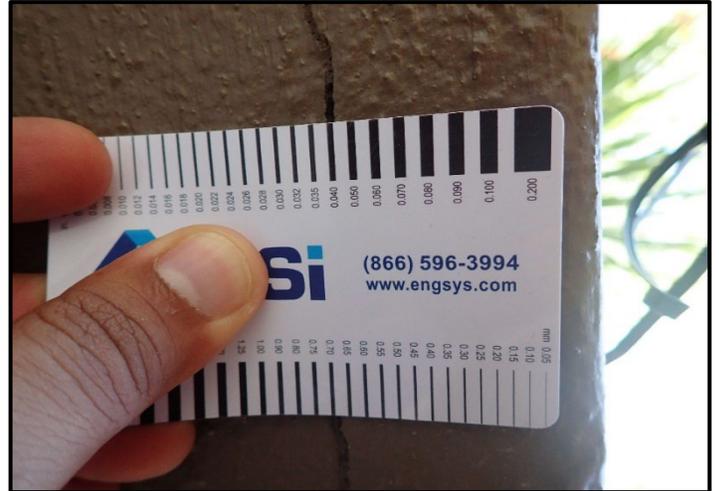
Photograph 06 - View of concrete railing crack near Unit 54, crack measuring approx. 0.04 inch.

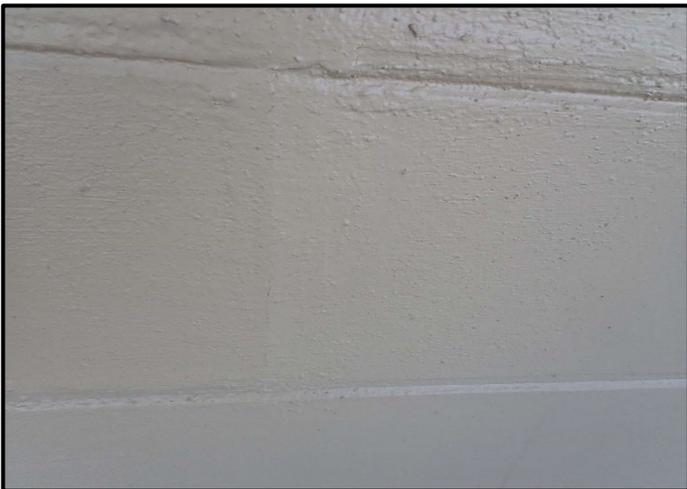
Photograph 07 - View of previous repair to stair step crack near Unit 60.

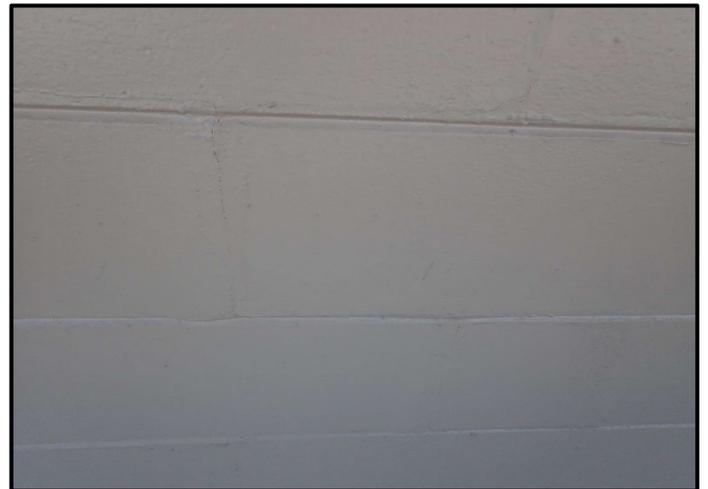
Photograph 08 - View of stair step mortar crack near Unit 23.

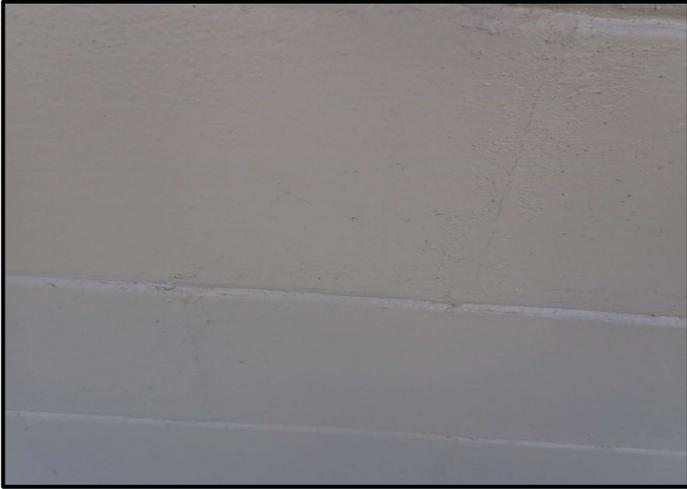
Photograph 09 - View of previous repair to stair step crack with a hairline re-opening near Unit 29.

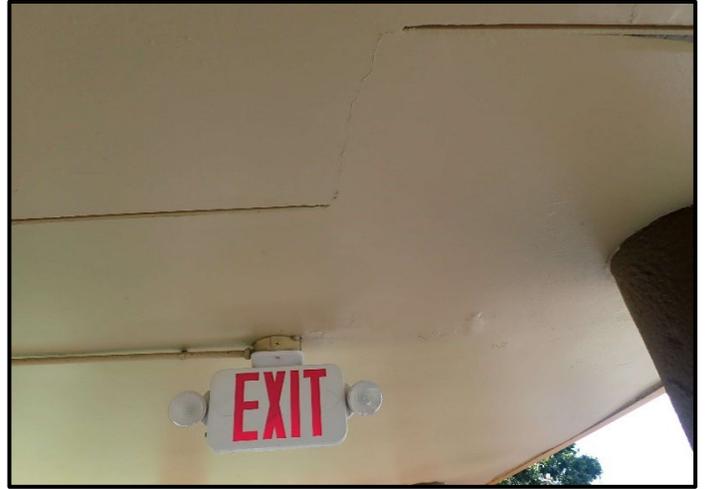
Photograph 10 - View of cracked ceiling finish near Unit 60.

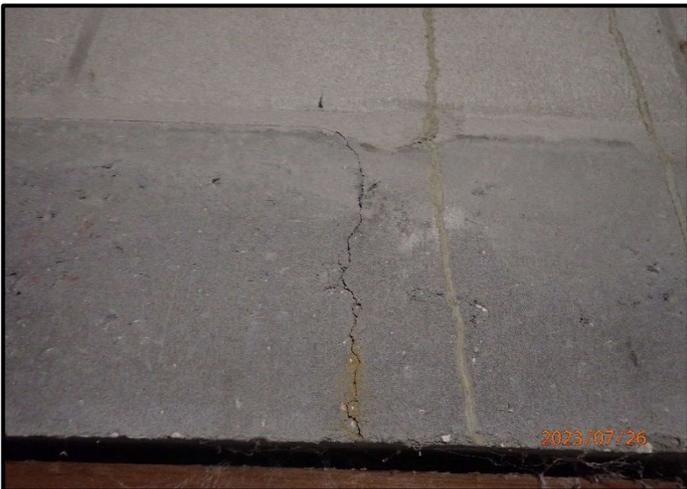
Photograph 11 - View of vertical crack through CMU above door header in 1st story elevator machine room.

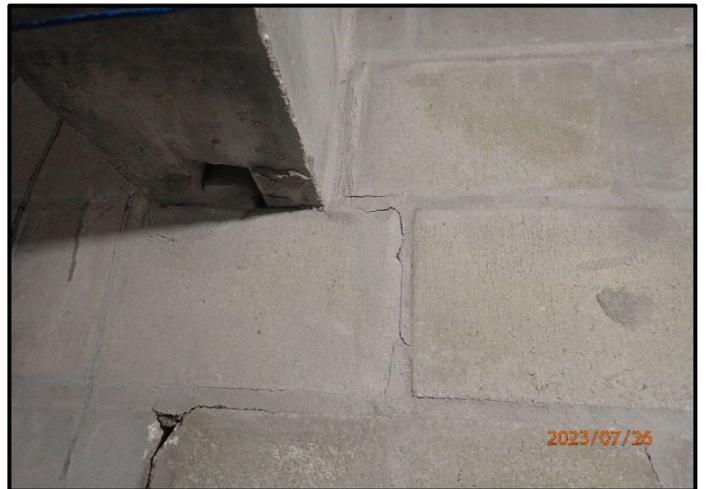
Photograph 12 - View of stair step mortar crack with missing portion of mortar in 1st story electrical room.

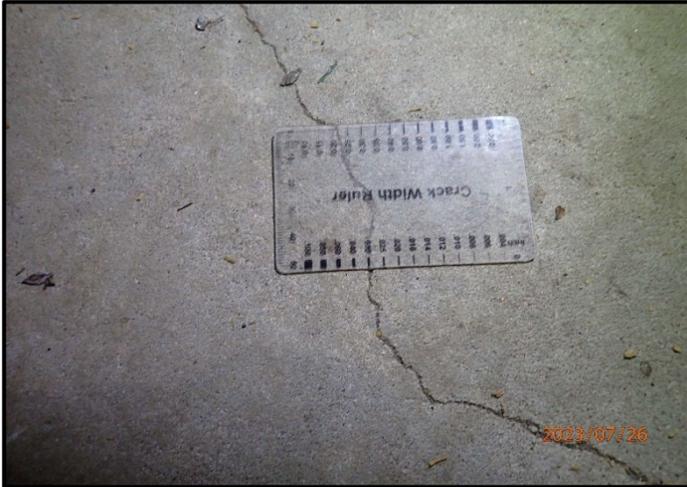
Photograph 13 - View of slab crack in 1st story storage room.

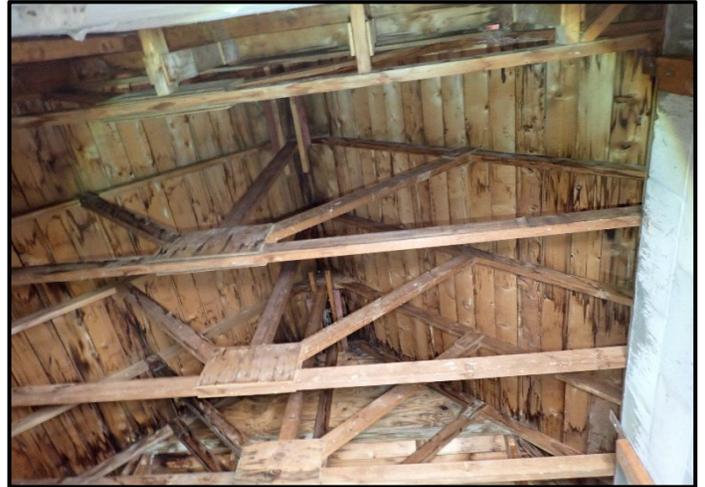
30	Water stains on the roof framing and/or deck.	Roof tower on the northwest wing roof, northeast wing roof, southeast wing roof and southwest wing roof.	N	N	Y - Localized as noted in the location column.	N	Monitor - no evidence of significant moisture damage at this time.	N

Photograph 14 - View of water stains on roof framing within the northeast wing roof hatch.

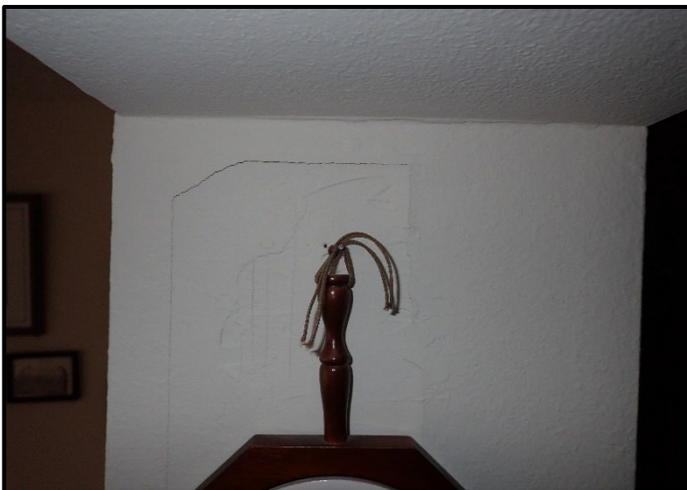
Photograph 15 - Hairline cracks on wall in Unit 48.

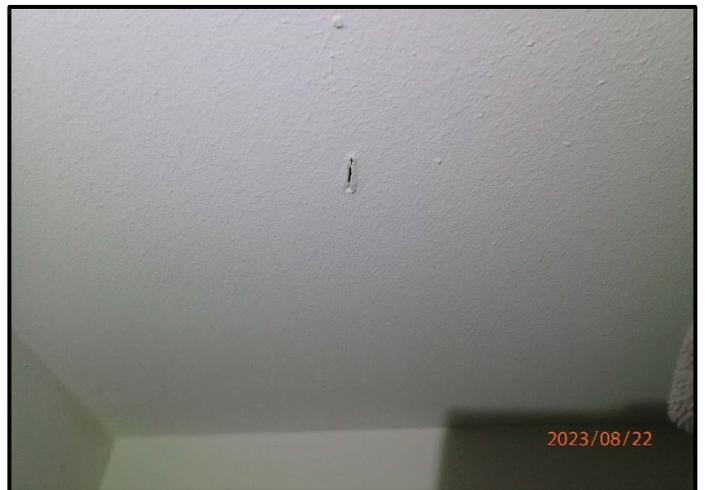
B30:57	In living room, two drywall nail pop above door. In back room, four prior repairs with sealant (nail hole type repair) and prior repair below window corners. In hall, cut in closet ceiling drywall (~1" length).	No	As noted in observation.	No	Monitor repairs.

Photograph 16 - Hole in ceiling of Unit 57.

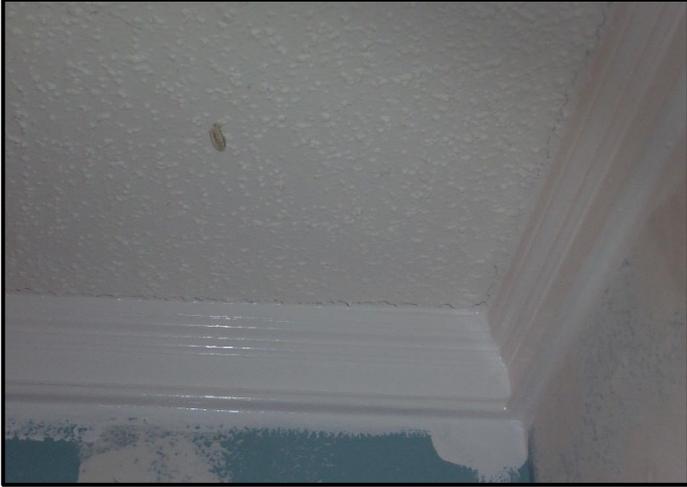
Photograph 17 - View of ceiling in Unit 14.
