Phase 1 Milestone Inspection Report

On Top of the World Clearwater

Building 34

ESi Project No: 98508

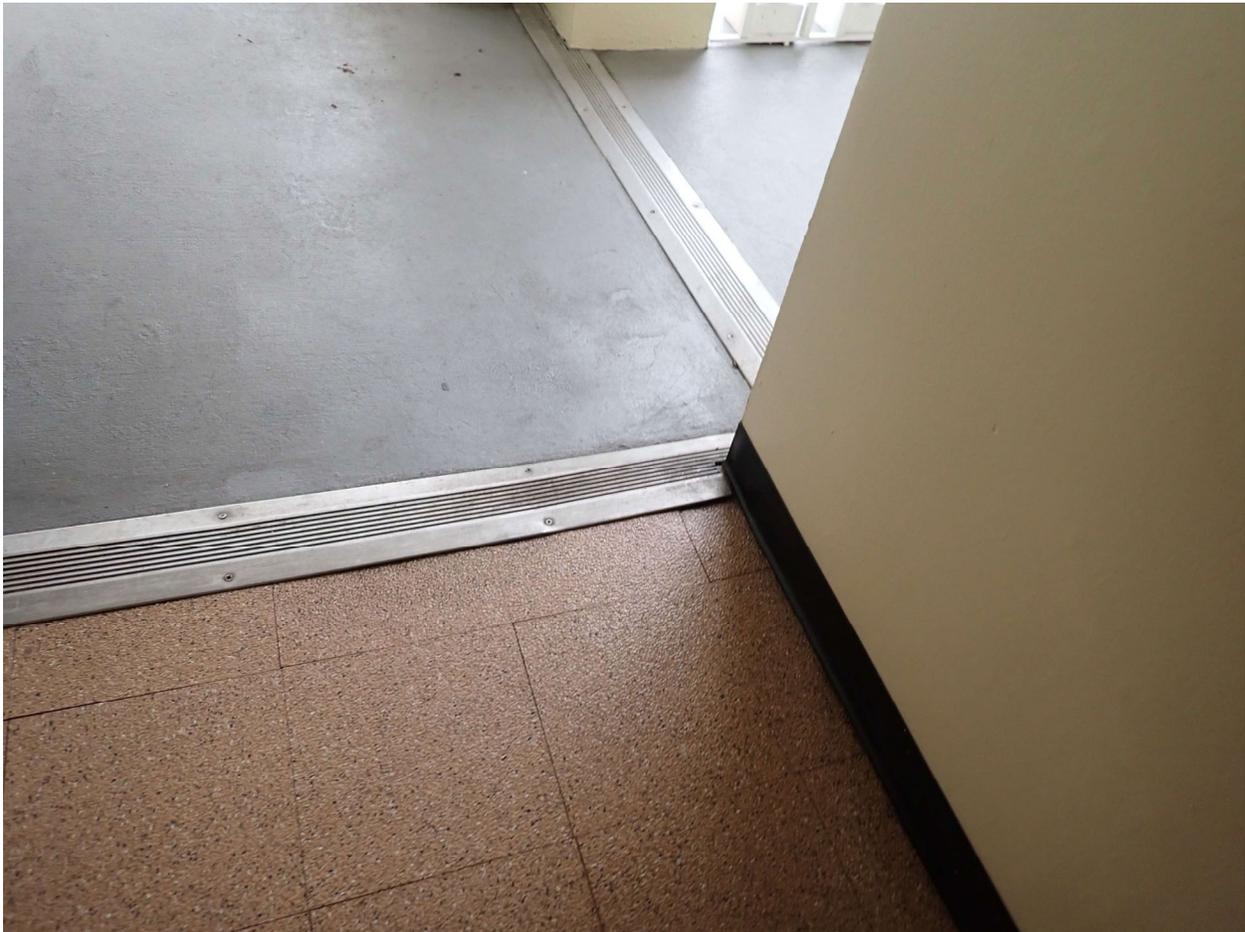
Figure 5. Representative expansion joint at wing/core intersection.

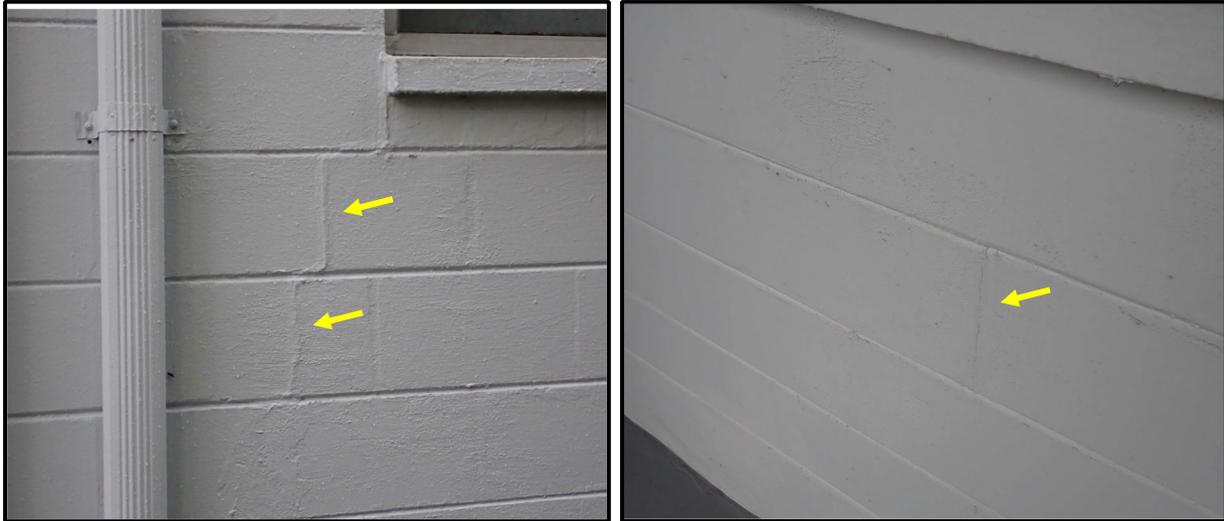
Stairstep cracks, both previously repaired and those appearing to be recent, on the CMU bearing walls of the wings particularly below windows and near the core were typically observed throughout the elevations of the building. Stairstep cracks are cracks in the mortar joints and form due to the movement of the structure, as mortar is a brittle material. The observed width and location of the cracks represent typical movement from a structure (commonly due to soil settlement) and do not appear to be indicative of structural damage. Recommendation for repairs and monitoring of the cracks is provided in Exhibit A. Representative photographs of this observation are shown below in **Figure 7**.

Figure 7. Representative photographs of step stair cracks at CMU walls.

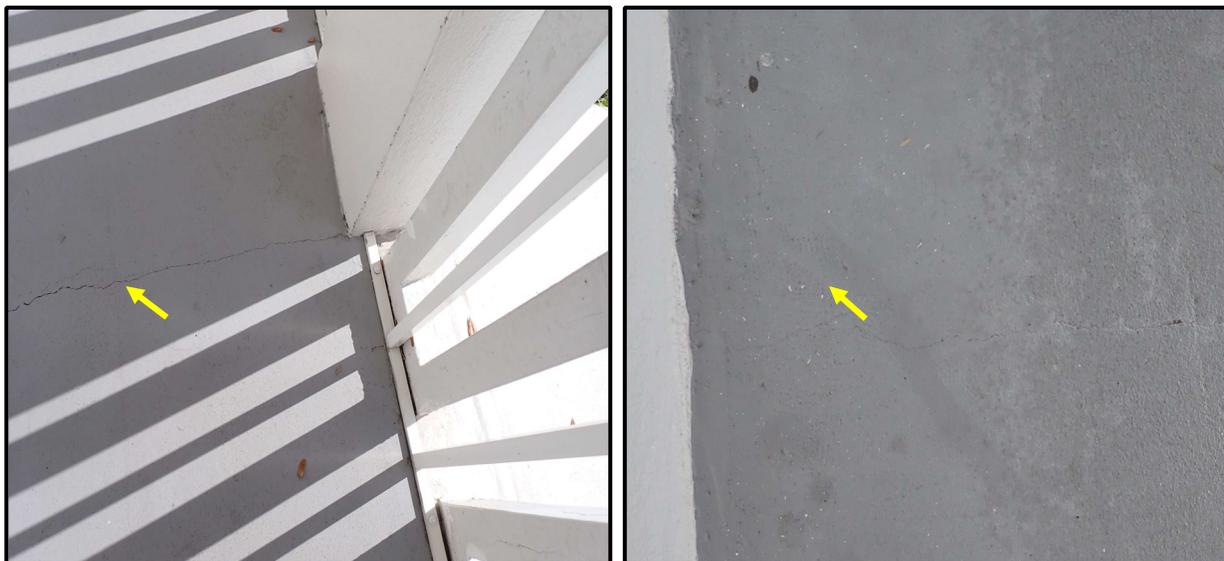
Cracks on the exterior hallway floor slabs were observed perpendicular to the length of the slab and the supporting wall. The observed cracks were typically hairline cracks and shallow. The cracks had weathered edges and dirt on the inside, representing they are historical in nature. The frequency and spacing of these cracks were not uniform. The observed cracks in the subject building are likely due to the expansion and contraction of the materials where control joints were not observed or due to the deflection of the slab at support locations and do not represent a structural damage or substantial deterioration. Recommendation for repairs and monitoring of the cracks is provided in Exhibit A. Representative photographs of this observation are shown below in **Figure 8**.

Figure 8. Representative photographs of shallow cracks at top surface of the exterior hallway.

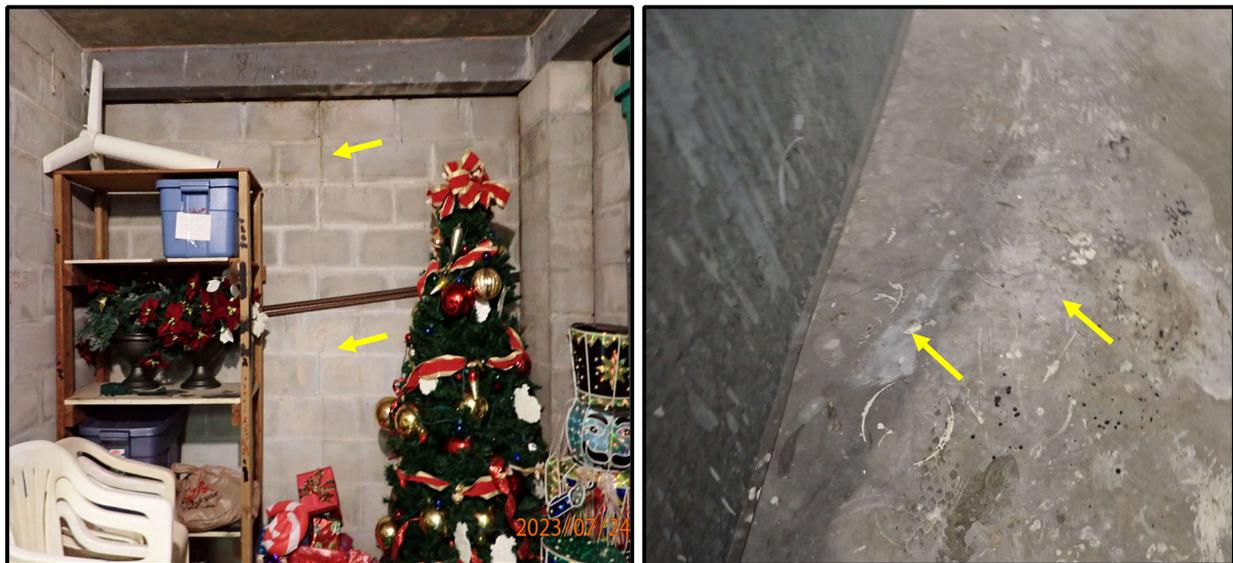
Vertical and horizontal cracking was observed on the building's core on the CMU walls of the storage rooms. CMU and mortar are brittle materials and are likely to crack when subjected to expansion and contraction and differential movement. The observed cracks are due to the movement of the core throughout its life. Similarly observed, were cracks on the concrete slab on grade on the first-floor electrical and storage rooms. The observed cracks are due to the expansion and contraction of the slab and typical settlement of the soils below the structure. Recommendations for repairs and monitoring of the cracks is provided in Exhibit A. Representative photographs of this observation are shown below in **Figure 9**.

Figure 9. Representative photographs of cracks on CMU walls and concrete slabs at common rooms in Core building.

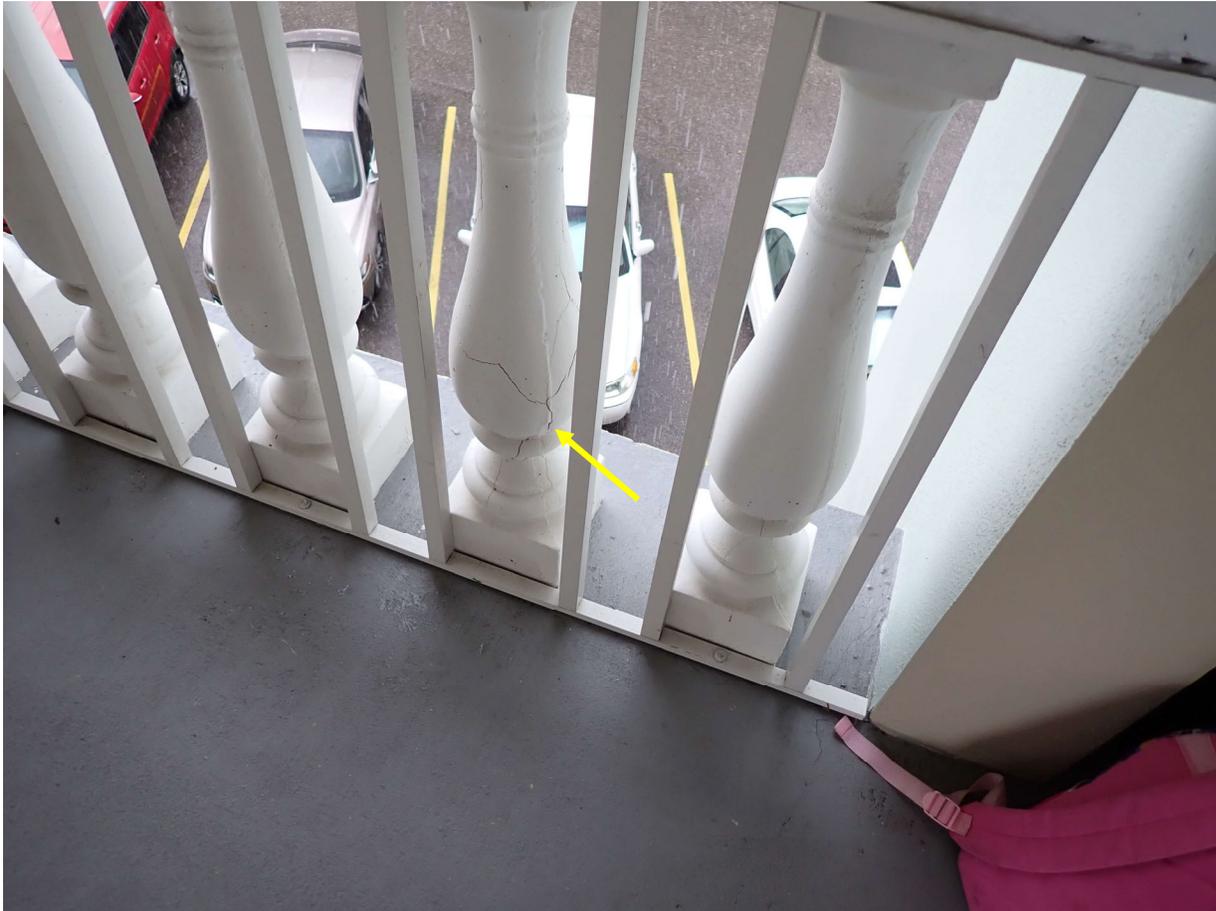
The building's exterior architectural features consisted of a decorative railing with exposed columns which extended from the roof to the slab. The railings and columns were constructed of a painted cementitious material. A secondary metal railing was installed in the interior of the decorative railing, which was in good condition. Evidence of deterioration of the decorative railings in the form of cracking was observed throughout the building (**Figure 10**). This is not structural damage, yet it is recommended that the decorative railing be repaired to prevent spalled pieces from detaching and falling.

Figure 10. Representative photograph of cracking of decorative railing

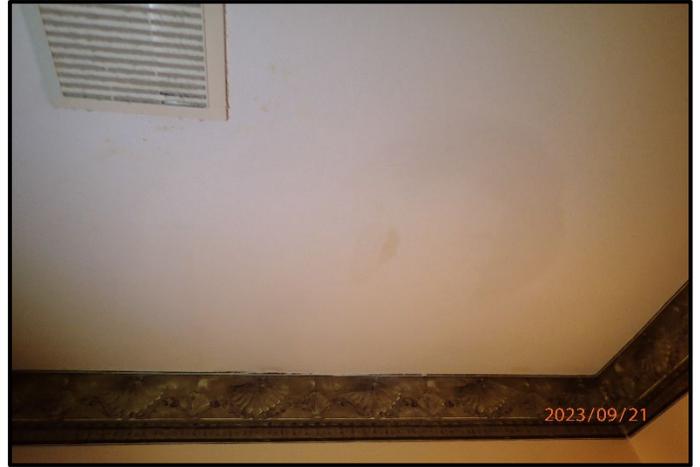
Photograph 18 - Moisture staining on ceiling of unit 2.

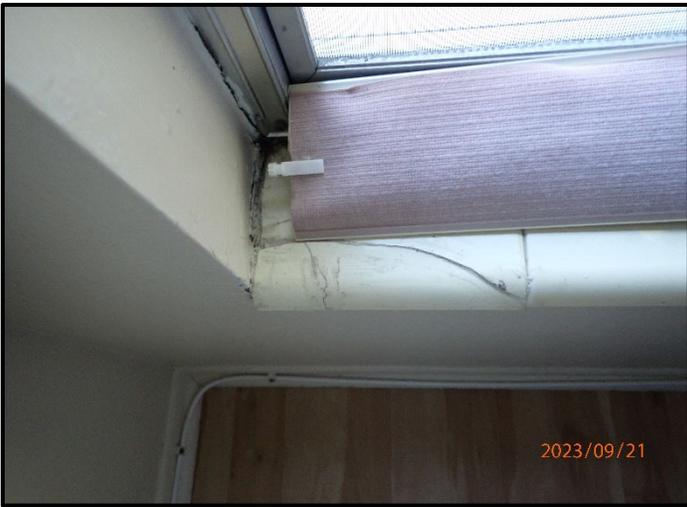
Photograph 19 - Cracking on window frame of unit 4.

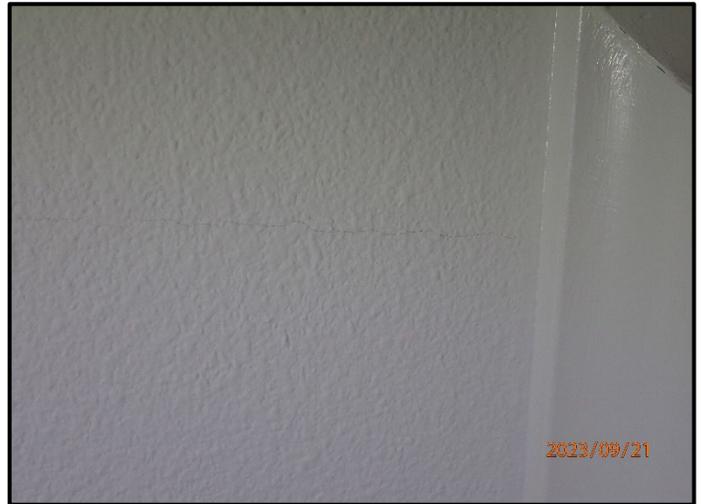
Photograph 20 - Cracking on ceiling of unit 55.
