# **Phase 1 Milestone Inspection Report**

**On Top of the World Clearwater**

**Building 36**

**2340 Grecian Way and 2341 Haitian Drive, Clearwater**

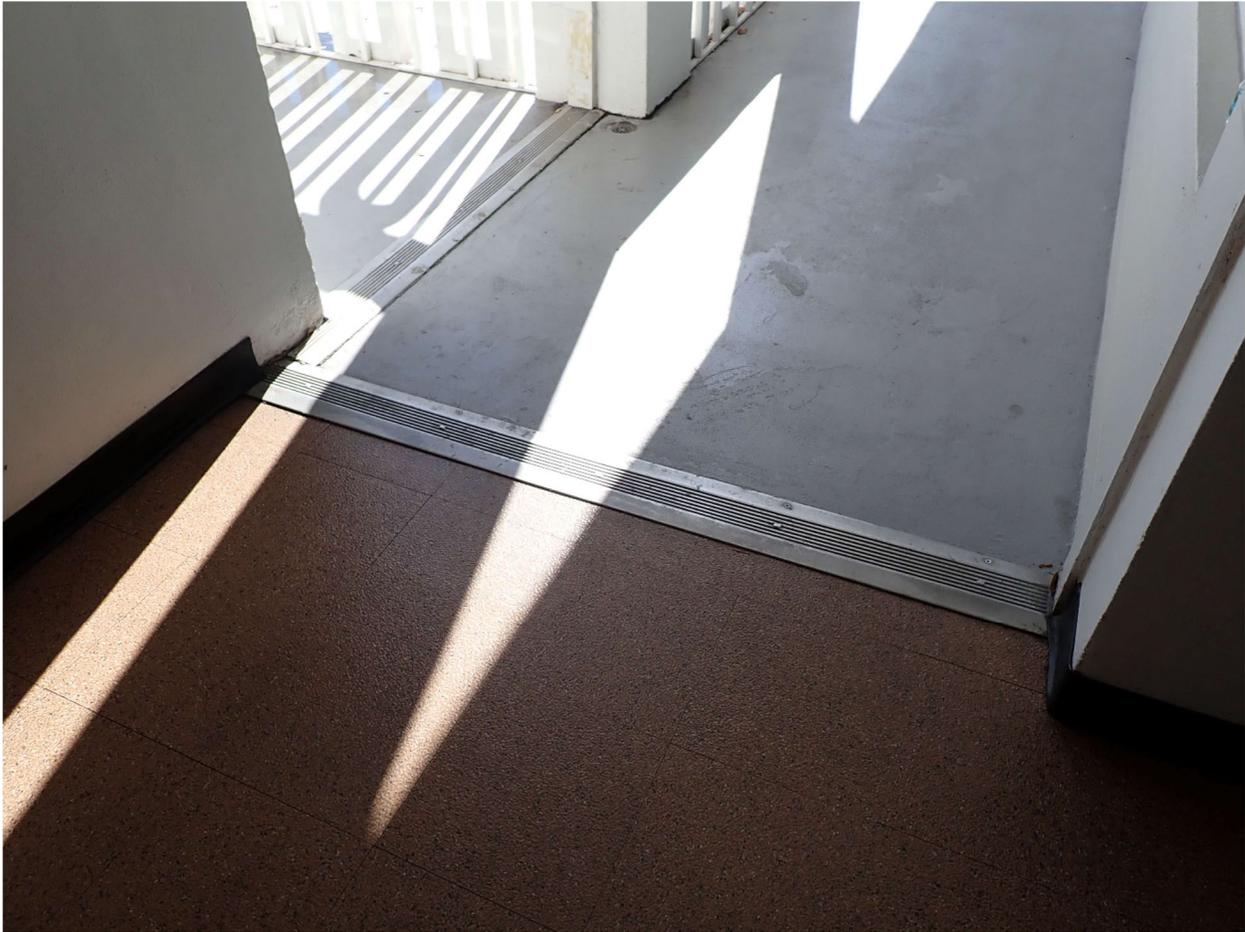
**Figure 5. Representative expansion joint at wing/core intersection.**

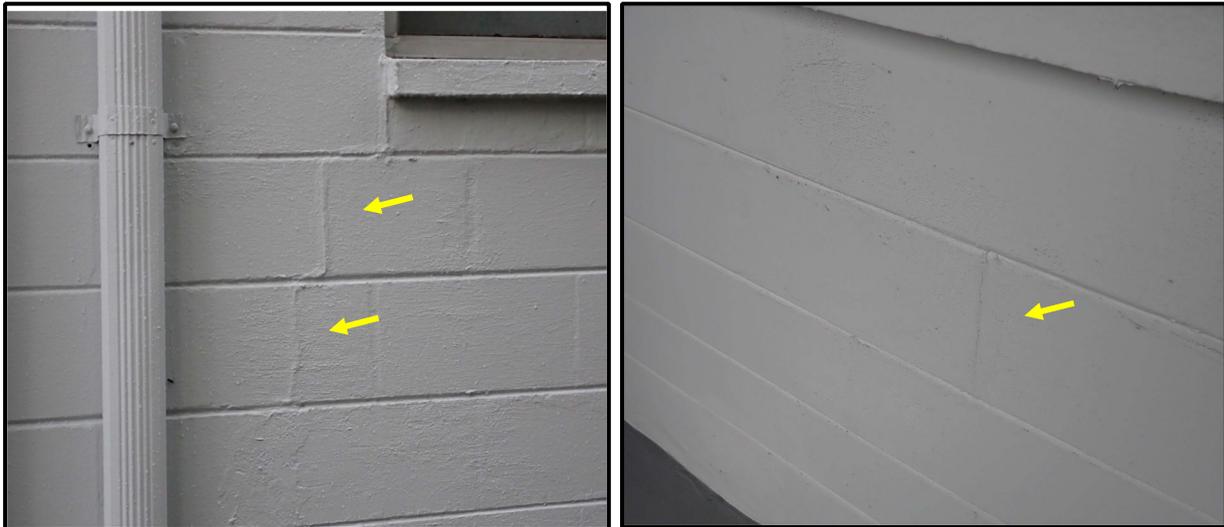
Stairstep cracks, both previously repaired and those appearing to be recent, on the CMU bearing walls of the wings particularly below windows and near the core were typically observed throughout the elevations of the building. Stairstep cracks are cracks in the mortar joints and form due to the movement of the structure, as mortar is a brittle material. The observed width and location of the cracks represent typical movement from a structure (commonly due to soil settlement) and do not appear to be indicative of structural damage. Recommendation for repairs and monitoring of the cracks is provided in Exhibit A. Representative photographs of this observation are shown below in **Figure 7**.

**Figure 7. Representative photographs of step stair cracks at CMU walls.**

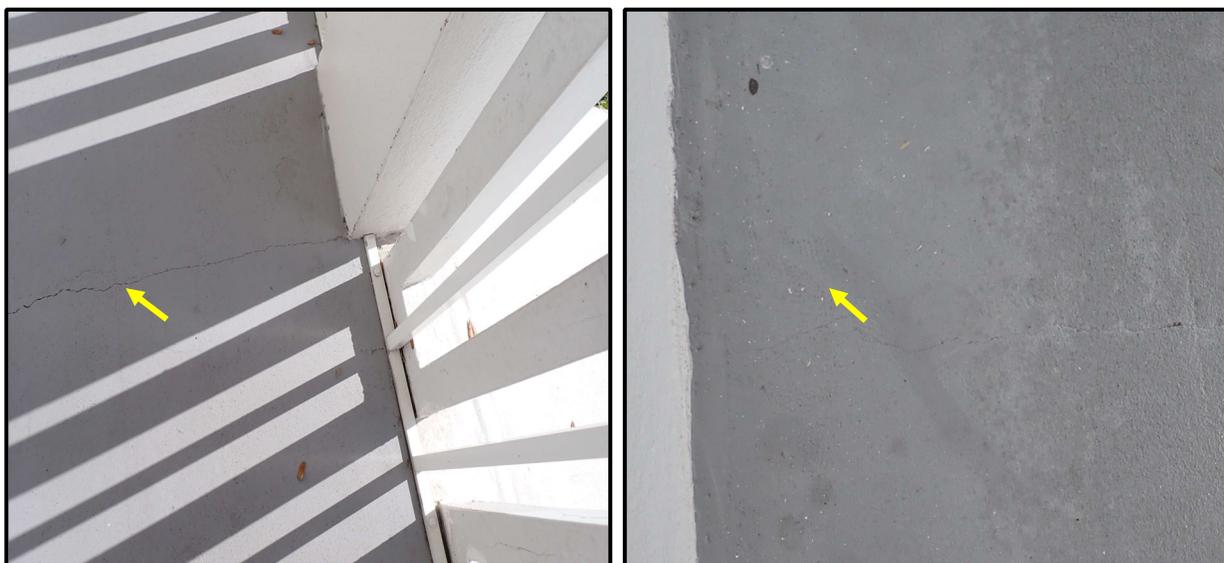
Cracks on the exterior hallway floor slabs were observed perpendicular to the length of the slab and the supporting wall. The observed cracks were typically hairline cracks and shallow. The cracks had weathered edges and dirt on the inside, representing they are historical in nature. The frequency and spacing of these cracks were not uniform. The observed cracks in the subject building are likely due to the expansion and contraction of the materials where control joints were not observed or due to the deflection of the slab at support locations and do not represent a structural damage or substantial deterioration. Recommendation for repairs and monitoring of the cracks is provided in Exhibit A. Representative photographs of this observation are shown below in **Figure 8**.

**Figure 8. Representative photographs of shallow cracks at top surface of the exterior hallway.**

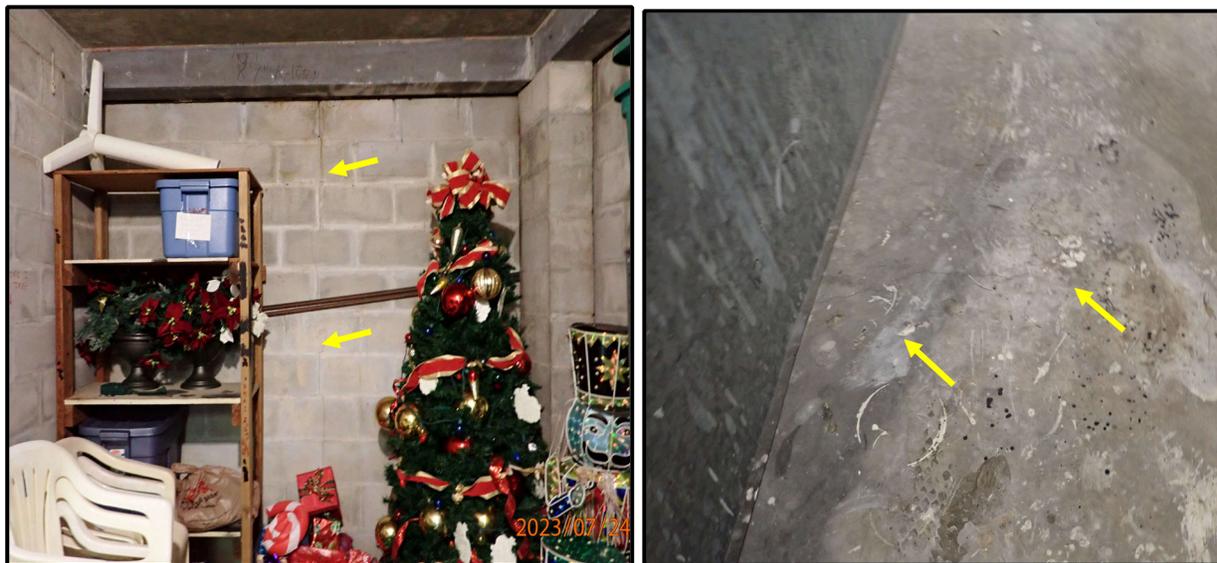
Vertical and horizontal cracking was observed on the building's core on the CMU walls of the storage rooms. CMU and mortar are brittle materials and are likely to crack when subjected to expansion and contraction and differential movement. The observed cracks are due to the movement of the core throughout its life. Similarly observed, were cracks on the concrete slab on grade on the first-floor electrical and storage rooms. The observed cracks are due to the expansion and contraction of the slab and typical settlement of the soils below the structure. Recommendations for repairs and monitoring of the cracks is provided in Exhibit A. Representative photographs of this observation are shown below in **Figure 9**.

**Figure 9. Representative photographs of cracks on CMU walls and concrete slabs at common rooms in Core building.**

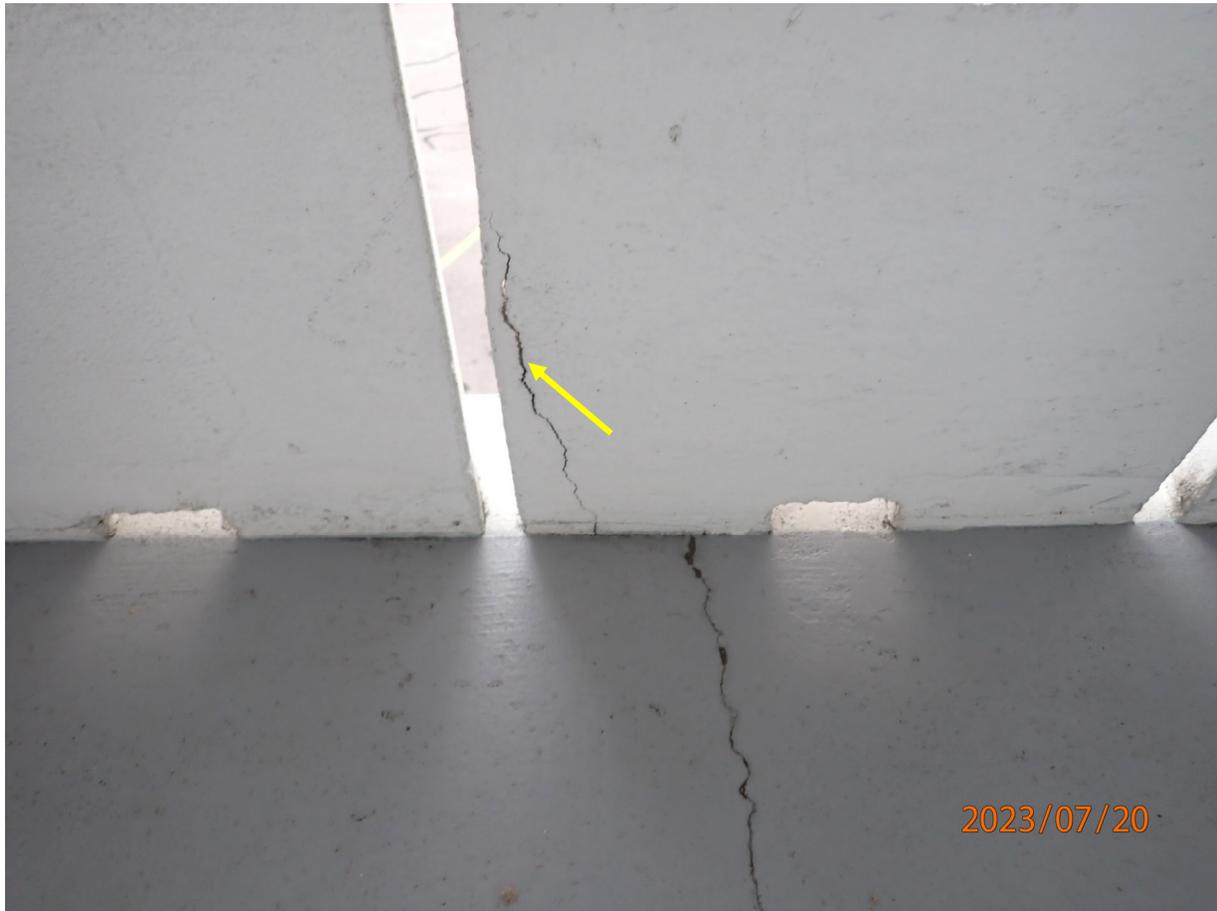
The building's exterior architectural features consisted of a decorative railing on the exterior walkways and architectural roof features at the corners of the wings and core of the building. The railings were constructed of a painted cementitious material. A secondary metal handrail was installed on top of the decorative railing, which was in good condition. Evidence of deterioration of the decorative railings in the form of cracking was observed throughout the building (Figure 10). This is not structural damage, yet it is recommended that the decorative railing be repaired to prevent spalled pieces from detaching and falling.

**Figure 10. Representative photograph of cracking of decorative railing**

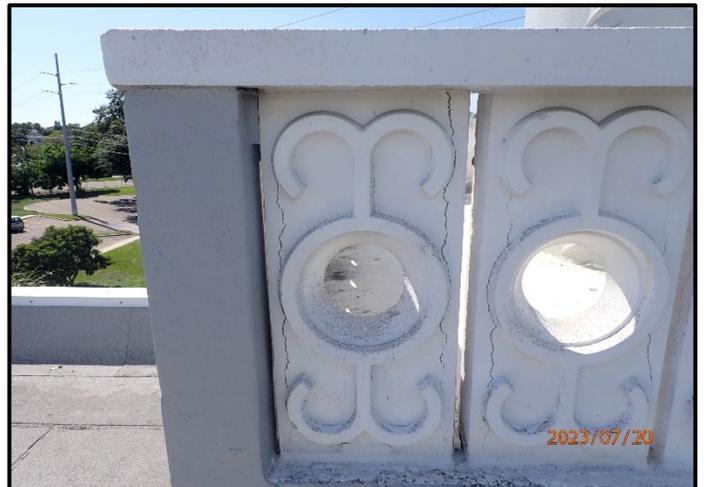
36	Cracks in exterior walkway railing common, cracks typically horizontal and on the top ledge of the railings or vertical on the balusters, some cracks with previous repairs.	Walkway and roof railings.	No	No	Y - vertical stucco cracks throughout all railings.	Yes	Consider full replacement of decorative concrete railings. Perform temporary spot patches until replacement.	No
36	Sealed crack (previous repair) at the underside of elevated walkway or elevated walkway soffit.	Exterior walkway in front of units: 61, 8.	No	No	Y - localized as noted in the Location column..	No	Monitor.	No
36	Spalled concrete at stair tread - localized to less than 1 SF.	Core stairs 1st floor.	No	No	Y - localized as noted in the Location column.	No	Repair - remove loose spalled concrete and resurface with resurfacing mixture.	No

Photograph 04 - View of typical condition of stucco cracks on railings.

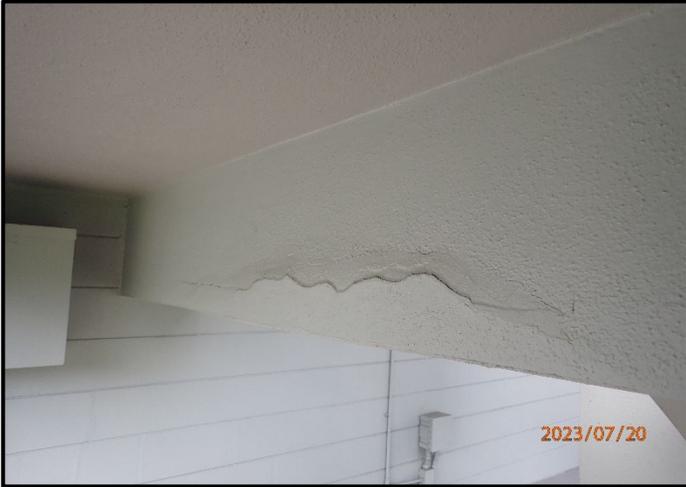
Photograph 05 - View of stucco crack and delamination under the stairs at the southwest stairs 1st floor.

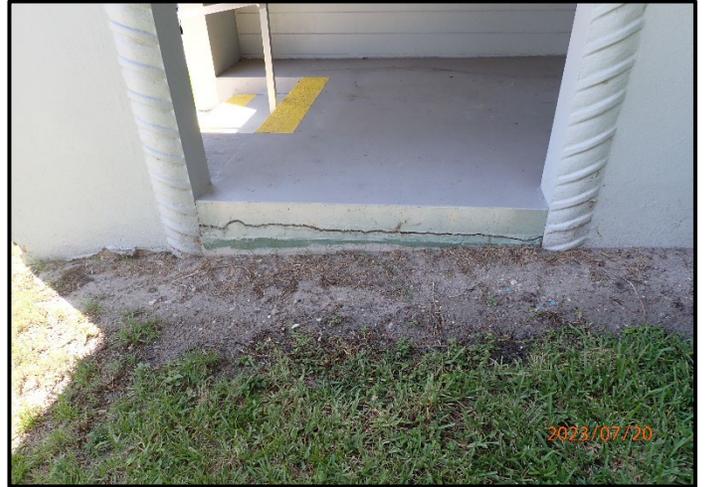
Photograph 06 - View of slab crack at the end face of the southeast stair 1st floor landing.

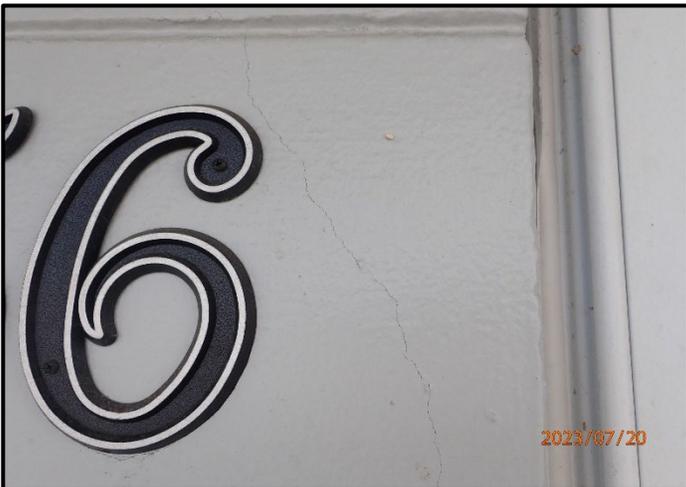
Photograph 07 - Close up view of a hairline vertical crack at the front elevation of unit 56.

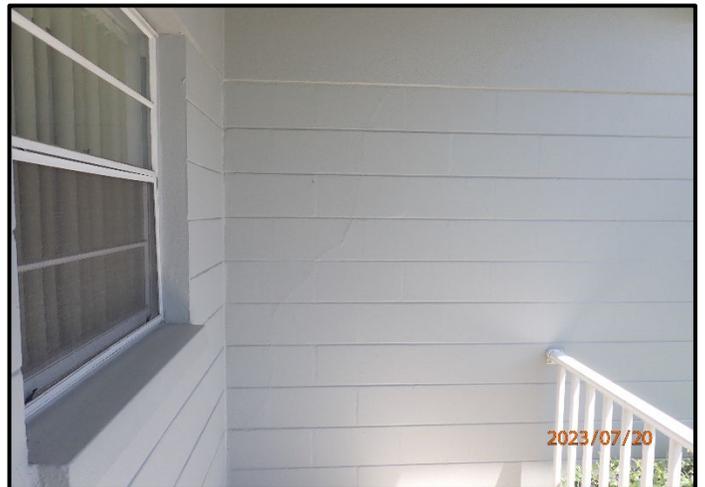
36	Re-opened mortar shallow hairline crack at previous repair to stair step mortar crack in exterior face of CMU wall.	Front elevation of units: 60, 58, 54, 48, 46, 42, 61, 45, 40, 2, 4, 6, 8, 20, 17, 15, 11 Rear elevation of units: 28 Core 3rd floor.	No	No	Y - localized as noted in the Location column.	No	Monitor.	No
36	Stair step mortar shallow hairline crack in CMU wall.	Front elevation of units: 58, 56, 43 2nd floor north storage.	No	No	Y - localized as noted in the Location column.	No	Monitor.	No
36	Stair step shallow mortar crack in CMU wall. 0.012" width.	1st floor storage.	No	No	Y - localized as noted in the Location column.	No	Seal crack with high-strength epoxy or mortar. Spot replacement of damaged CMU.	No

Photograph 08 - View of re opened previous repair to CMU wall at the front elevation of unit 20.

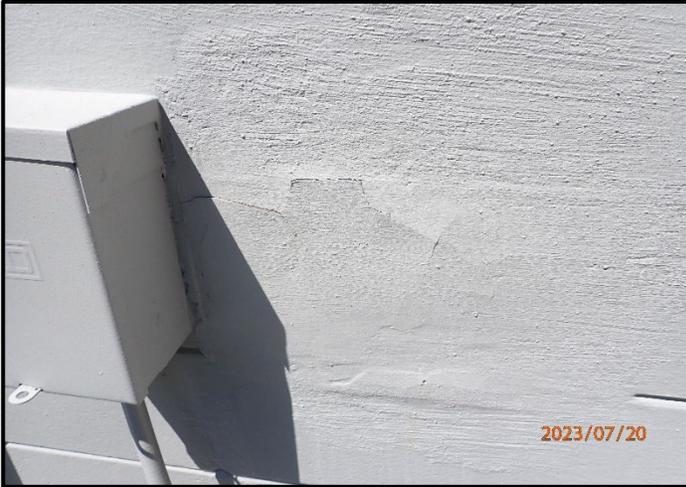
Photograph 09 - View of delaminated stucco at the rear elevation of unit 37.

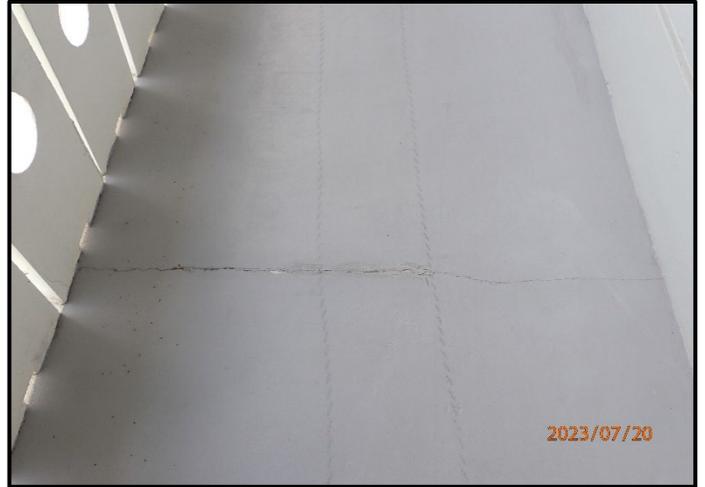
Photograph 10 - View of a crack in the exterior walkway surface perpendicular to the building.

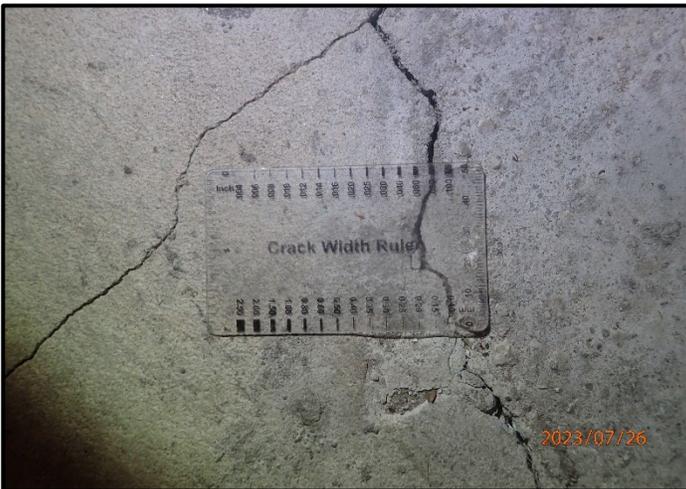
Photograph 11 - Close up view of a slab crack in the electrical room.

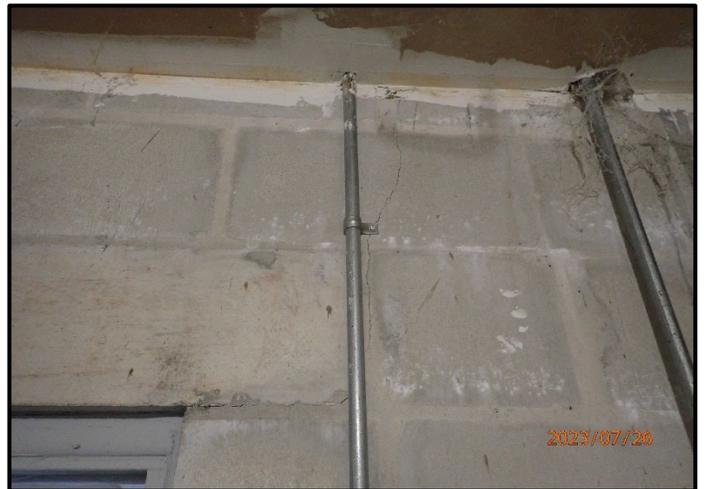
36	Crack in concrete slab. 0.06" width.	Elevator machine room/bike storage room, 1st floor storage.	No	No	Y - localized as noted in the Location column.	No	Repair crack with high-strength epoxy.	No

Photograph 12 - View of a vertical crack in the CMU wall in the elevator machine and bike storage room.

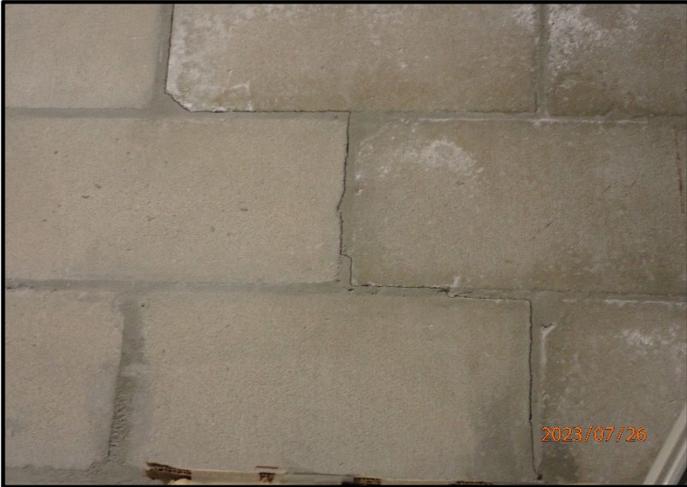
Photograph 13 - Close up view of a stair step crack in the CMU wall in the roof access room.

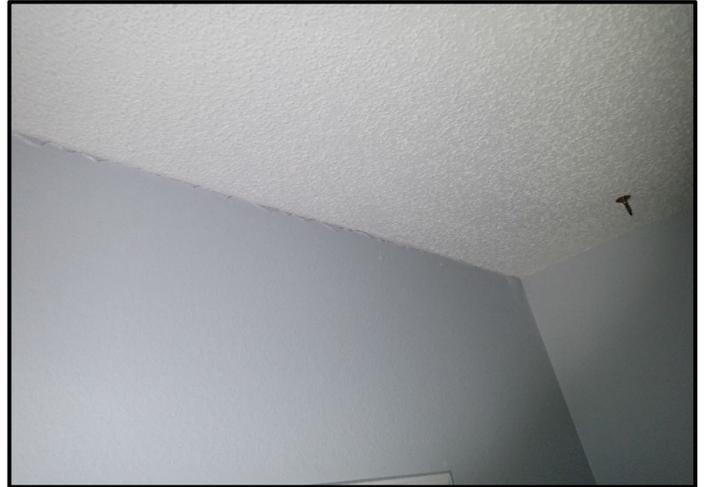
Photograph 14 - View of a crack at a ceiling and wall drywall joint in unit 50.

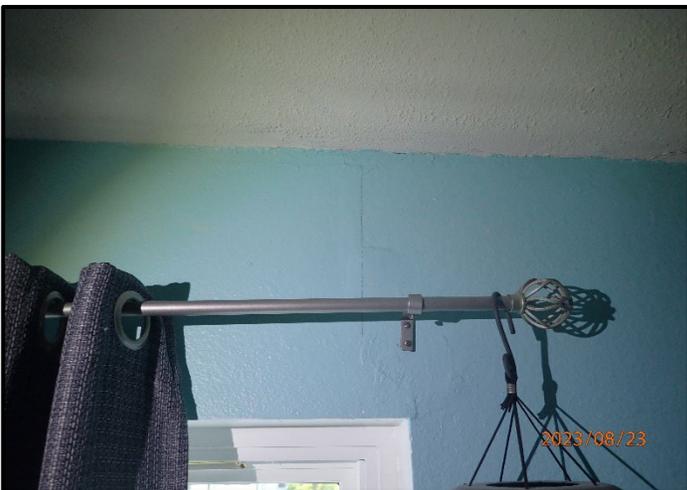
Photograph 15 - View of a drywall crack above a window corner in unit 53.

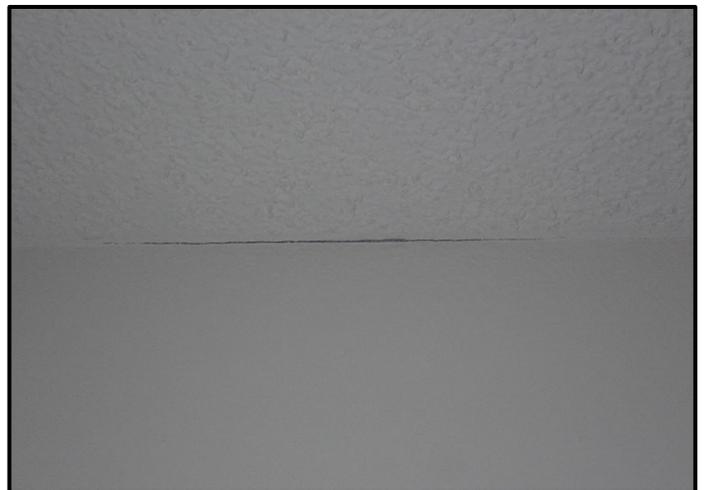
Photograph 16 - Close up view of a crack at a ceiling and wall drywall joint in unit 58.

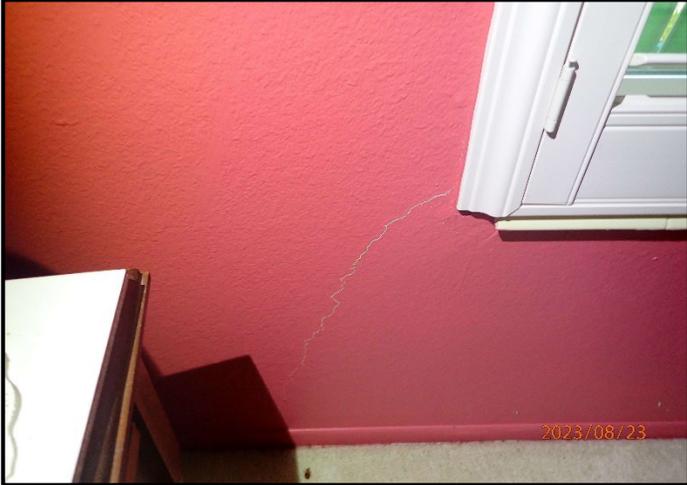
Photograph 17 - Hairline crack on wall in unit 2.

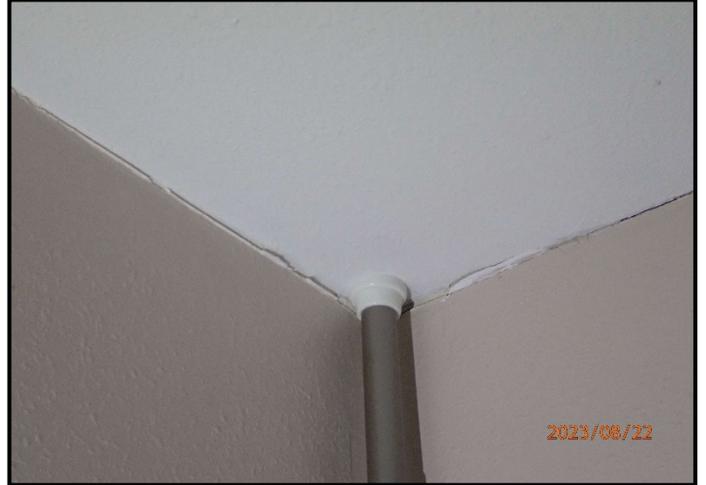
Photograph 18 - Crack at a ceiling and wall drywall joint in unit 44.

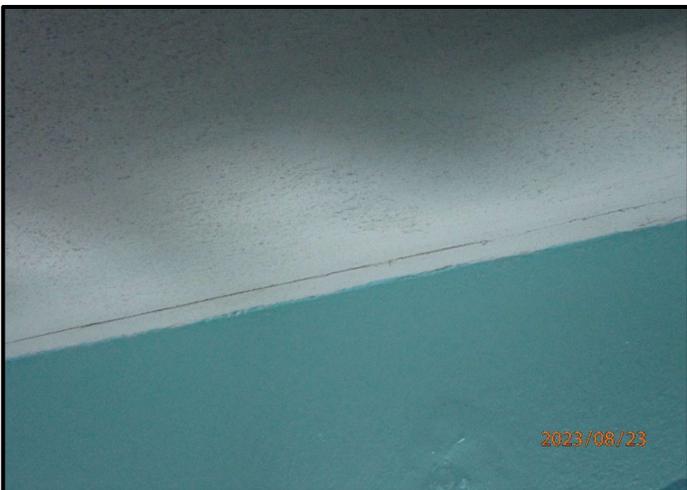
Photograph 19 - Crack at ceiling in unit 53.
