Phase 1 Milestone Inspection Report

**On Top of the World Clearwater
Building 37
2350 Haitian Way and 2351 Irish Lane
Clearwater, Florida 33763
ESi Project No: 98508**

December 29, 2023

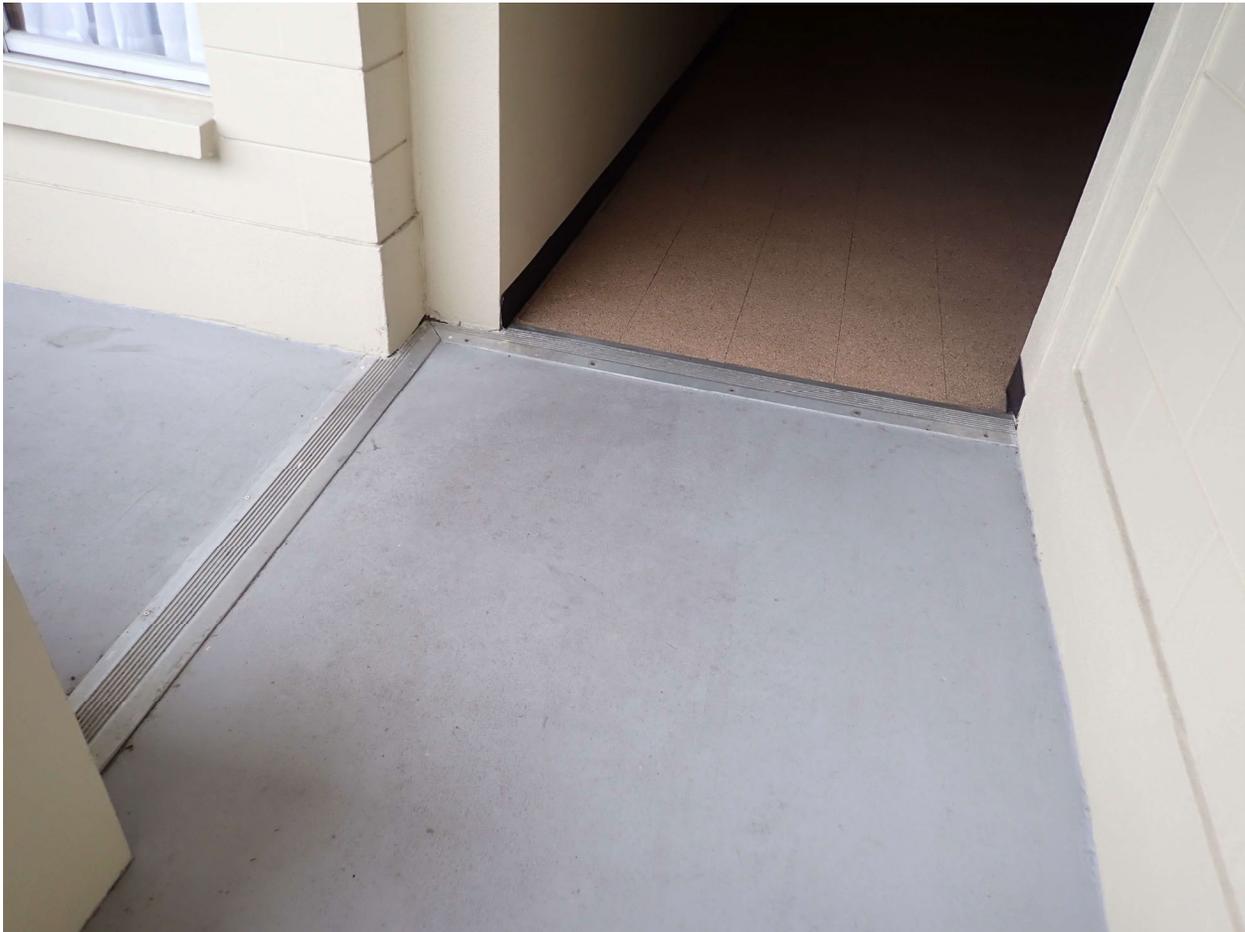
Figure 5. Representative expansion joint at wing/core intersection.

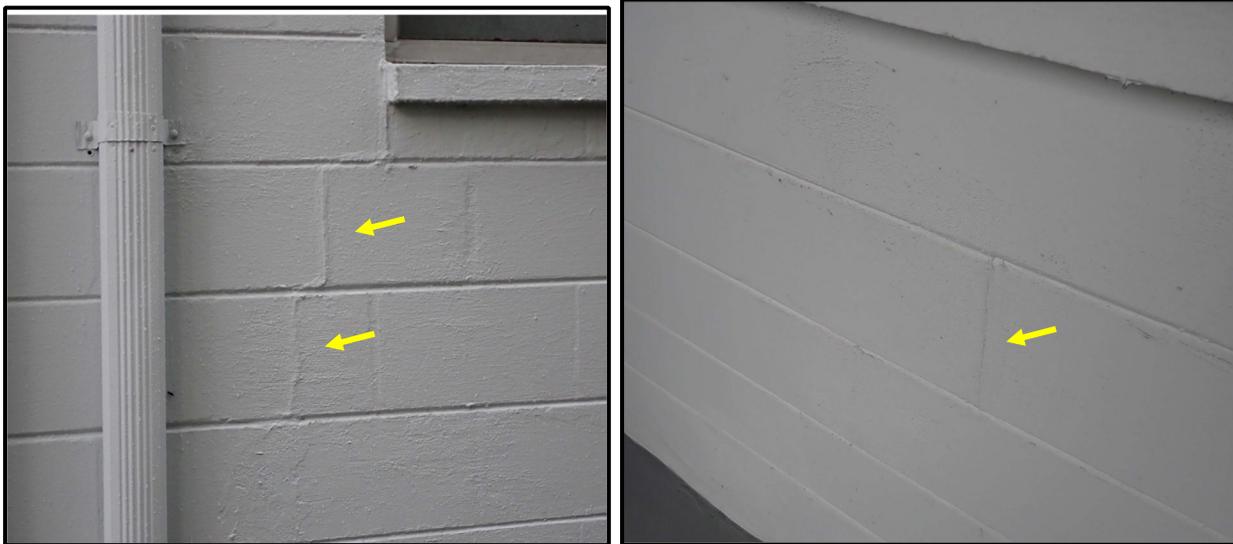
Stairstep cracks, both previously repaired and those appearing to be recent, on the CMU bearing walls of the wings particularly below windows and near the core were typically observed throughout the elevations of the building. Stairstep cracks are cracks in the mortar joints and form due to the movement of the structure, as mortar is a brittle material. The observed width and location of the cracks represent typical movement from a structure (commonly due to soil settlement) and do not appear to be indicative of structural damage. Recommendation for repairs and monitoring of the cracks is provided in Exhibit A. Representative photographs of this observation are shown below in **Figure 7**.

Figure 7. Representative photographs of step stair cracks at CMU walls.

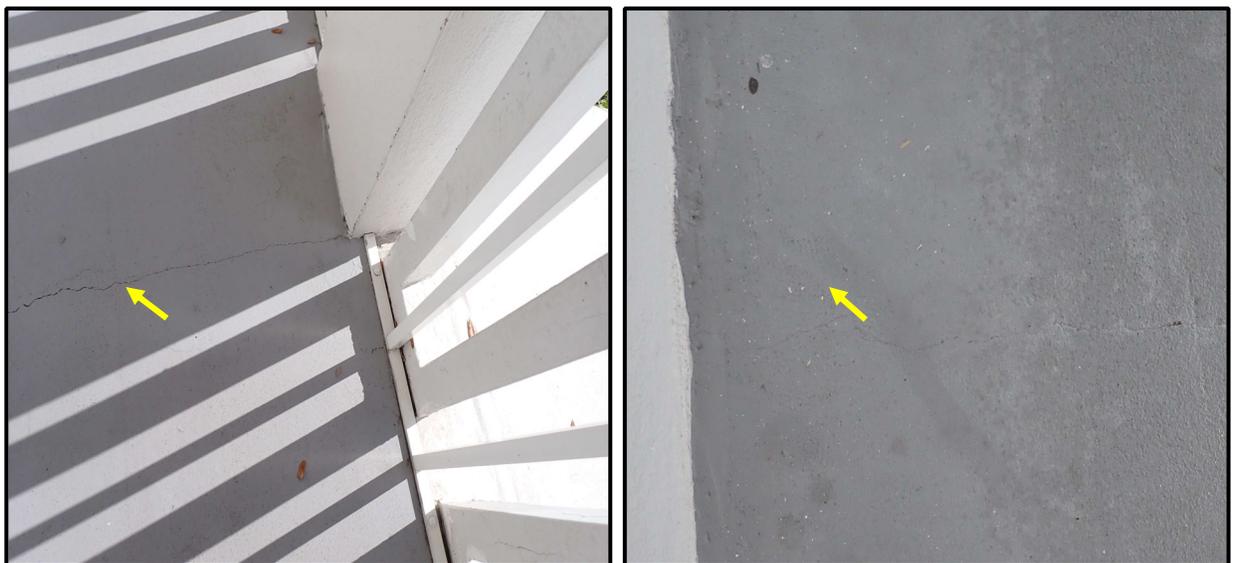
Cracks on the exterior hallway floor slabs were observed perpendicular to the length of the slab and the supporting wall. The observed cracks were typically hairline cracks and shallow. The cracks had weathered edges and dirt on the inside, representing they are historical in nature. The frequency and spacing of these cracks were not uniform. The observed cracks in the subject building are likely due to the expansion and contraction of the materials where control joints were not observed or due to the deflection of the slab at support locations and do not represent a structural damage or substantial deterioration. Recommendation for repairs and monitoring of the cracks is provided in Exhibit A. Representative photographs of this observation are shown below in **Figure 8**.

Figure 8. Representative photographs of shallow cracks at top surface of the exterior hallway.

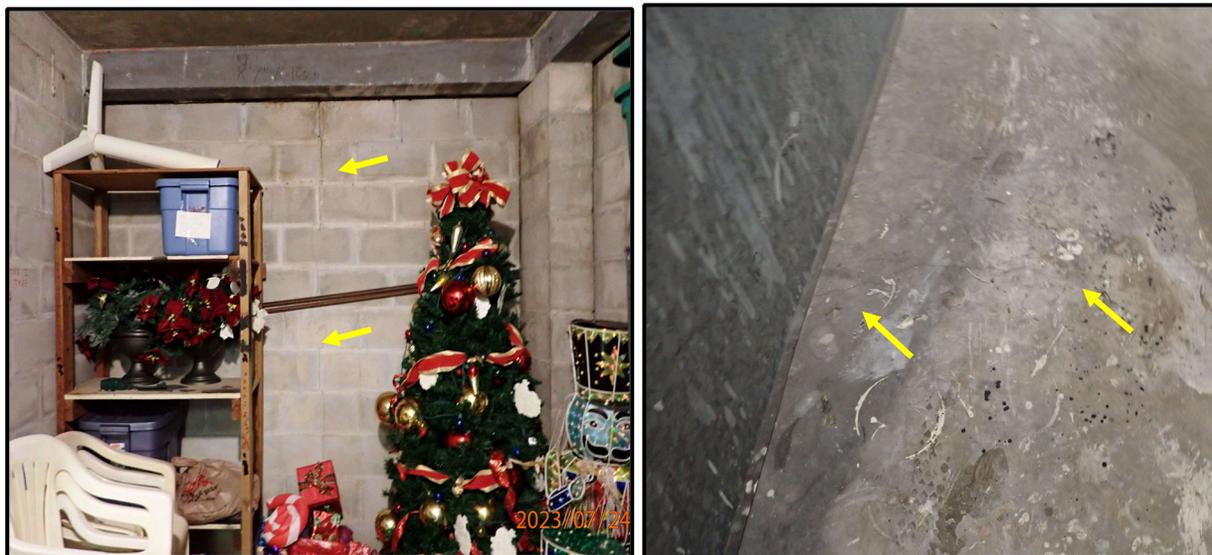
Vertical and horizontal cracking was observed on the building's core on the CMU walls of the storage rooms. CMU and mortar are brittle materials and are likely to crack when subjected to expansion and contraction and differential movement. The observed cracks are due to the movement of the core throughout its life. Similarly observed, were cracks on the concrete slab on grade on the first-floor electrical and storage rooms. The observed cracks are due to the expansion and contraction of the slab and typical settlement of the soils below the structure. Recommendations for repairs and monitoring of the cracks is provided in Exhibit A. Representative photographs of this observation are shown below in **Figure 9**.

Figure 9. Representative photographs of cracks on CMU walls and concrete slabs at common rooms in Core building.

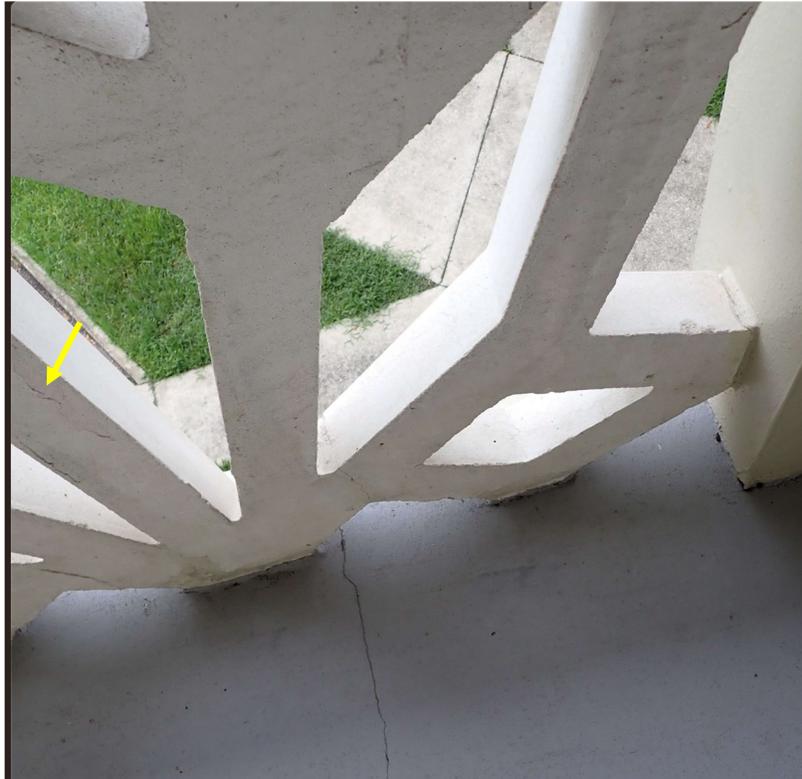
The building's exterior architectural features consisted of a decorative railing with exposed columns which extended from the roof to the slab. The railings and columns were constructed of a painted cementitious material. Evidence of deterioration of the decorative railings in the form of cracking was observed throughout the building (Figure 10). This is not structural damage, yet it is recommended that the decorative railing be repaired to prevent spalled pieces from detaching and falling.

Figure 10. Representative photograph of cracking of decorative railing

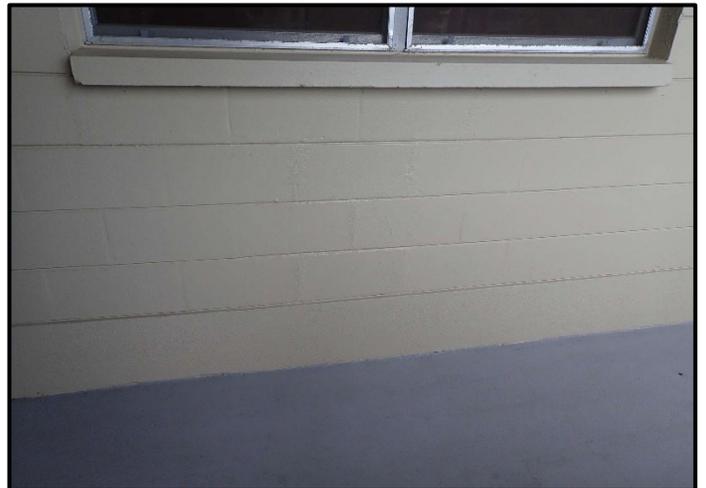
Photograph 04 - Previous repair to stair step crack in CMU wall.

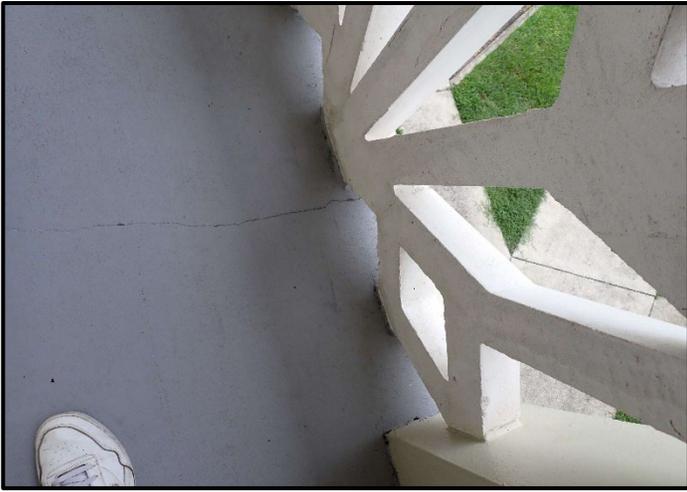
Photograph 05 - Crack in walkway slab.

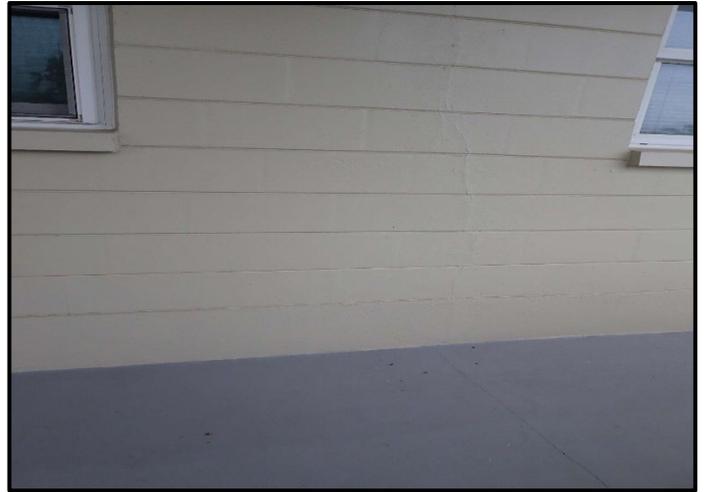
Photograph 06 - Vertical crack in CMU wall.

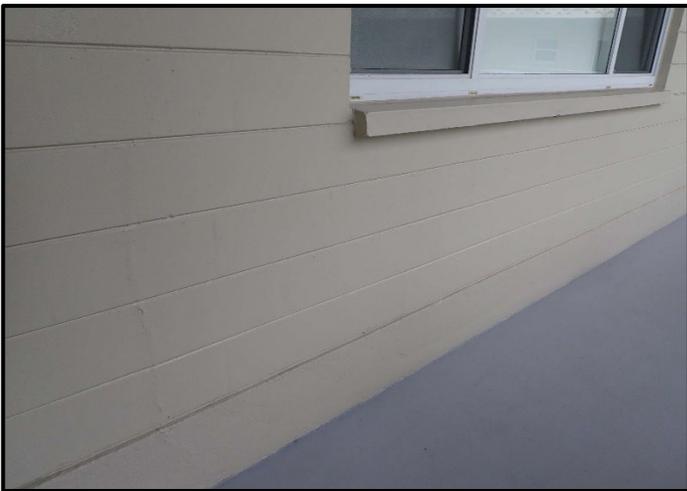
Photograph 07 - Vertical crack in CMU wall.

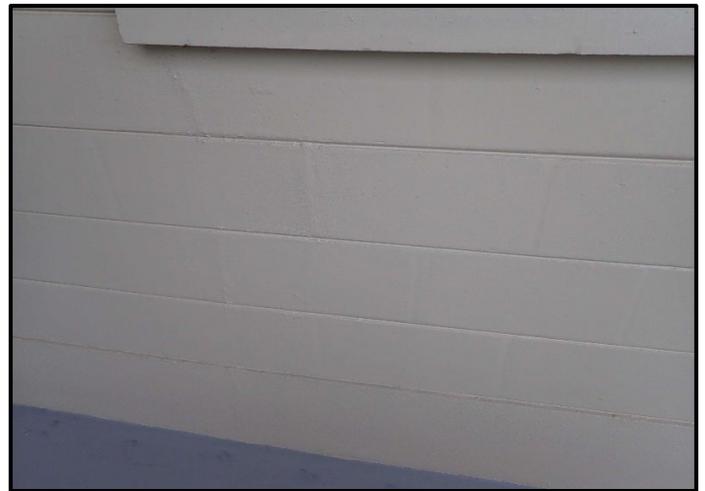
Photograph 08 - Previous repair to stair step crack in CMU wall.

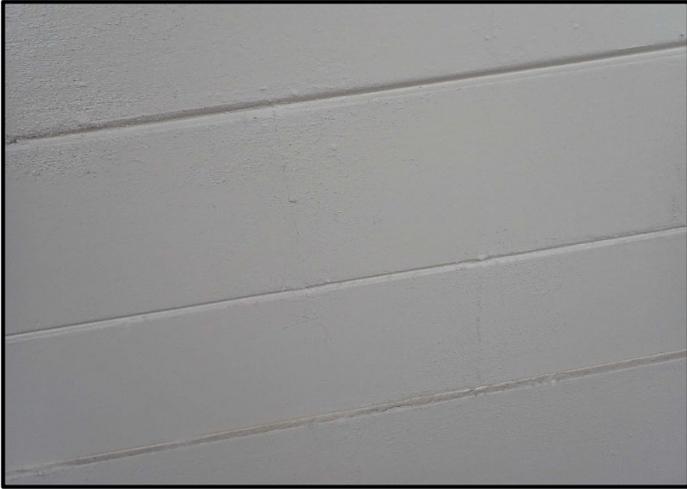
Photograph 09 - Reopened stair step crack in mortar joint.

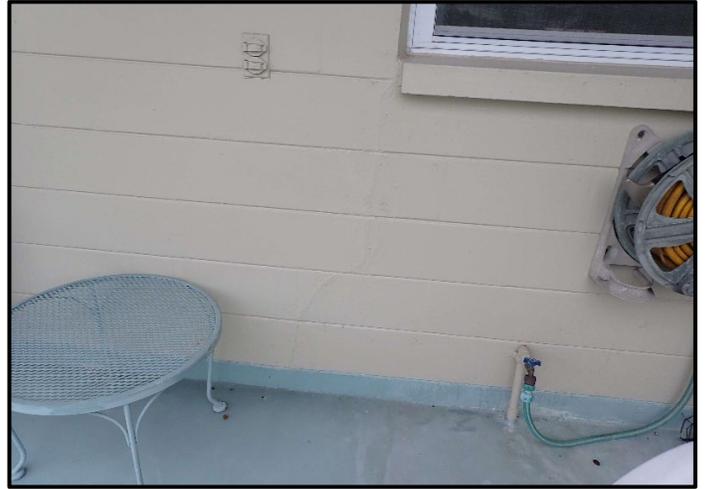
Photograph 10 - Previous repair to vertical crack.

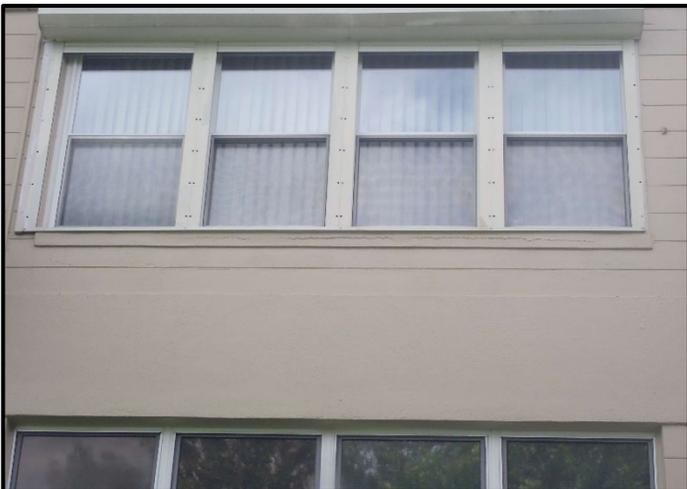
Photograph 11 - Previous repair to window sill.

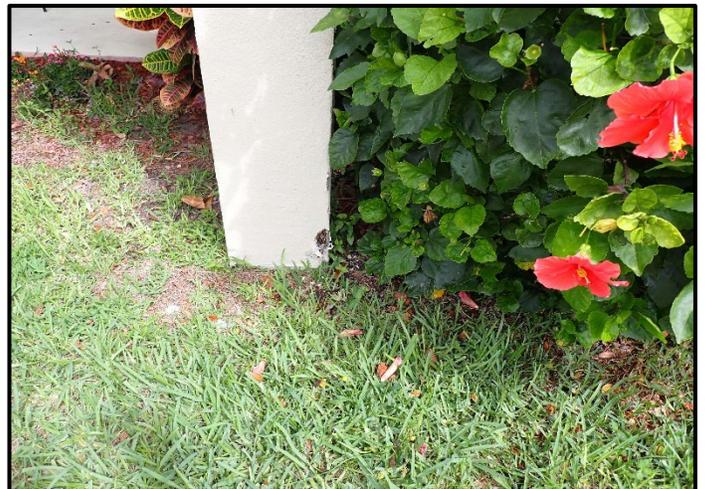
Photograph 12 - Cracked stucco at base of column.

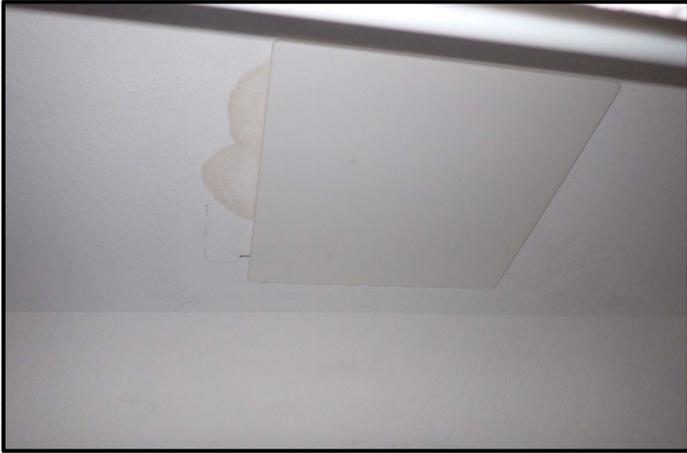
Photograph 13 - Moisture staining on ceiling of unit 7.

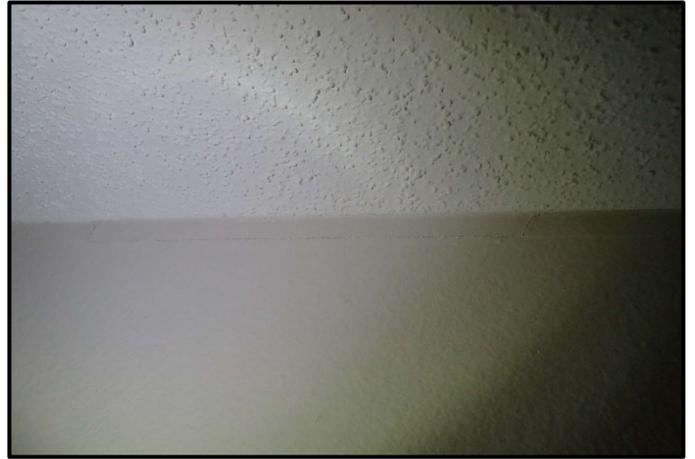
Photograph 14 - Horizontal crack on wall in unit 43.

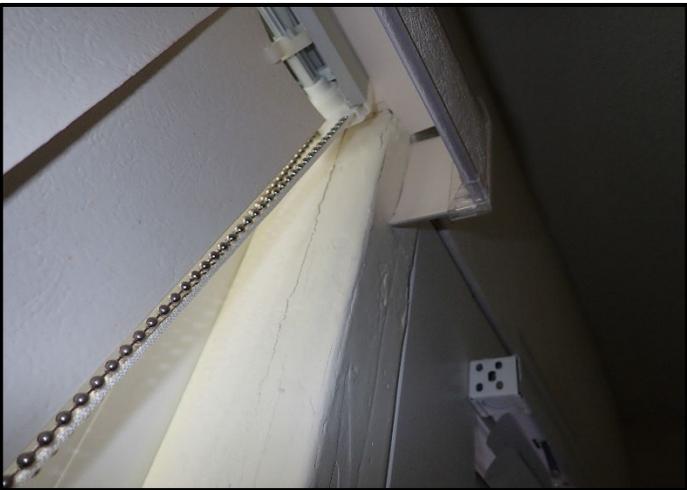
Photograph 15 - Vertical crack on window frame in unit 14.
