Phase 1 Milestone Inspection Report

**On Top of the World Clearwater
Building 44
2460 Franciscan Drive
Clearwater, Florida 33763
ESi Project No: 98508**

December 29, 2023

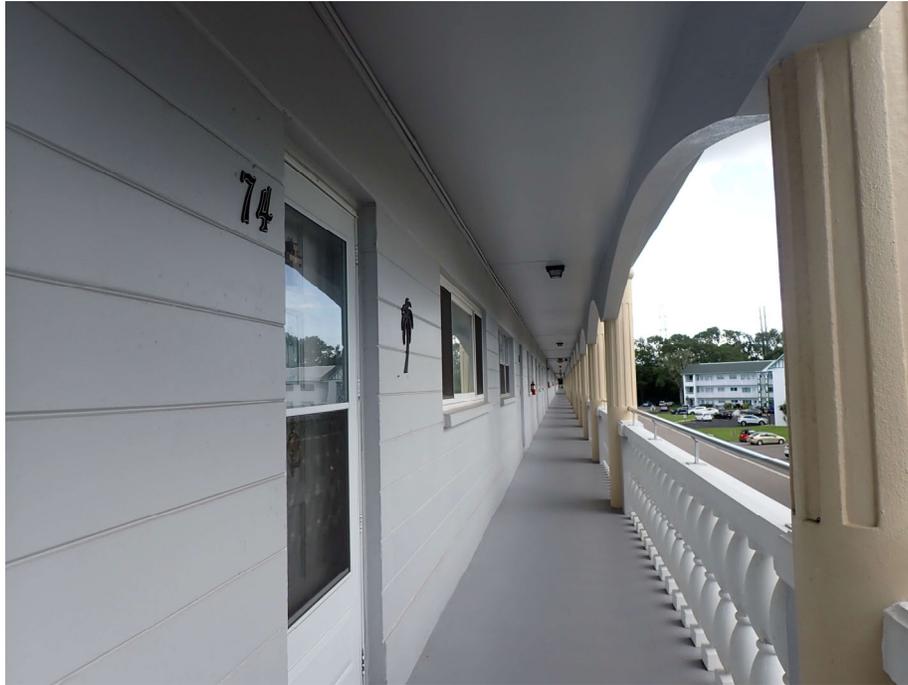
The front of the units has an exterior walkway which consists of a tapered, cast-in-place, cantilevered concrete slab, and protective metal railings and architectural railings on the exterior edge. The as-built walkway structural support is unknown. The drawings show the walkway being cantilevered from the front CMU bearing building wall. Additionally, there are columns extending from ground level to the third level on the exterior side of the walkway in line with the railing system. Shown in Figure 4 is a photograph of the walkway as constructed.

Figure 4. Exterior walkway as constructed.

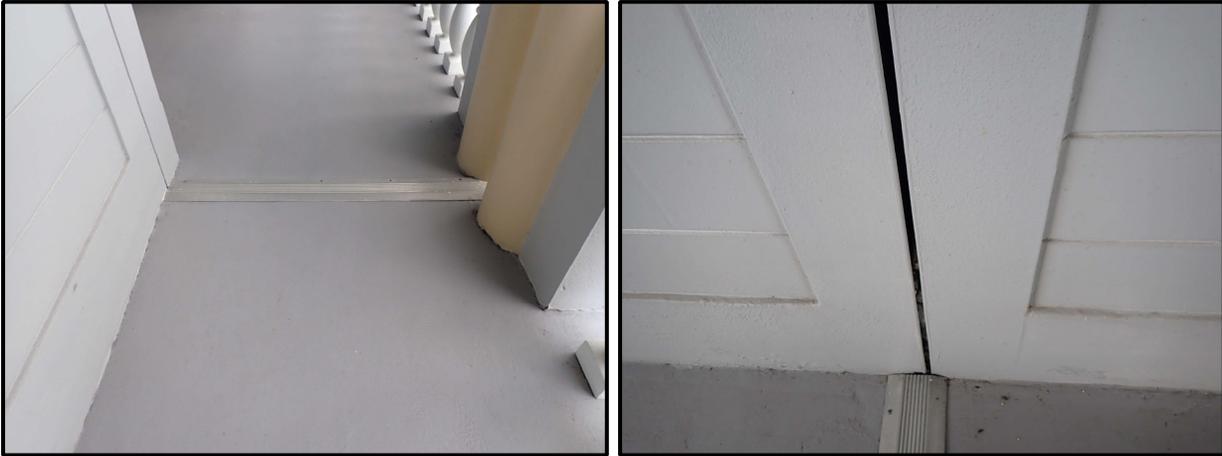
Figure 5. Representative photographs of building expansion joints at exterior corridor at top and bottom of slab.

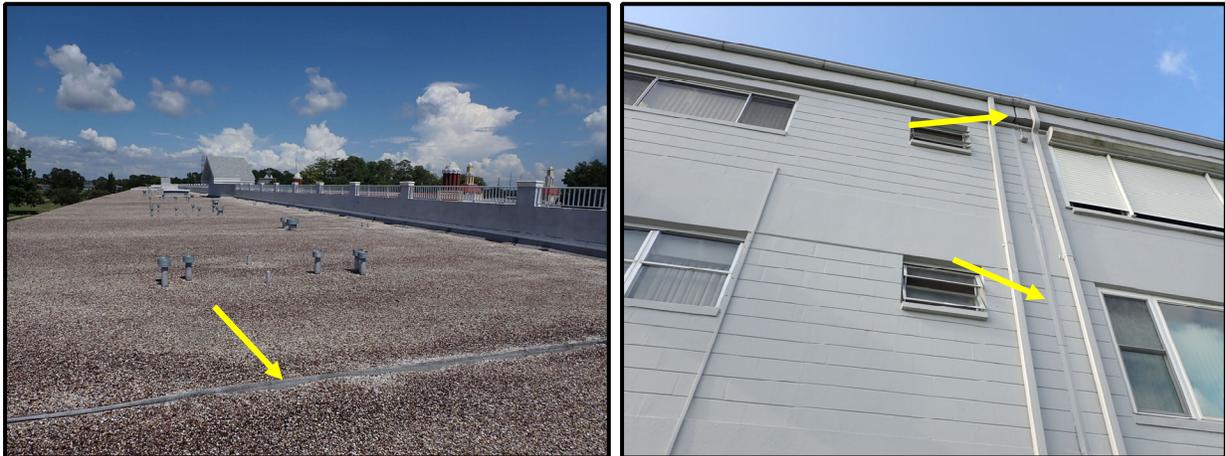
Figure 6. Representative photographs of building expansion joints at roof and rear wall.

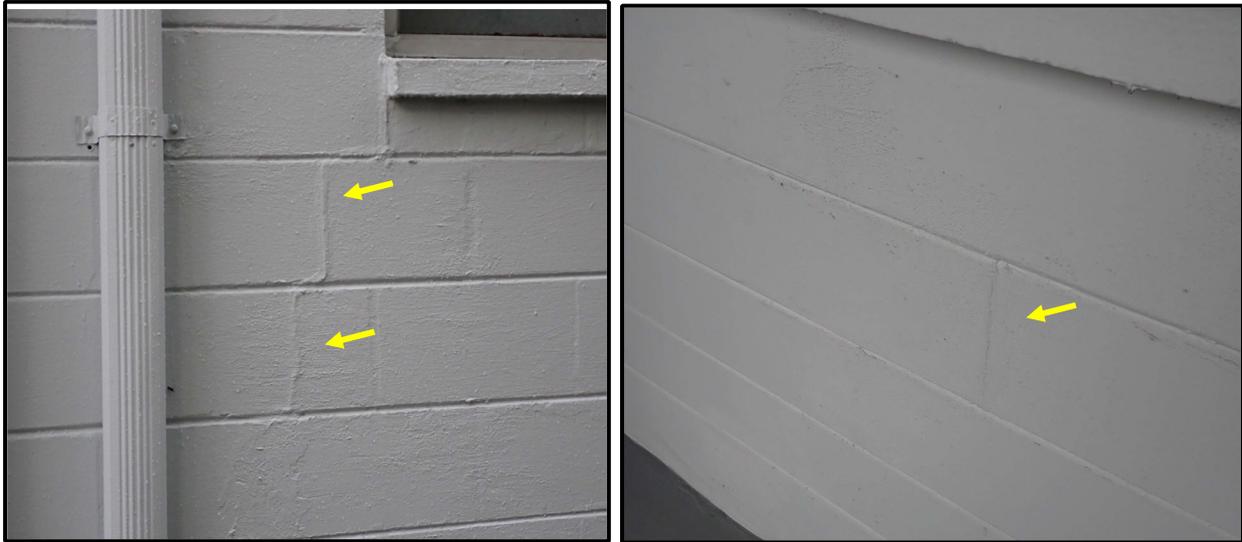
Stairstep cracks, both previously repaired and those appearing to be recent, on the CMU bearing walls of the wings particularly below windows and near the core were typically observed throughout the elevations of the building. Stairstep cracks are cracks in the mortar joints and form due to the movement of the structure, as mortar is a brittle material. The observed width and location of the cracks represent typical movement from a structure (commonly due to soil settlement) and do not appear to be indicative of structural damage. Recommendation for repairs and monitoring of the cracks is provided in Exhibit A. Representative photographs of this observation are shown below in **Figure 5**.

Figure 5. Representative photographs of step stair cracks at CMU walls.

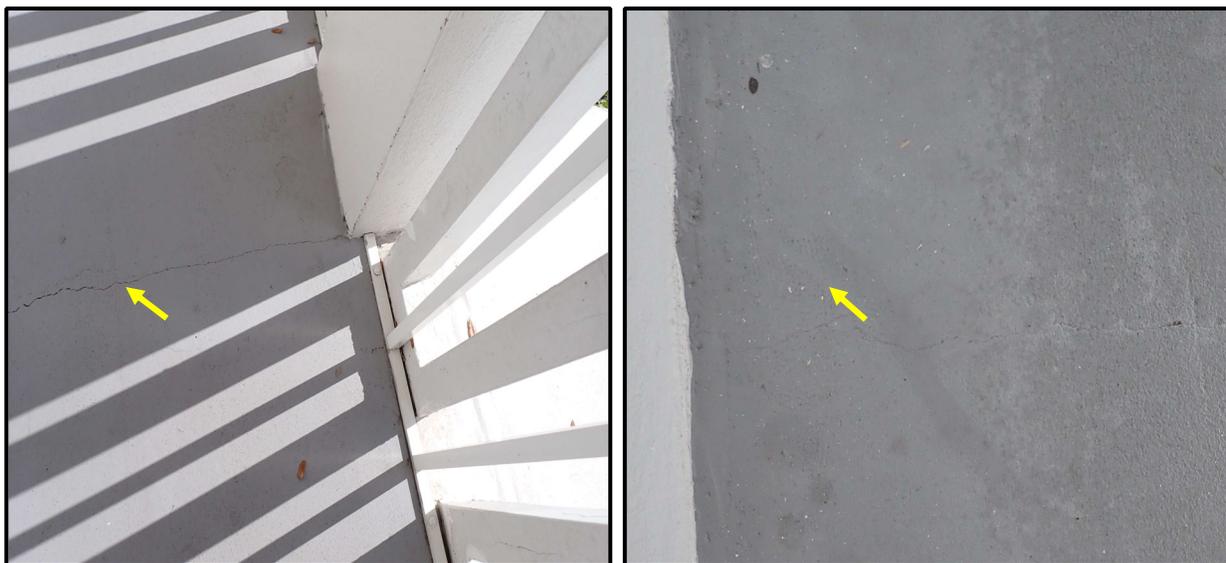
Cracks on the exterior hallway floor slabs were observed perpendicular to the length of the slab and the supporting wall. The observed cracks were typically hairline cracks and shallow. The cracks had weathered edges and dirt on the inside, representing they are historical in nature. The frequency and spacing of these cracks were not uniform. The observed cracks in the subject building are likely due to the expansion and contraction of the materials where control joints were not observed or due to the deflection of the slab at support locations and do not represent a structural damage or substantial deterioration. Recommendation for repairs and monitoring of the cracks is provided in Exhibit A. Representative photographs of this observation are shown below in **Figure 6**.

Figure 6. Representative photographs of shallow cracks at top surface of the exterior hallway.

44	Shallow line cracks in the top face of the concrete slab of the exterior walkway perpendicular to the wall.	Consistent throughout exterior walkways.	No	No	Y - Perpendicular single cracks throughout all walkways..	No	Repair - Seal hairline cracks with high-strength epoxy.	No
44	Cracks in concrete walkway railings.	Periodic throughout all exterior walkways.	No	No	Y - Periodic cracks throughout all walkway railings.	Yes	Consider full replacement of decorative concrete railings. Perform temporary spot patches until replacement.	No
44	Crack in concrete arch of stairwell.	Stairwell near unit 72.	No	No	Y - Localized as noted in the Location column..	No	Repair - Seal crack with high-strength epoxy or mortar.	No

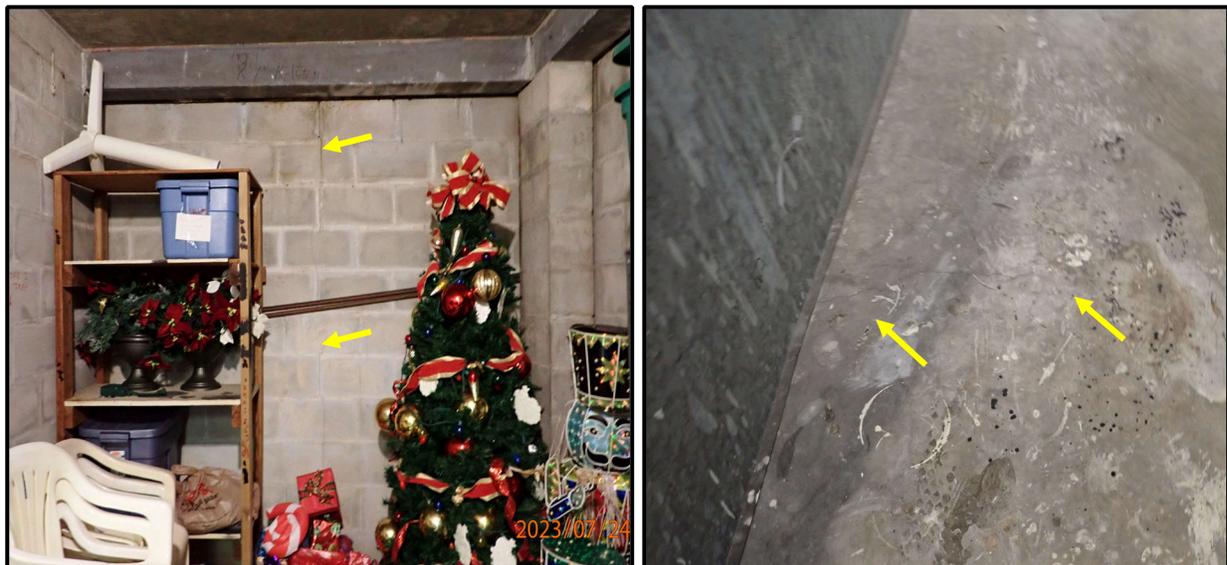
Vertical and horizontal cracking was observed on the building's core on the CMU walls of the storage rooms. CMU and mortar are brittle materials and are likely to crack when subjected to expansion and contraction and differential movement. The observed cracks are due to the movement of the core throughout its life. Similarly observed, were cracks on the concrete slab on grade on the first-floor electrical and storage rooms. The observed cracks are due to the expansion and contraction of the slab and typical settlement of the soils below the structure. Recommendations for repairs and monitoring of the cracks is provided in Exhibit A. Representative photographs of this observation are shown below in **Figure 7**.

Figure 7. Representative photographs of cracks on CMU walls and concrete slabs at common rooms in Core building.

44	Vertical crack in mortar and block of CMU wall.	1st floor: storage room.	No	No	Y - Two courses of CMU wall..	No	Repair - Seal crack with high-strength epoxy or mortar. Locally replace damaged CMU	No
44	Chipped concrete in door header.	3rd floor: fire alarm panel room.	Y - Approximately 1 SF of door header.	No	No	No	Repair - Fill area of chipped concrete with mortar.	No

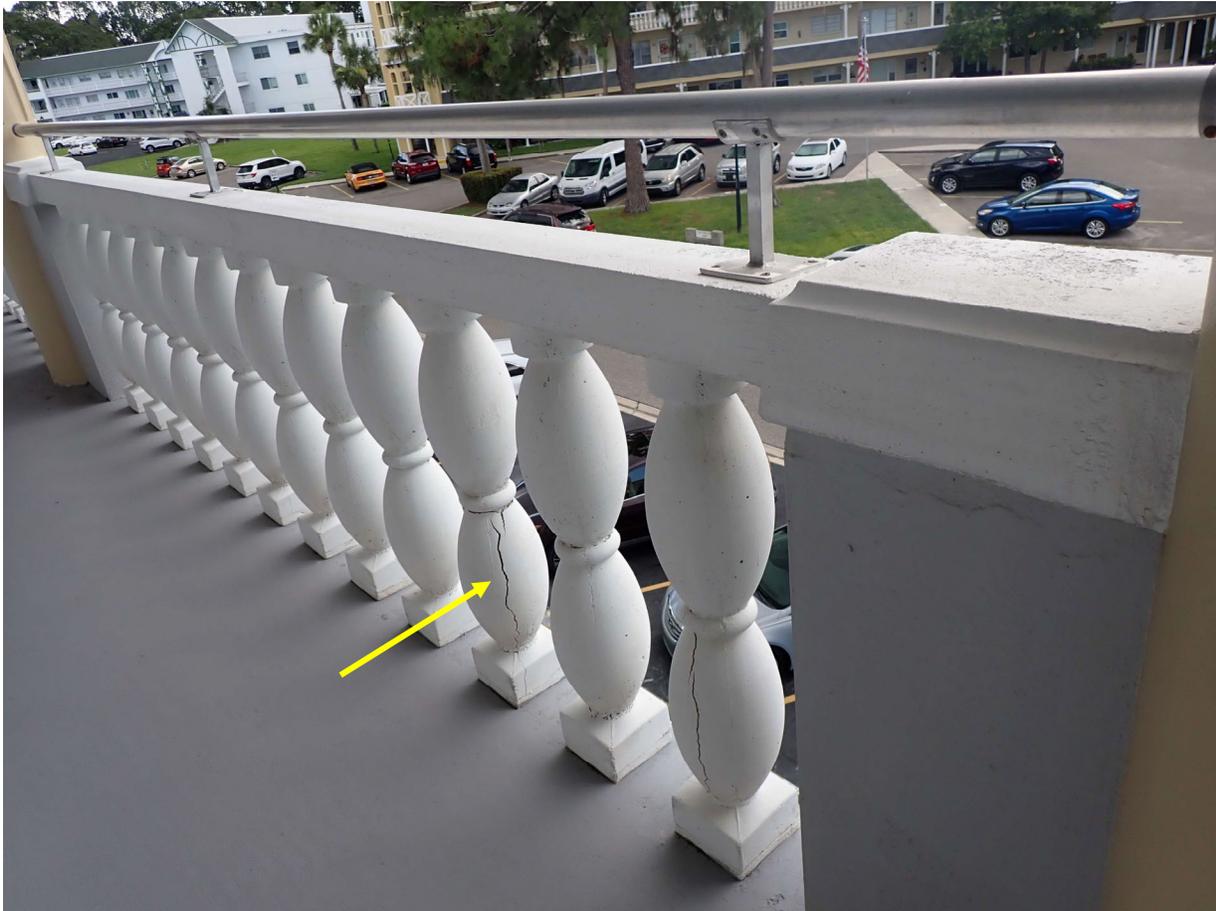
The building's exterior architectural features consisted of a decorative railing with exposed columns which extended from the roof to the slab. The railings and columns were constructed of a painted cementitious material. Evidence of deterioration of the decorative railings in the form of cracking was observed throughout the building (**Figure 8**). This is not structural damage, yet it is recommended that the decorative railing be repaired to prevent spalled pieces from detaching and falling.

Figure 8. Representative photograph of cracking of decorative railing

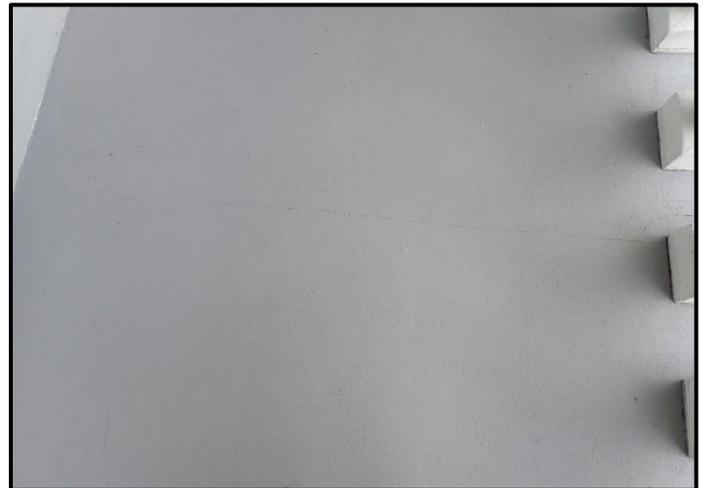
Photograph 04 - Crack in elevated concrete walkway.

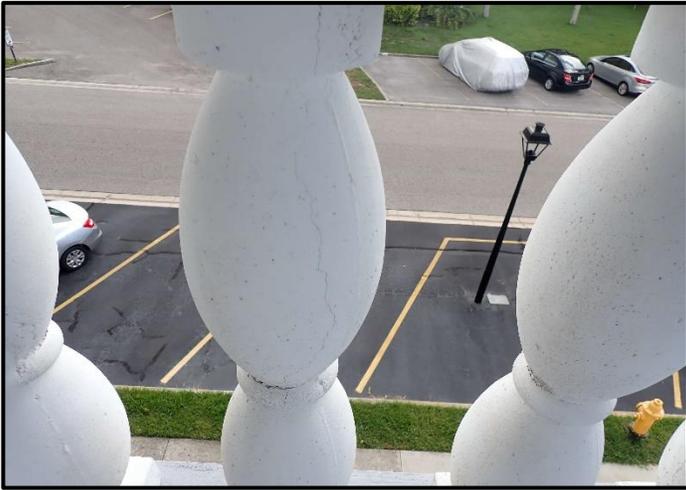
Photograph 05 - Crack in decorative concrete railing.

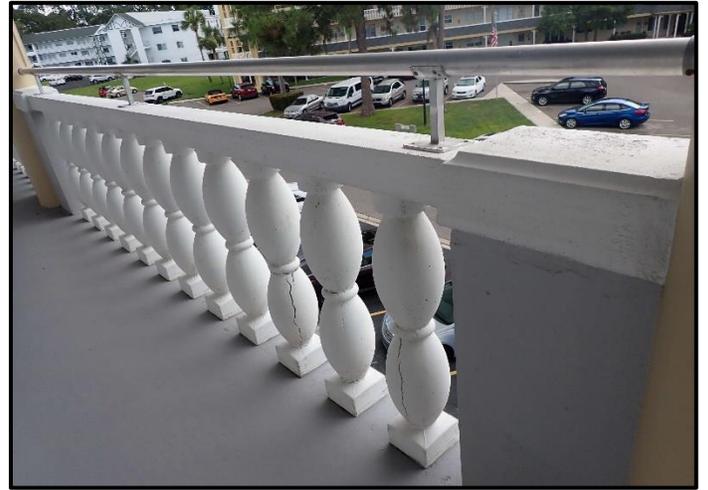
Photograph 06 - Cracks in decorative concrete railing.

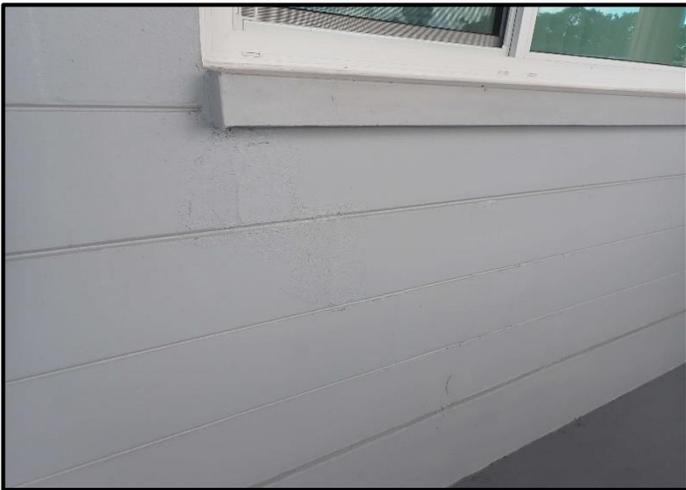
Photograph 07 - Step crack in CMU wall below window.

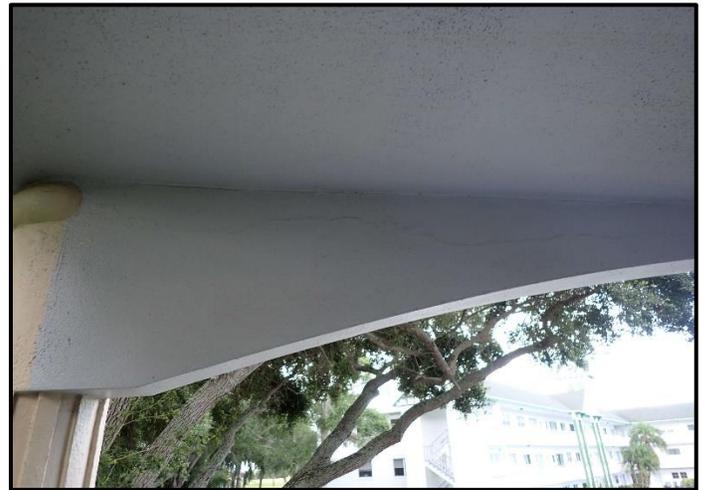
Photograph 08 - Crack in concrete archway of stairwell.

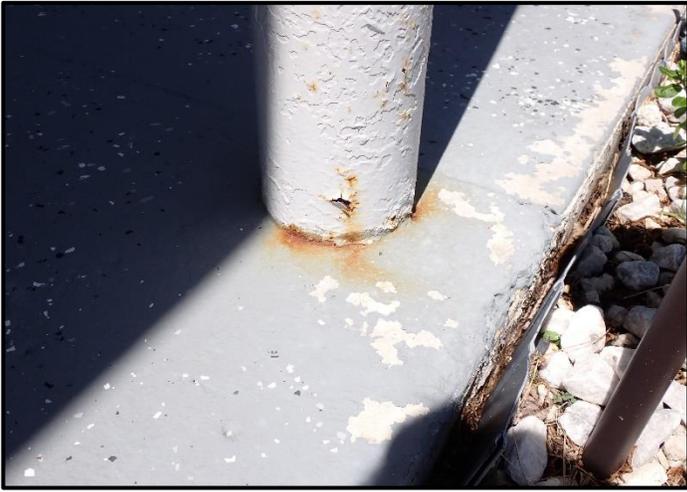
Photograph 09 - Corrosion at bottom of steel column.

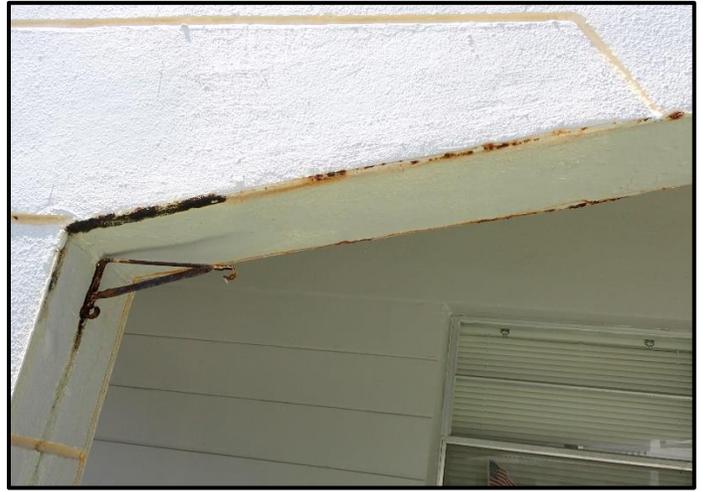
Photograph 10 - Corrosion of stucco mesh at bottom of arch.

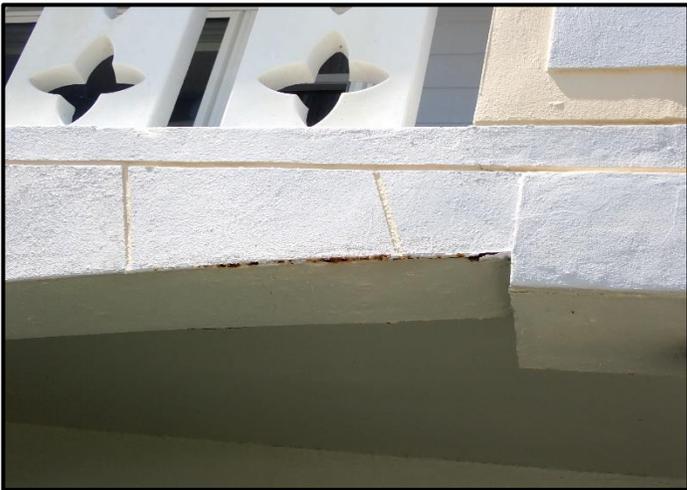
Photograph 11 - Corrosion of stucco mesh at bottom of arch.

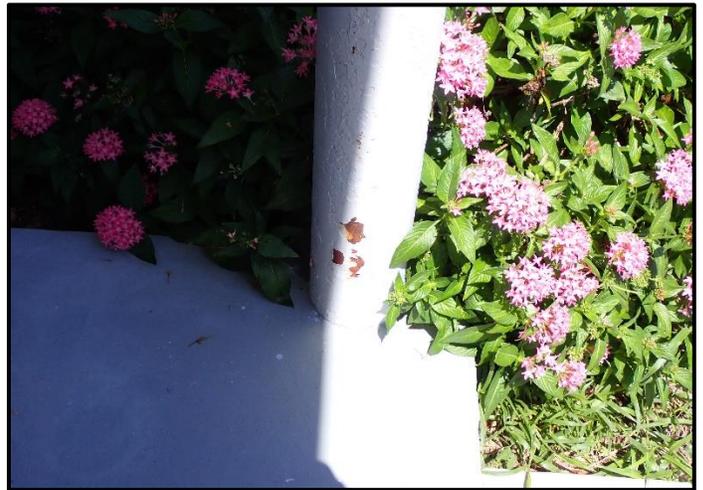
Photograph 12 - Corrosion at bottom of steel column.

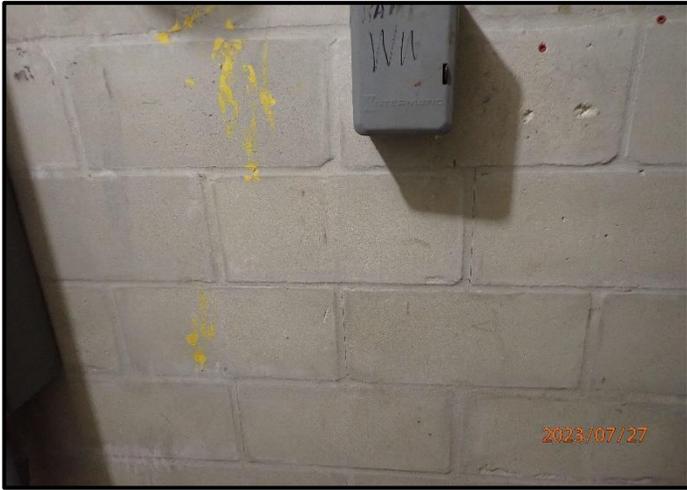
Photograph 13 - Stair step crack in CMU wall.

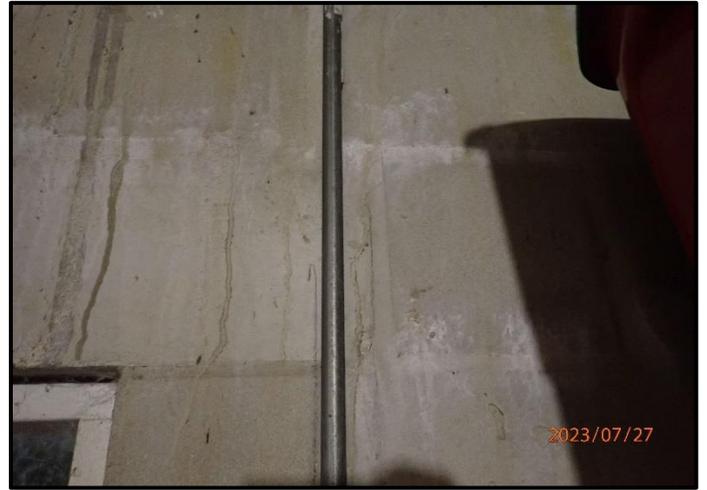
Photograph 14 - Vertical crack in CMU wall.

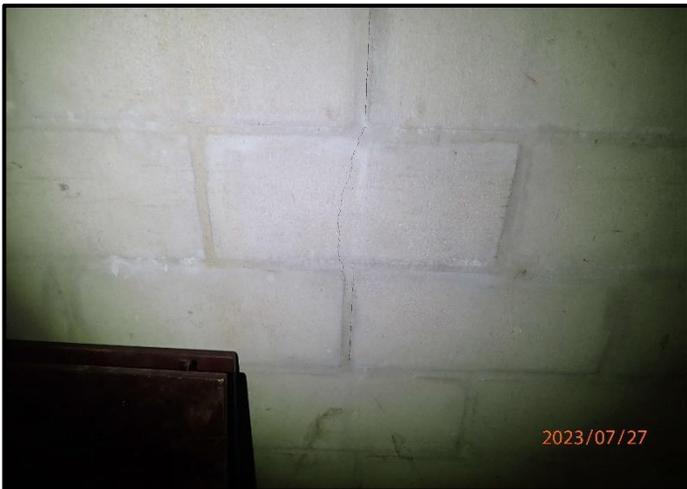
Photograph 15 - Vertical crack in CMU wall.

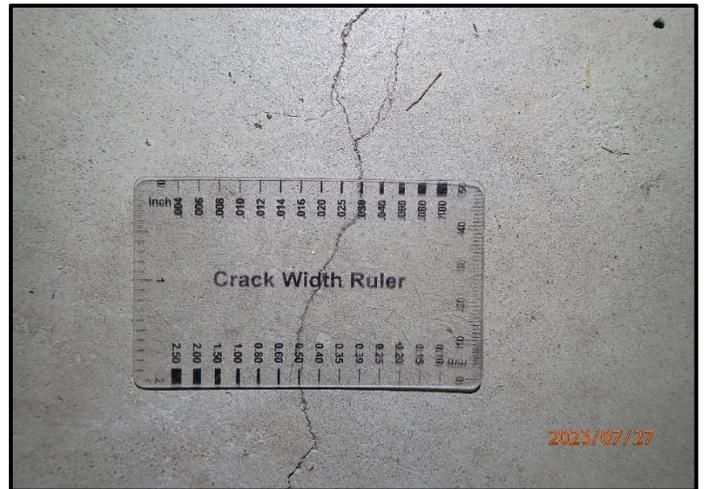
Photograph 16 - Crack in concrete slab.

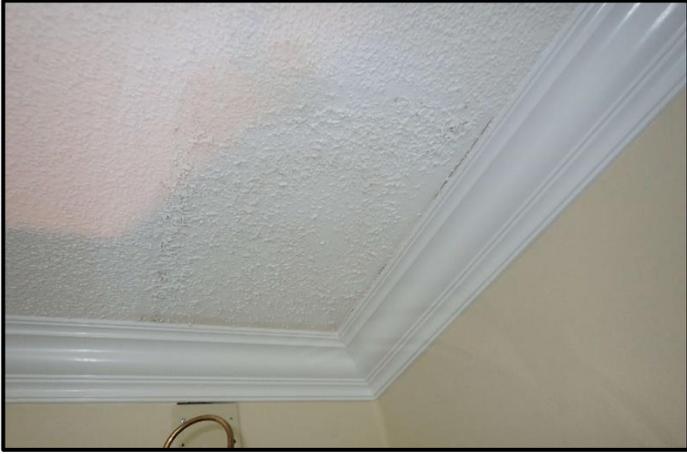
Photograph 17 - Moisture staining on ceiling in unit 4.

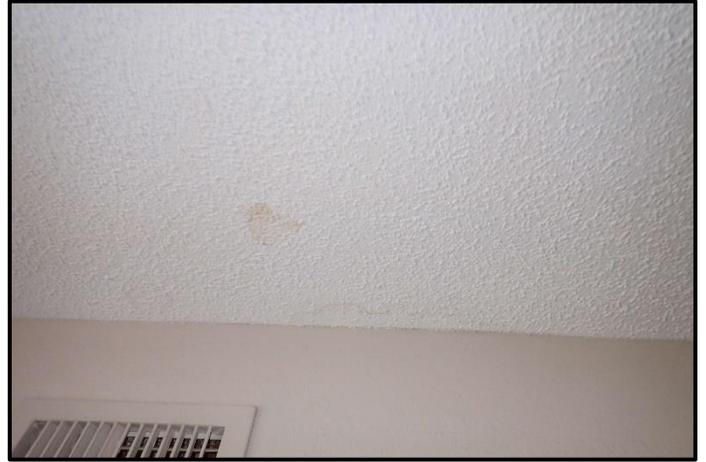
Building Unit	Observations	Substantial Structural Damage (Y/N) If yes - extent	Surface imperfection* (Y/N) If yes - extent	Further (Phase 2) inspection required? (Y/N)	Recommendations (maintenance, repair, replace, or monitor)
B44:46	Water stains on ceiling in master bedroom, noticed approximately 6 months prior. Reportedly upper unit is vacant currently.	No	As noted in observation.	No	Verify if moisture damage is due to active leak and if so, repair damage and source.
B44:62	No evidence of structural damage or surface imperfections observed.	No	No	No	No action.
B44:80	In back room, separation between wall and ceiling drywall at exterior wall joint, hairline, length of room. In master bedroom, door gets stuck at top of side; door and frame measure level. No cracks observed.	No	As noted in observation.	No	Monitor separation.

Photograph 18 - Moisture staining on ceiling in unit 46.

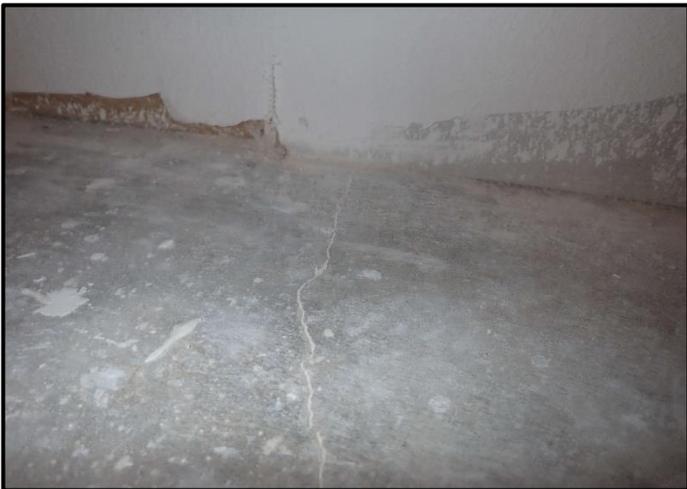
Building Unit	Observations	Substantial Structural Damage (Y/N) If yes - extent	Surface imperfection* (Y/N) If yes - extent	Further (Phase 2) inspection required? (Y/N)	Recommendations (maintenance, repair, replace, or monitor)
B44:2	Exposed slab as part of remodeling the kitchen. Noted slab cracks in two separate area of the kitchen. The slab cracks measured approx. less than 0.060 inch (isolated) with majority of the cracks measuring 0.030 inch or less. There were no signs of significant movement with no evidence of cracks in the wall near the location of the slab cracks. Separation at ceiling to wall interface in kitchen. Water stain on ceiling in hall bathroom.	No	As noted in observation.	No	Seal cracks if exposed and desired, No action.
B44:4	Prior repair to ceiling in the kitchen. Prior repair to ceiling in hallway closet and master bedroom closet. Crack on ceiling in master bedroom, has been present for few years according to owner. Discoloration on ceiling in Florida room has been present since moving in the unit 5 years ago according to owner. Doors and windows were all replaced approximately 4 years prior. Water stains on top portion of door. Noticed delaminated baseboard trim below window in Florida room approximately a few months prior. Had window installers come out and they recaulked outside window.	No	As noted in observation.	No	Monitor cracks and delaminations.

Photograph 19 - Hairline crack in concrete slab in unit 2.
