# **Phase 1 Milestone Inspection Report**

**On Top of the World Clearwater**

**Building 46**

**ESi Project No: 98508**

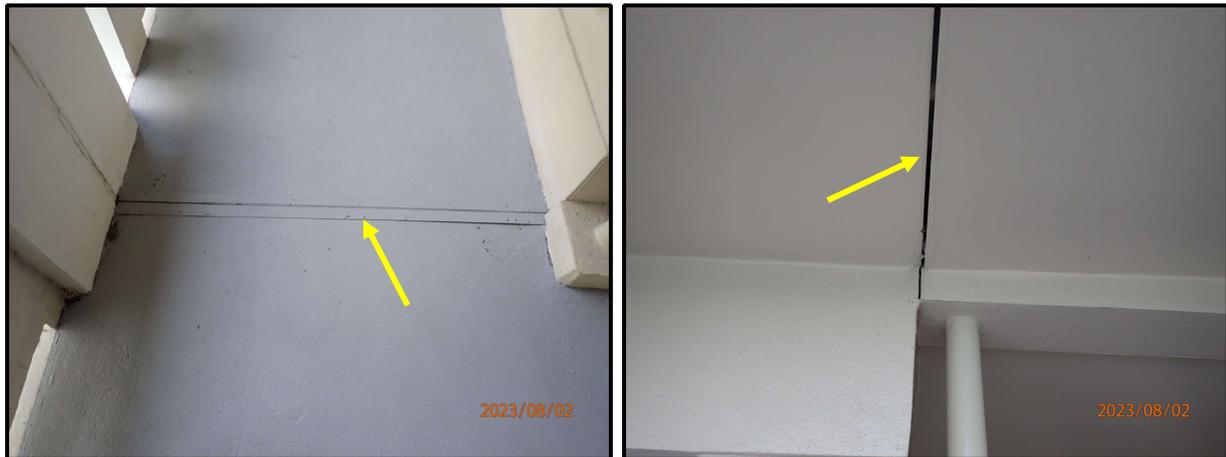
**Figure 5. Representative photographs of building expansion joints at exterior corridor at top and bottom of slab.**

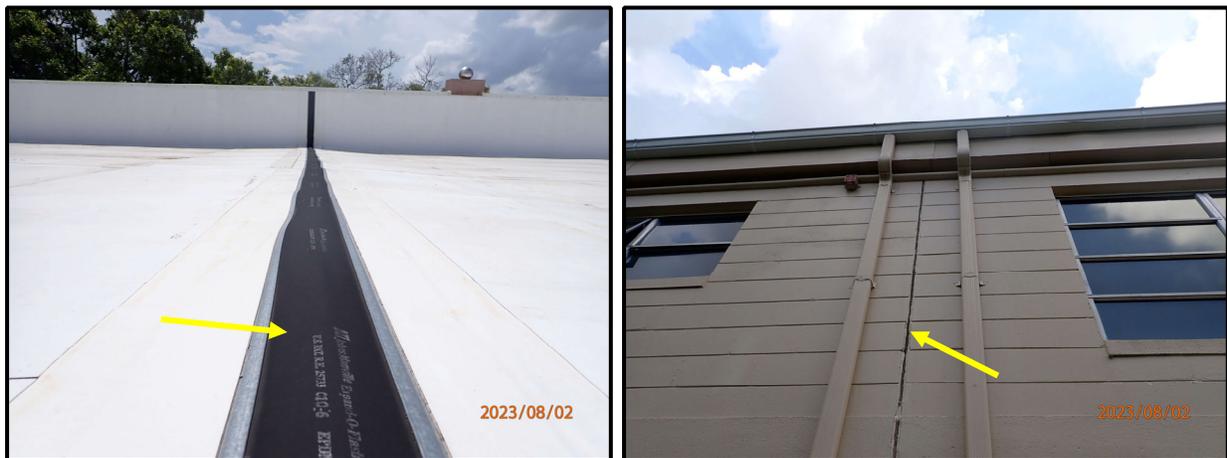
**Figure 6. Representative photographs of building expansion joints at roof and rear wall.**

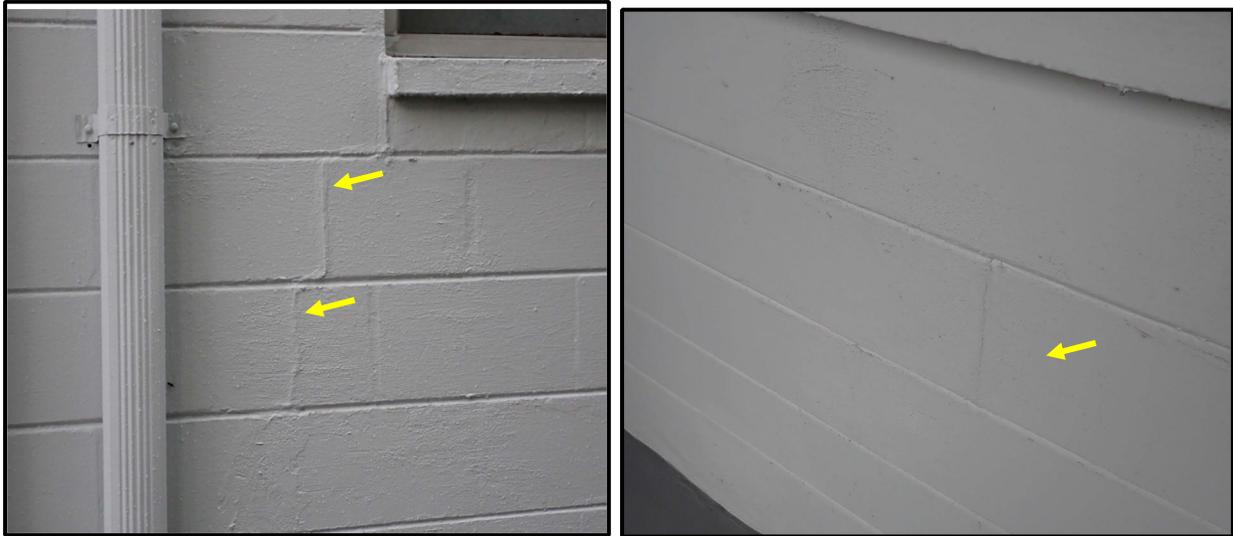
Stairstep cracks, both previously repaired and those appearing to be recent, on the CMU bearing walls of the wings particularly below windows and near the core were typically observed throughout the elevations of the building. Stairstep cracks are cracks in the mortar joints and form due to the movement of the structure, as mortar is a brittle material. The observed width and location of the cracks represent typical movement from a structure (commonly due to soil settlement) and do not appear to be indicative of structural damage. Recommendation for repairs and monitoring of the cracks is provided in Exhibit A. Representative photographs of this observation are shown below in **Figure 5**.

**Figure 5. Representative photographs of step stair cracks at CMU walls.**

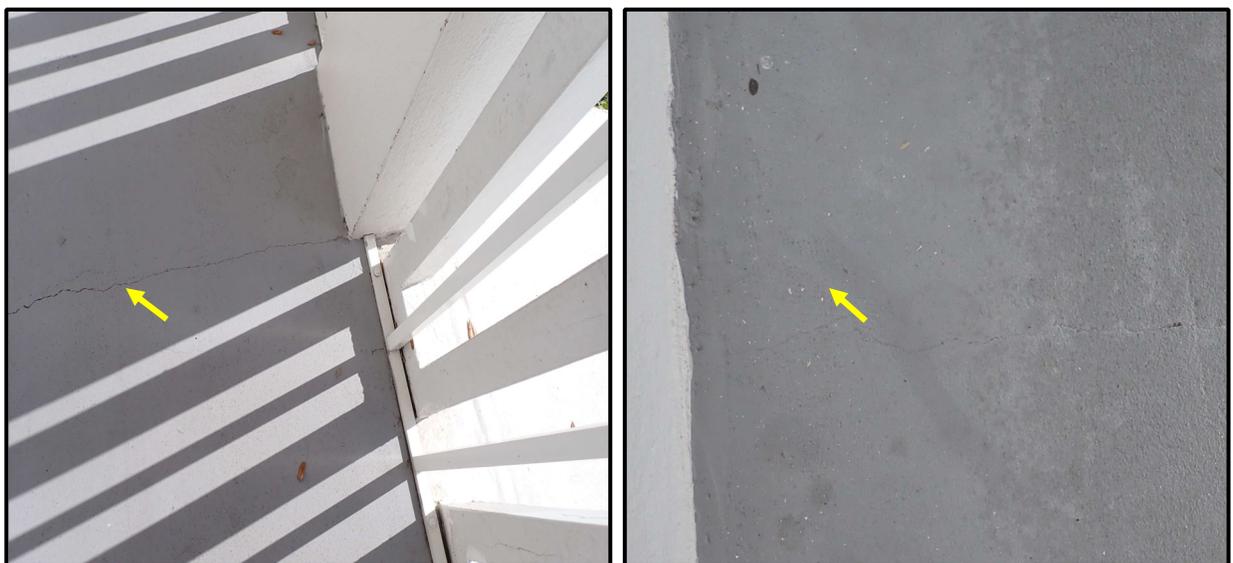
Cracks on the exterior hallway floor slabs were observed perpendicular to the length of the slab and the supporting wall. The observed cracks were typically hairline cracks and shallow. The cracks had weathered edges and dirt on the inside, representing they are historical in nature. The frequency and spacing of these cracks were not uniform. The observed cracks in the subject building are likely due to the expansion and contraction of the materials where control joints were not observed or due to the deflection of the slab at support locations and do not represent a structural damage or substantial deterioration. Recommendation for repairs and monitoring of the cracks is provided in Exhibit A. Representative photographs of this observation are shown below in **Figure 6**.

**Figure 6. Representative photographs of shallow cracks at top surface of the exterior hallway.**

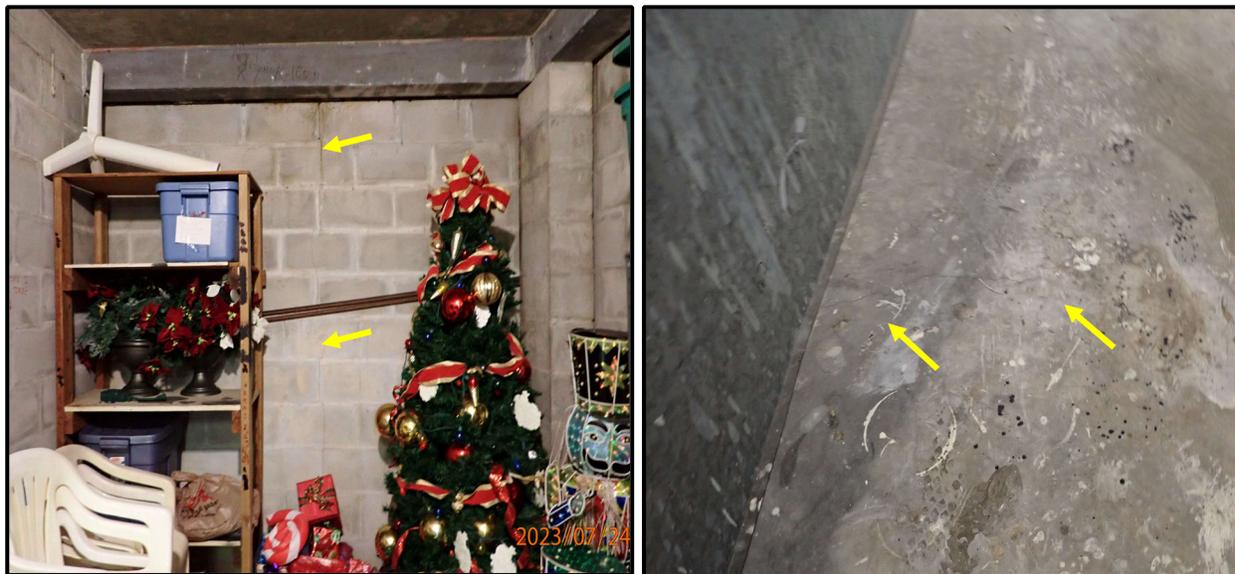
Vertical and horizontal cracking was observed on the building's core on the CMU walls of the storage rooms. CMU and mortar are brittle materials and are likely to crack when subjected to expansion and contraction and differential movement. The observed cracks are due to the movement of the core throughout its life. Similarly observed, were cracks on the concrete slab on grade on the first-floor electrical and storage rooms. The observed cracks are due to the expansion and contraction of the slab and typical settlement of the soils below the structure. Recommendations for repairs and monitoring of the cracks is provided in Exhibit A. Representative photographs of this observation are shown below in **Figure 7**.

**Figure 7. Representative photographs of cracks on CMU walls and concrete slabs at common rooms in Core building.**

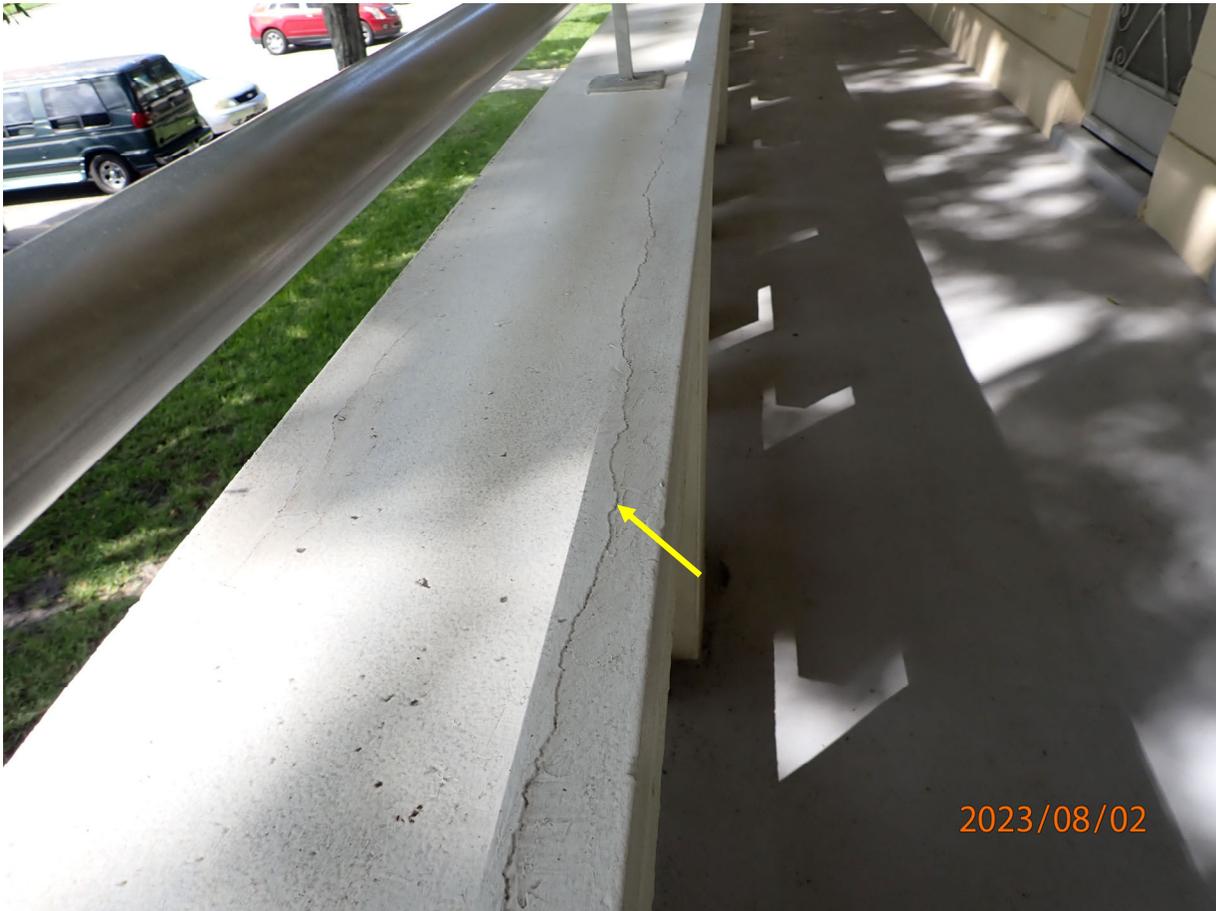
The building's exterior architectural features consisted of a decorative railing with exposed columns which extended from the roof to the slab. The railings and columns were constructed of a painted cementitious material. A secondary metal handrail was installed in the interior of the decorative railing, which was in good condition. Evidence of deterioration of the decorative railings in the form of cracking was observed throughout the building (**Figure 8**). This is not structural damage, yet it is recommended that the decorative railing be repaired to prevent spalled pieces from detaching and falling.

**Figure 8. Representative photograph of cracking of decorative railing**

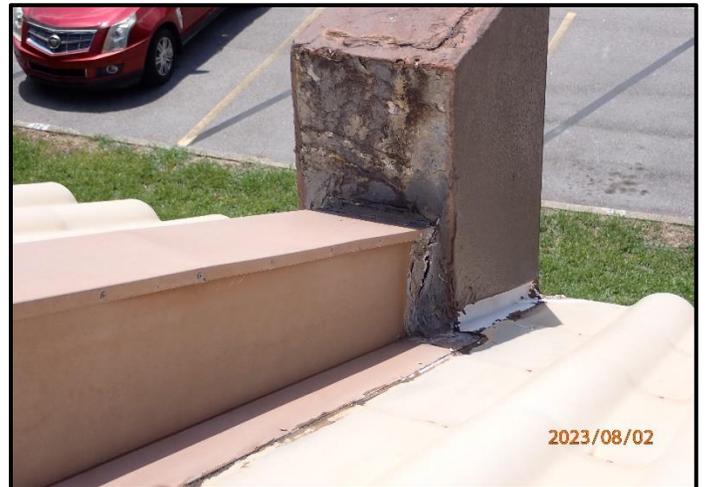
Photograph 04 - Close up view of typical deteriorated sealant at the joint between the sloped roof and exterior columns at the front elevation.

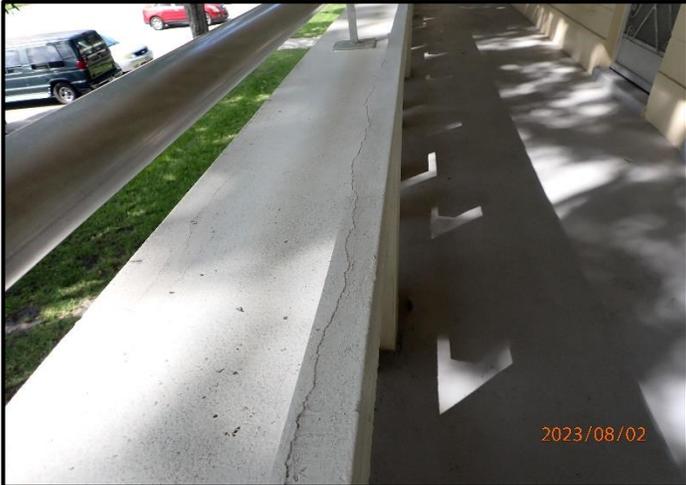
Photograph 05 - View of typical crack in top ledge of exterior walkway railing.

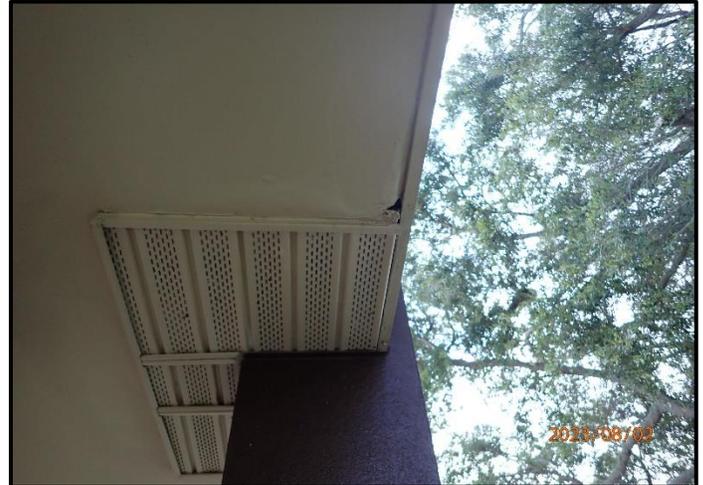
Photograph 06 - View of moisture damage to soffit panel surrounding a column at the front elevation of unit 20.

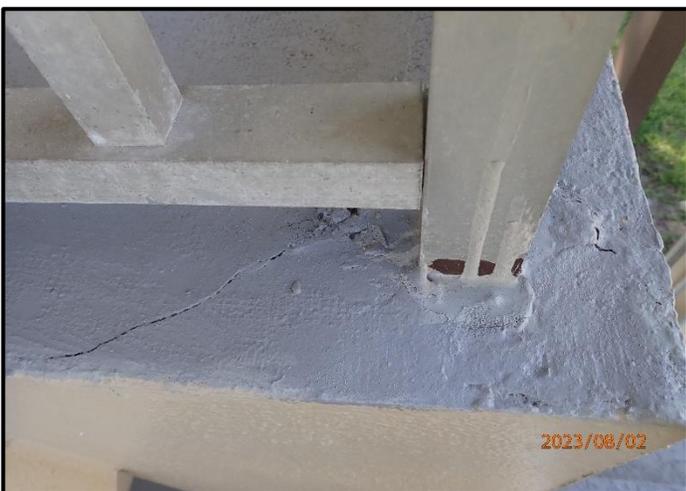
Photograph 07 - Close up view of the crack at the corner of the south stair 2nd floor landing.

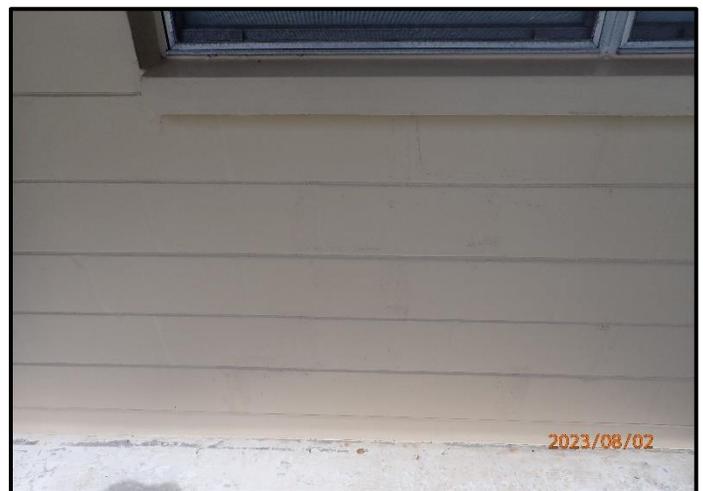
Photograph 08 - View of a previous repair to a stair step mortar crack at the front elevation of unit 6.

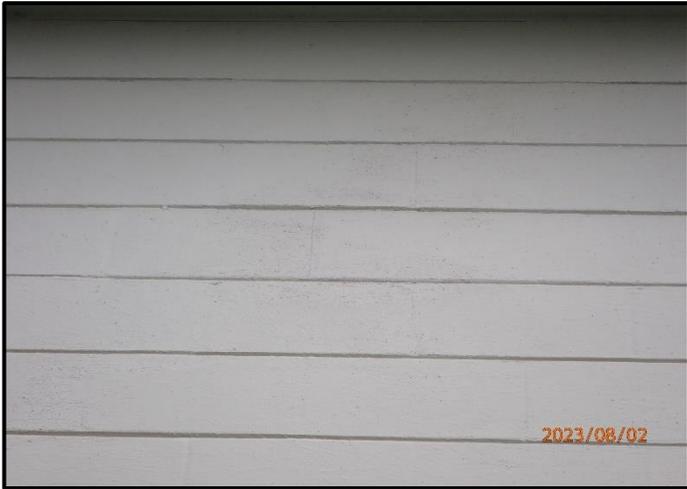
Photograph 09 - Close up view of a stair step mortar crack at the rear elevation of unit 2.

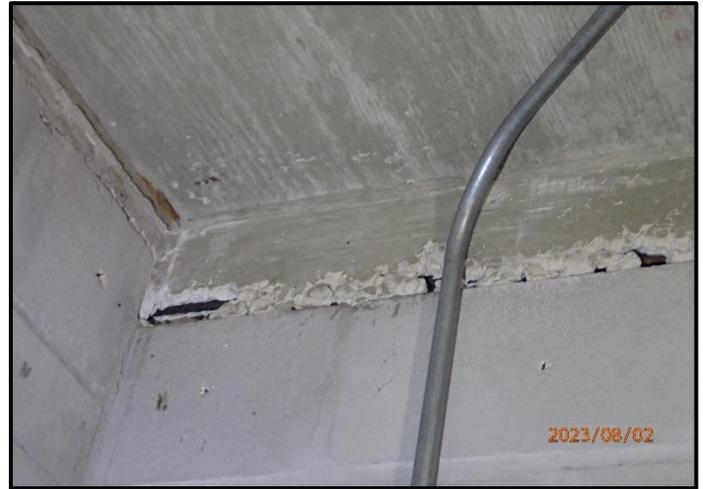
Photograph 10 - View of voids between the 2nd floor concrete slab and CMU wall in the fire panel room.

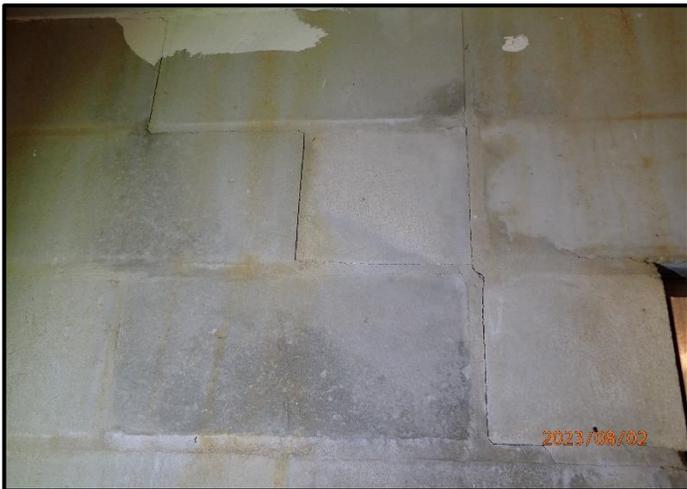
Photograph 11 - View of a stair step mortar crack in the 1st floor storage room.

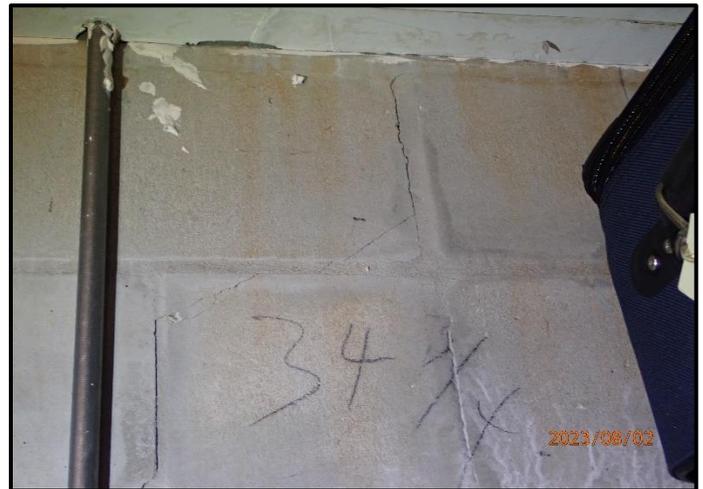
Photograph 12 - Close up view of a stair step mortar crack in the 1st floor storage room.
