# **Phase 1 Milestone Inspection Report**

**On Top of the World Clearwater**

**Building 54**

**ESi Project No: 98508**

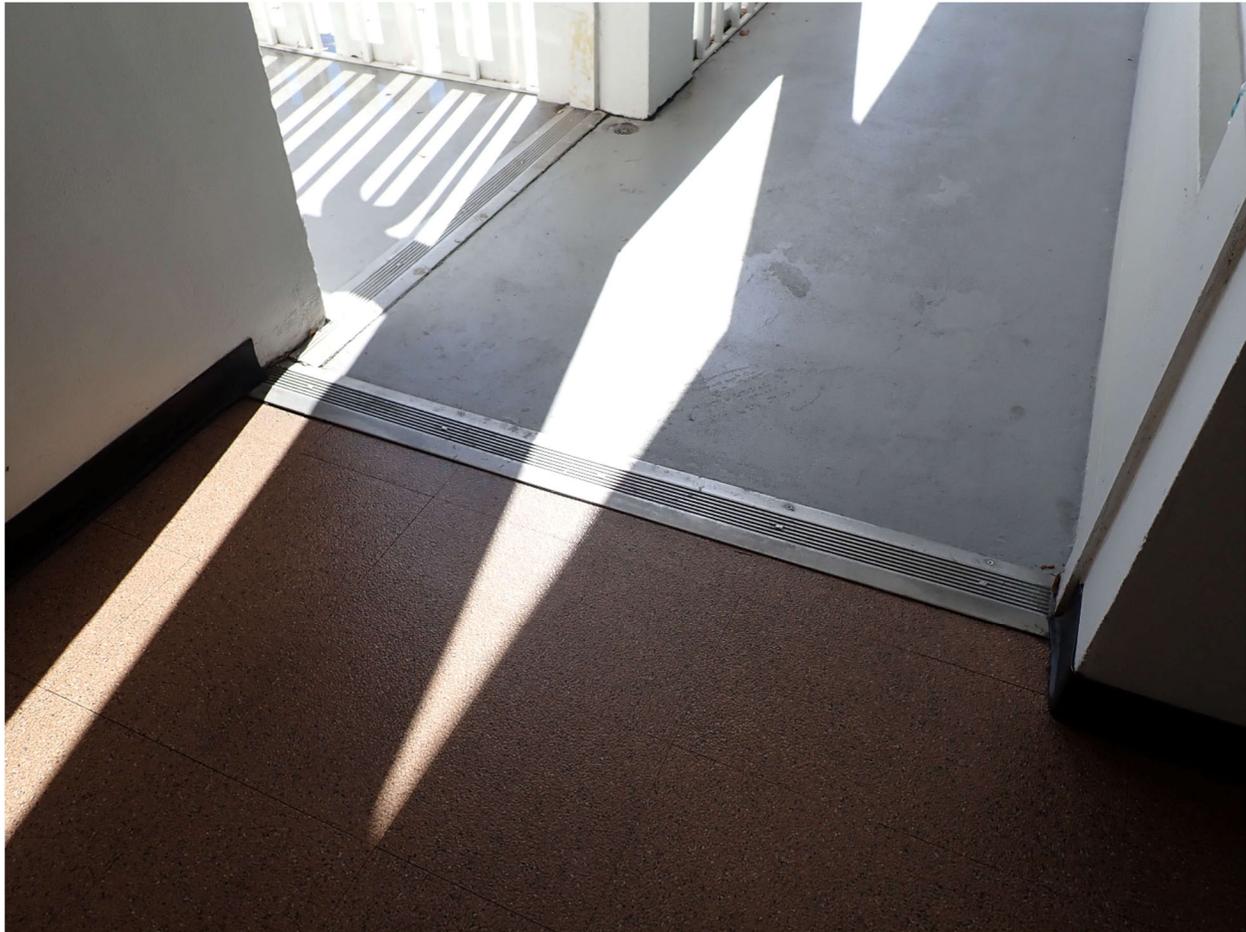
**Figure 5. Representative expansion joint at wing/core intersection.**

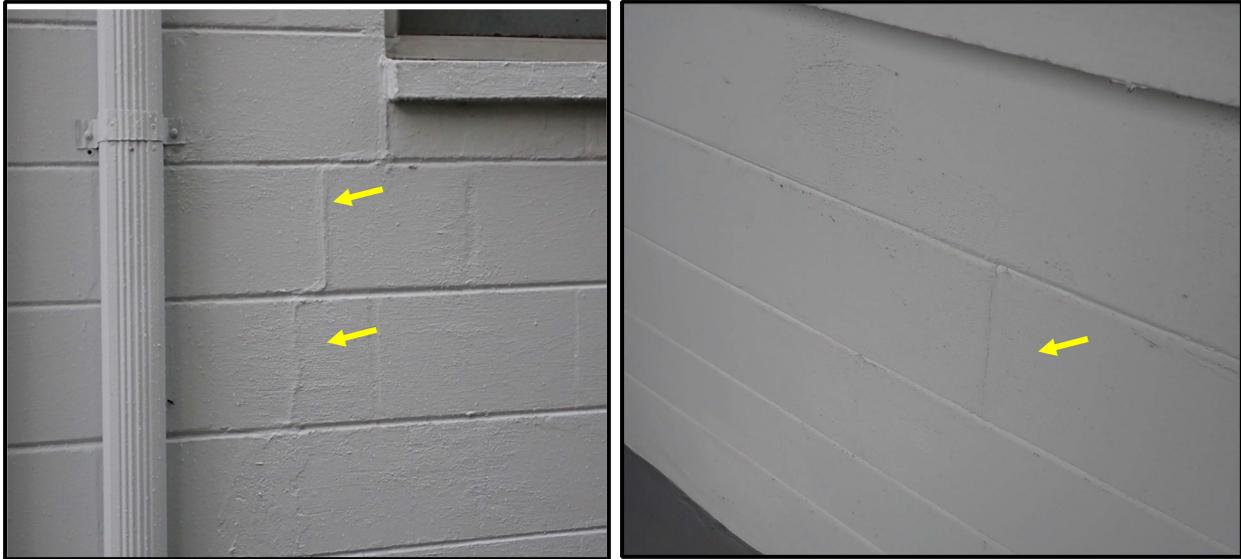
Stairstep cracks, both previously repaired and those appearing to be recent, on the CMU bearing walls of the wings particularly below windows and near the core were typically observed throughout the elevations of the building. Stairstep cracks are cracks in the mortar joints and form due to the movement of the structure, as mortar is a brittle material. The observed width and location of the cracks represent typical movement from a structure (commonly due to soil settlement) and do not appear to be indicative of structural damage. Recommendation for repairs and monitoring of the cracks is provided in Exhibit A. Representative photographs of this observation are shown below in **Figure 7**.

**Figure 7. Representative photographs of step stair cracks at CMU walls.**

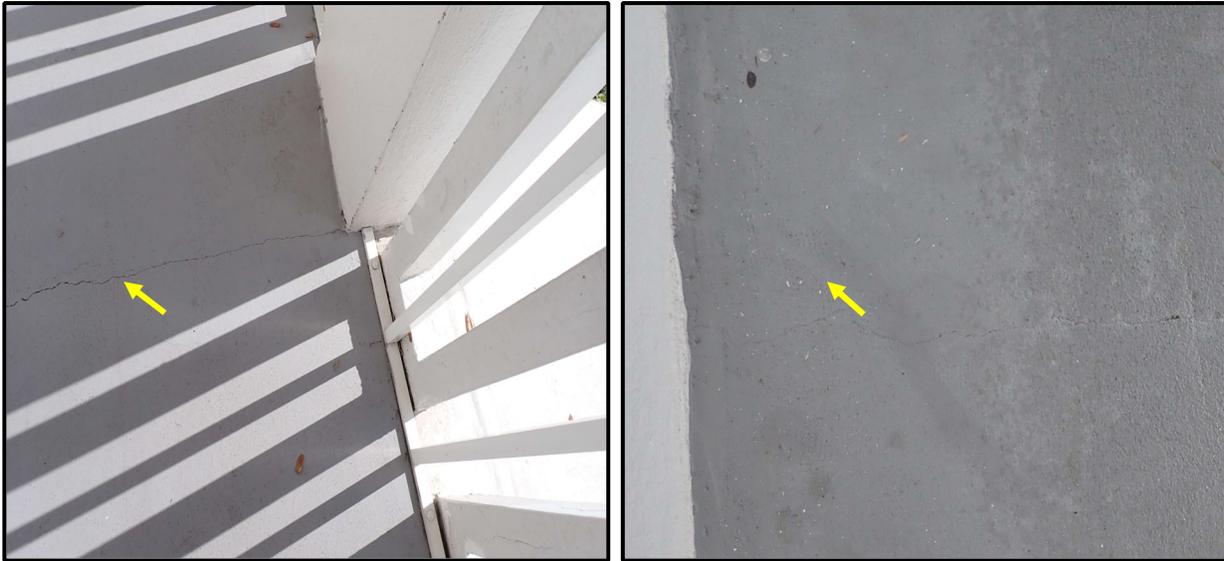
Cracks on the exterior hallway floor slabs were observed perpendicular to the length of the slab and the supporting wall. The observed cracks were typically hairline cracks and shallow. The cracks had weathered edges and dirt on the inside, representing they are historical in nature. The frequency and spacing of these cracks were not uniform. The observed cracks in the subject building are likely due to the expansion and contraction of the materials where control joints were not observed or due to the deflection of the slab at support locations and do not represent a structural damage or substantial deterioration. Recommendation for repairs and monitoring of the cracks is provided in Exhibit A. Representative photographs of this observation are shown below in **Figure 8**.

**Figure 8. Representative photographs of shallow cracks at top surface of the exterior hallway.**

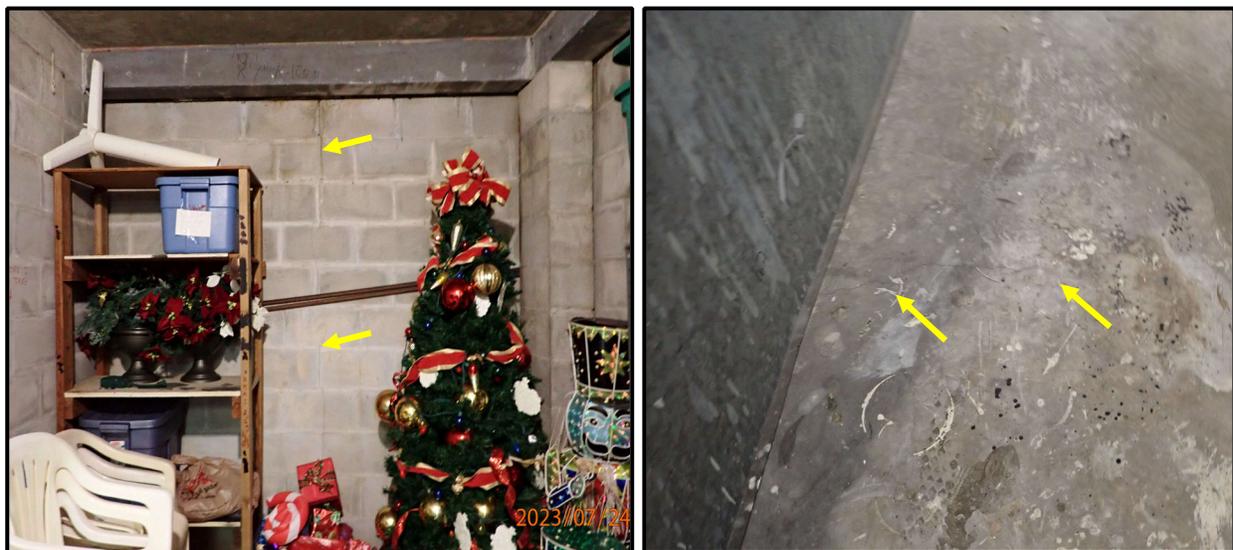
Vertical and horizontal cracking was observed on the building's core on the CMU walls of the storage rooms. CMU and mortar are brittle materials and are likely to crack when subjected to expansion and contraction and differential movement. The observed cracks are due to the movement of the core throughout its life. Similarly observed, were cracks on the concrete slab on grade on the first-floor electrical and storage rooms. The observed cracks are due to the expansion and contraction of the slab and typical settlement of the soils below the structure. Recommendations for repairs and monitoring of the cracks is provided in Exhibit A. Representative photographs of this observation are shown below in **Figure 9**.

**Figure 9. Representative photographs of cracks on CMU walls and concrete slabs at common rooms in Core building.**

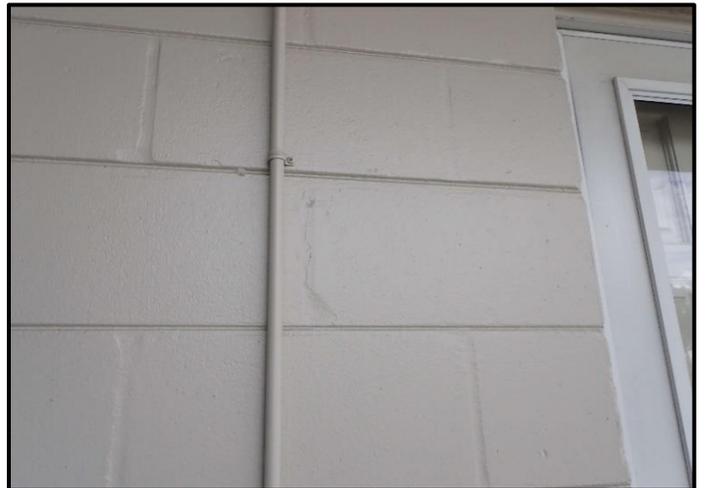
Photograph 04 - Vertical crack in mortar.

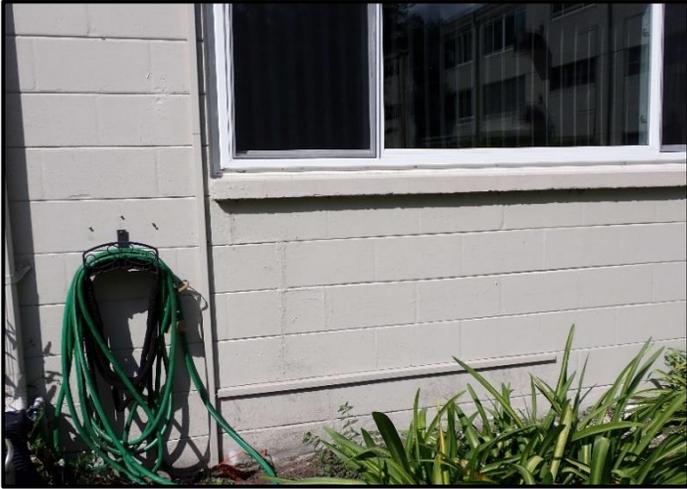
Photograph 05 - Vertical crack in CMU block.

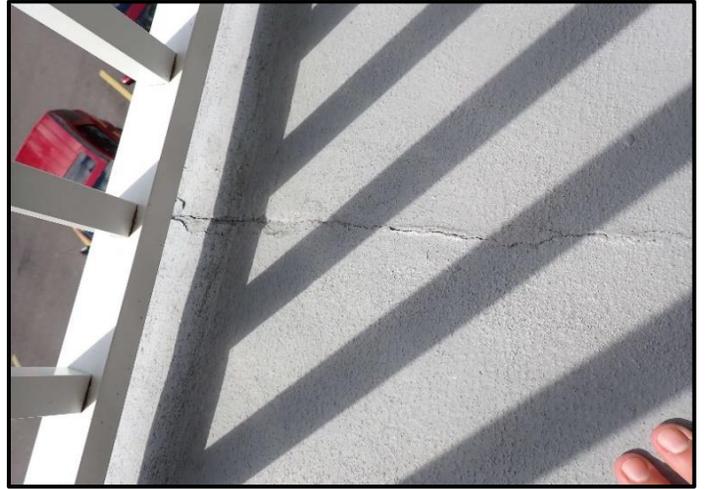
Photograph 06 - Crack in elevated walkway slab.

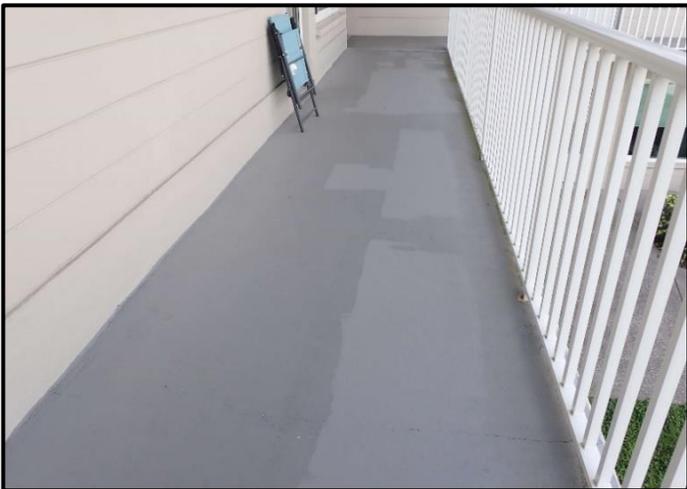
Photograph 07 - Previous repairs to walkway surface.

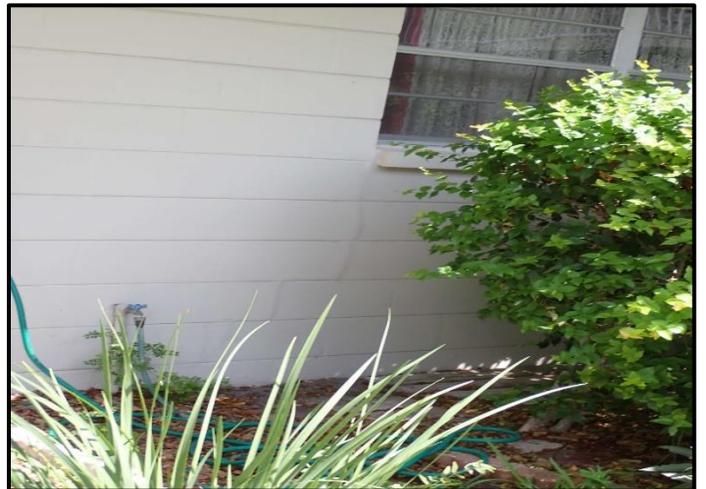
Photograph 08 - Previous repair to vertical crack in CMU wall.

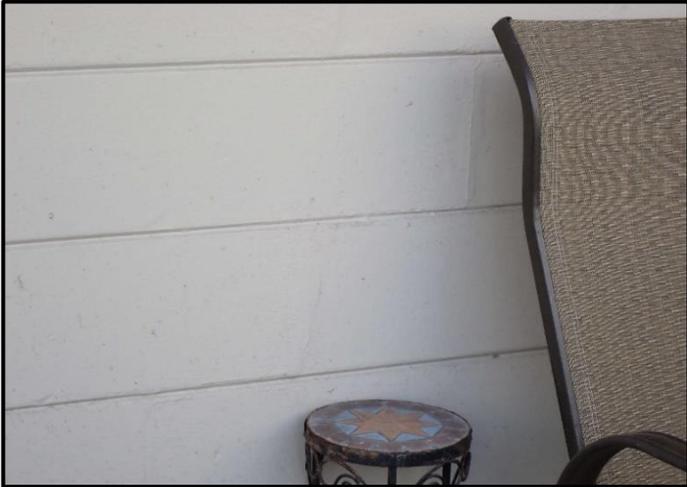
Photograph 09 - Previous repair to stair step crack.

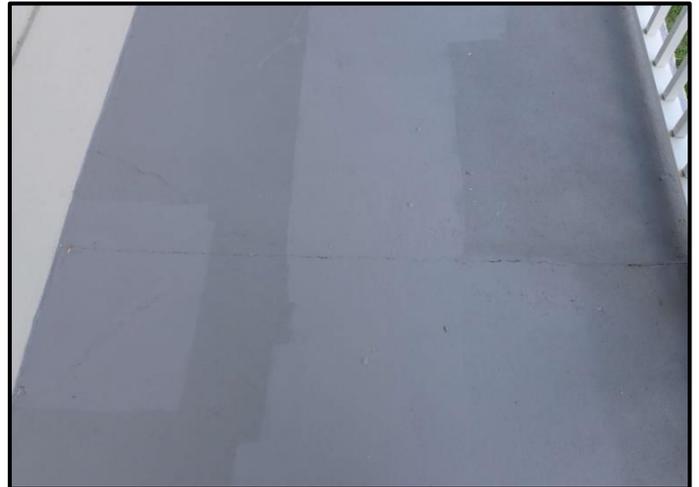
Photograph 10 - Crack in elevated walkway slab.

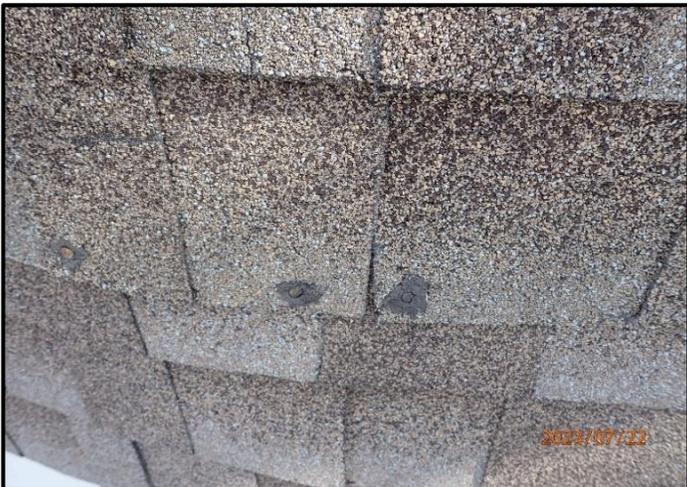
Photograph 11 - Nails through exposed shingles surfaces.

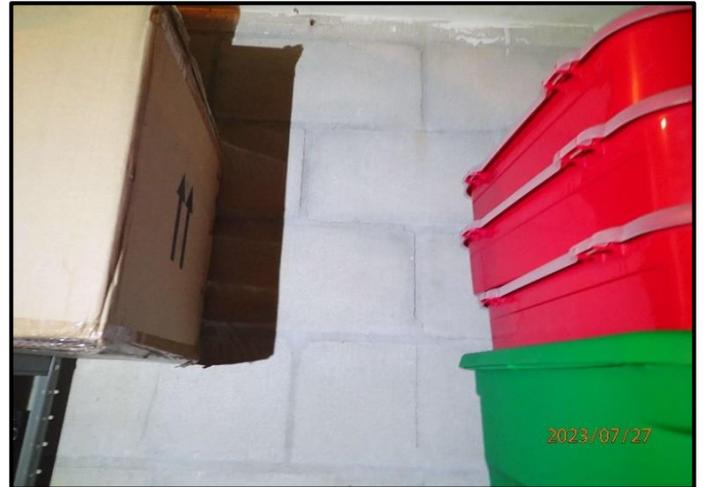
Photograph 12 - Stair step crack in CMU wall.

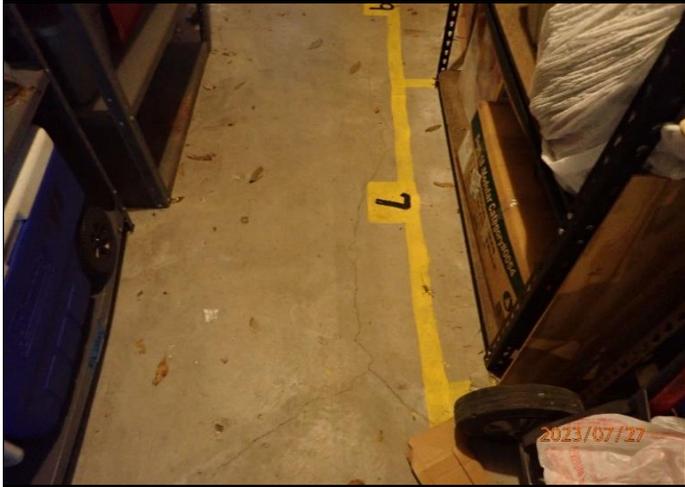
Photograph 13 - Cracks in slab of storage room.

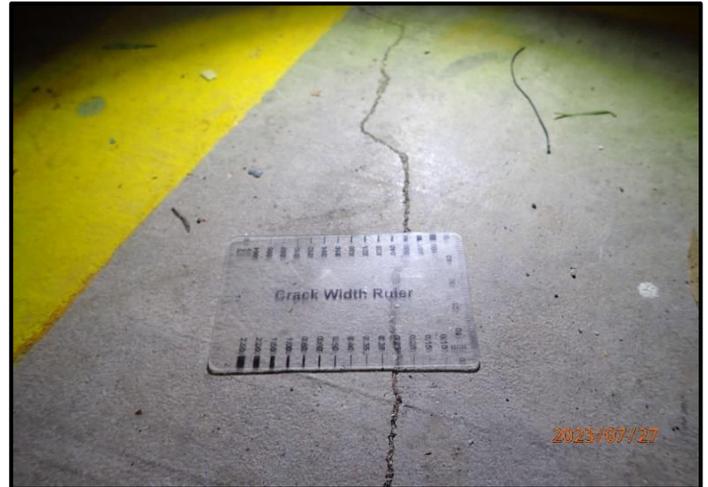
Photograph 14 - Crack in slab of elevator room.

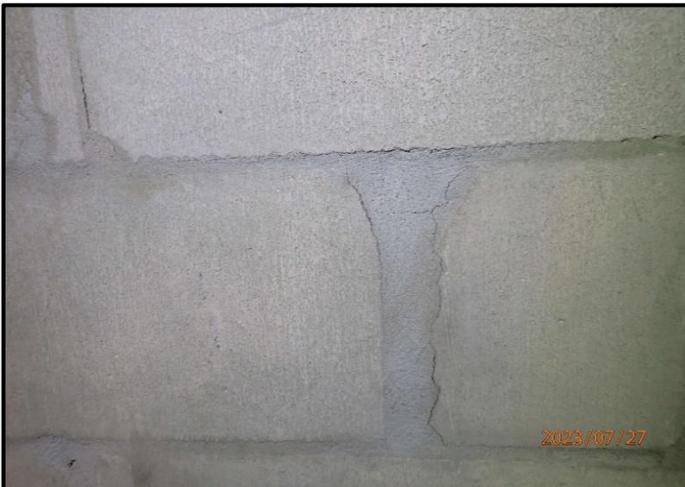
Photograph 15 - Crack in mortar joint of CMU wall.

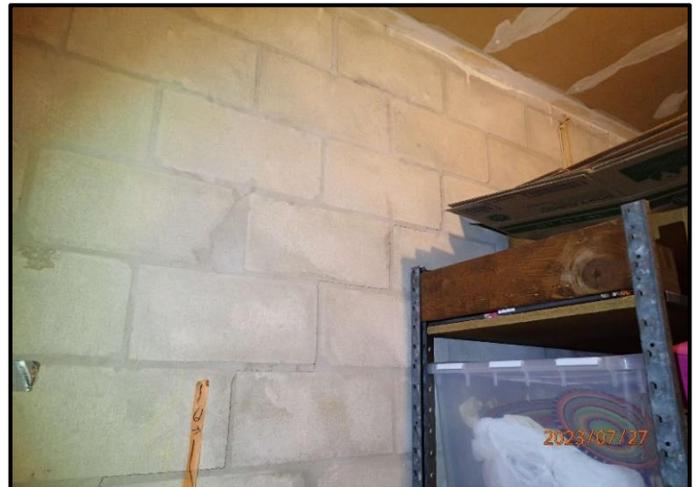
Photograph 16 - Stair step crack in CMU wall.

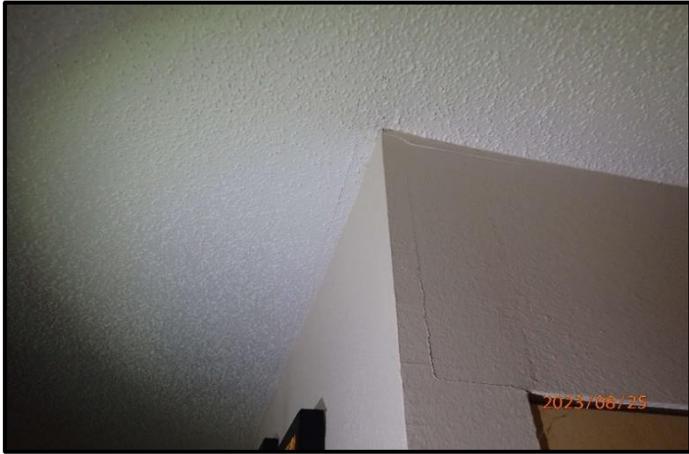
Building Unit	Observations	Substantial Structural Damage (Y/N) If yes - extent	Surface imperfection* (Y/N) If yes - extent	Further (Phase 2) inspection required? (Y/N)	Recommendations (maintenance, repair, replace, or monitor)
B54:52	<p>In living room, drywall tape separation at ceiling of exterior wall and southwest corner wall, hairline drywall crack between window and door corner, drywall crack extending to drywall separation crack at opposite wall corner, hairline drywall crack (~8") at top of east wall, drywall corner bead separation at ceiling/wall joints at kitchen/living room joint, and hairline drywall crack (12") above hall entry. 0.025' drywall crack above cabinets in living room/kitchen entry. Hairline drywall crack above kitchen/back entry that starts at corner. In back room, drywall tape/corner bead separation in ceiling at exterior wall/ceiling joint and hairline drywall crack below right window. In master bedroom, drywall tape/corner bead separation (hairline) above back entry ceiling, at bathroom wall, and at core wall. Paint delamination in master bedroom/core wall (4"x18"). In master bathroom, wall/ceiling separation (~18" length) at northwest corner. In bathroom, hairline crack in sealant at top of tile wall/ceiling throughout (construction issue). In bedroom, loose carpet, drywall tape/corner bead separation in closet on bedroom/core wall (&gt;HL), and hairline drywall tape/corner bead separation at exterior wall/ceiling on ceiling and wall. In hall, prior repair to ceiling crack in drywall (~6" length).</p>	No	As noted in observation.	No	Monitor crack and separation.

Photograph 17 - Vertical and horizontal cracks on wall in unit 52.

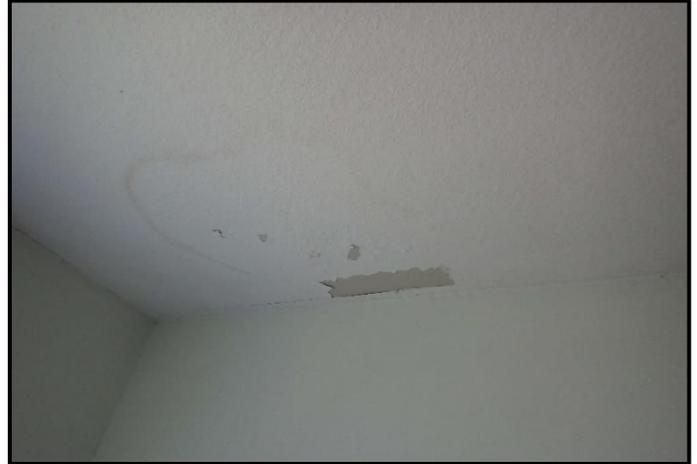
B54:57	<p>Crack on wall in living room. Crack on ceiling and separation at ceiling to wall interface in master bathroom. Water stain on ceiling and cracked/peeled off portion of ceiling finish in master bathroom. Reportedly leaked from shower head approximately 3 years prior; ceiling hasn't been fixed. Separation at ceiling to wall interface in kitchen.</p>	No	As noted in observation.	No	Monitor cracks.

Photograph 18 - Moisture staining and cracks on ceiling in unit 57.

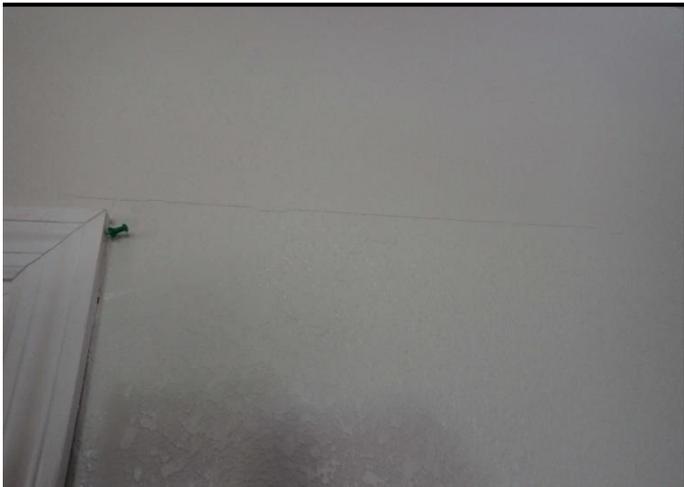
B54:22	Crack on wall in living room. Crack on wall in Florida room, shares common wall with crack on wall in living room. Crack on wall below window in Florida room.	No	As noted in observation.	No	Monitor cracks.
B54:24	Crack on ceiling with evidence of prior repair to crack in kitchen. Water stain on ceiling in couple areas of master closet, evidence of prior repair on ceiling noted in close proximity of the water stain.	No	As noted in observation.	No	Verify if moisture damage is due to active leak and if so, repair damage and source.

Photograph 19 - horizontal crack on wall in unit 22
