Phase 1 Milestone Inspection Report

On Top of the World Clearwater

Building 56

ESi Project No: 98508

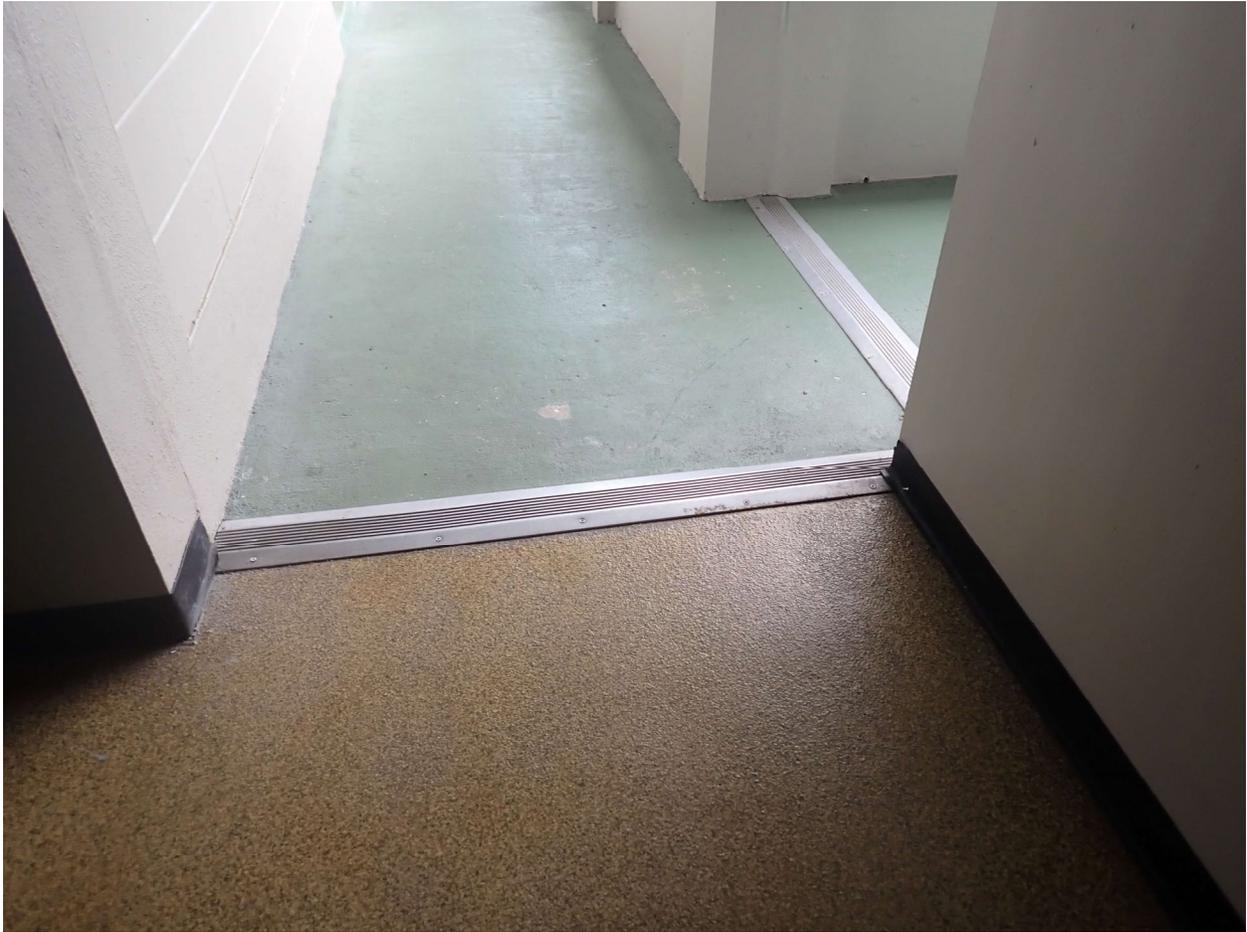
Figure 5. Representative expansion joint at wing/core intersection.

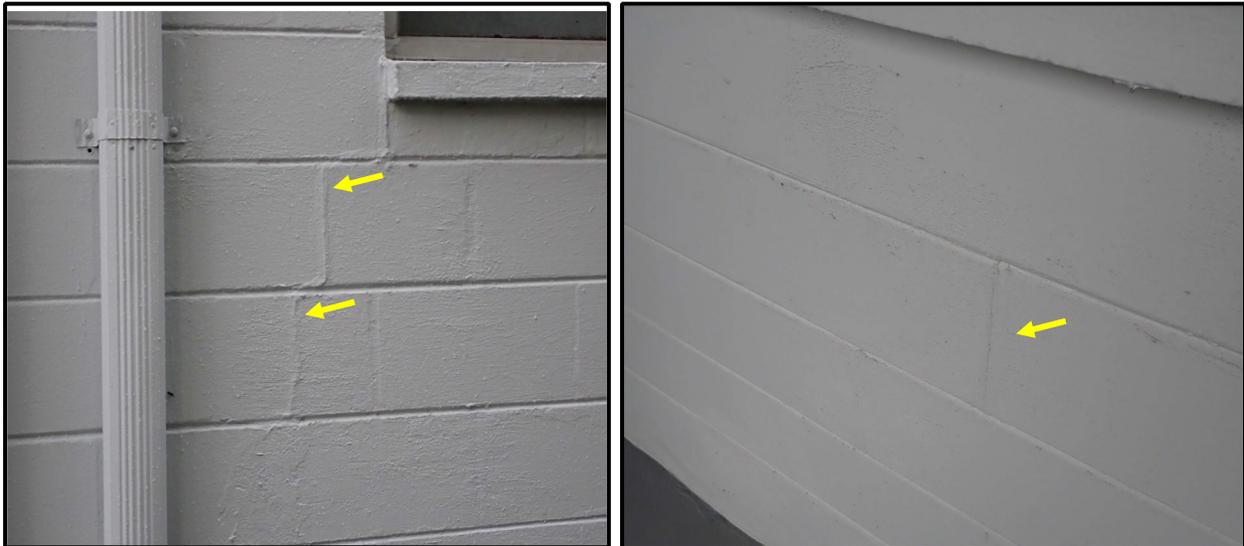
Stairstep cracks, both previously repaired and those appearing to be recent, on the CMU bearing walls of the wings particularly below windows and near the core were typically observed throughout the elevations of the building. Stairstep cracks are cracks in the mortar joints and form due to the movement of the structure, as mortar is a brittle material. The observed width and location of the cracks represent typical movement from a structure (commonly due to soil settlement) and do not appear to be indicative of structural damage. Recommendation for repairs and monitoring of the cracks is provided in Exhibit A. Representative photographs of this observation are shown below in **Figure 7**.

Figure 7. Representative photographs of step stair cracks at CMU walls.

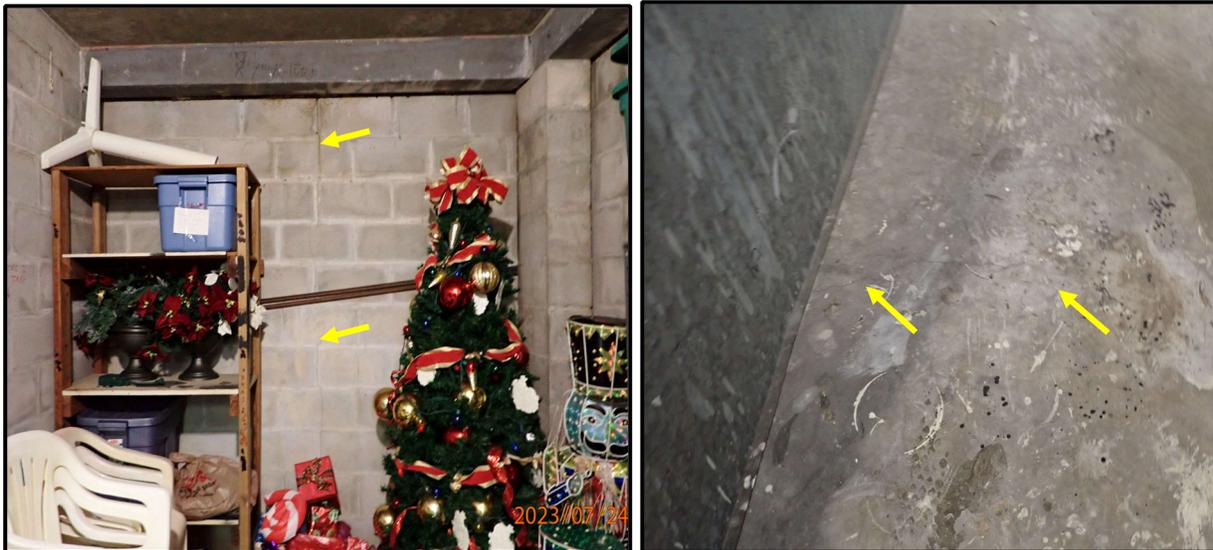
Vertical and horizontal cracking was observed on the building's core on the CMU walls of the storage rooms. CMU and mortar are brittle materials and are likely to crack when subjected to expansion and contraction and differential movement. The observed cracks are due to the movement of the core throughout its life. Similarly observed, were cracks on the concrete slab on grade on the first-floor electrical and storage rooms. The observed cracks are due to the expansion and contraction of the slab and typical settlement of the soils below the structure. Recommendations for repairs and monitoring of the cracks is provided in Exhibit A. Representative photographs of this observation are shown below in **Figure 9**.

Figure 9. Representative photographs of cracks on CMU walls and concrete slabs at common rooms in Core building.

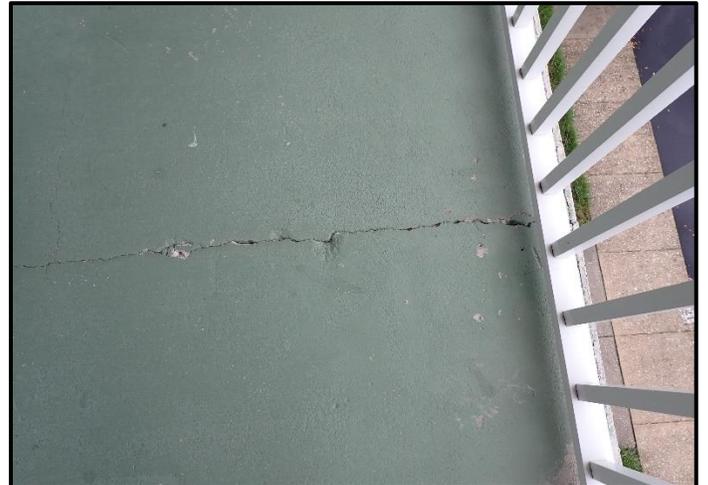
Photograph 04 - View of a typical crack in the exterior walkway perpendicular to the building.

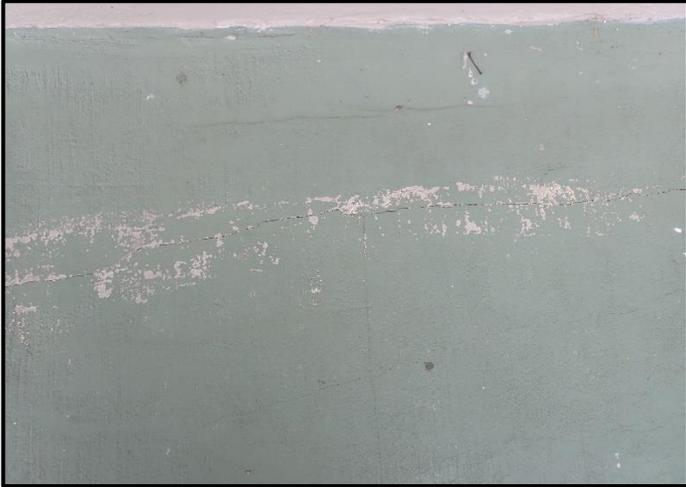
Photograph 05 - View of a typical crack in the exterior walkway parallel to the building.

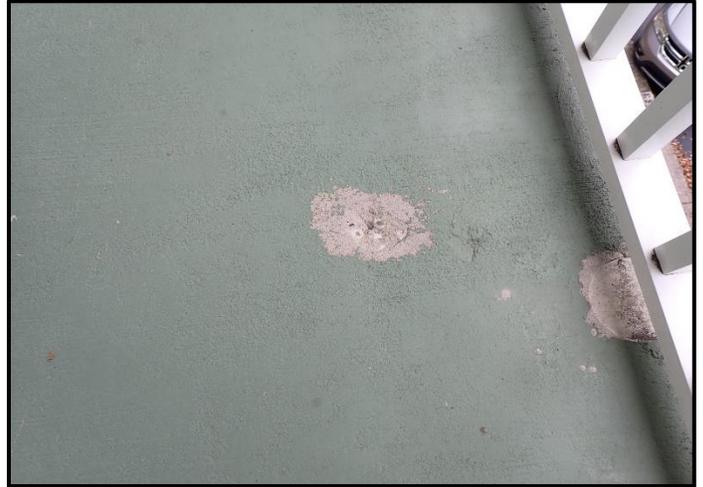
Photograph 06 - View of a typical chip or delamination in the exterior walkway surface of the subject building.

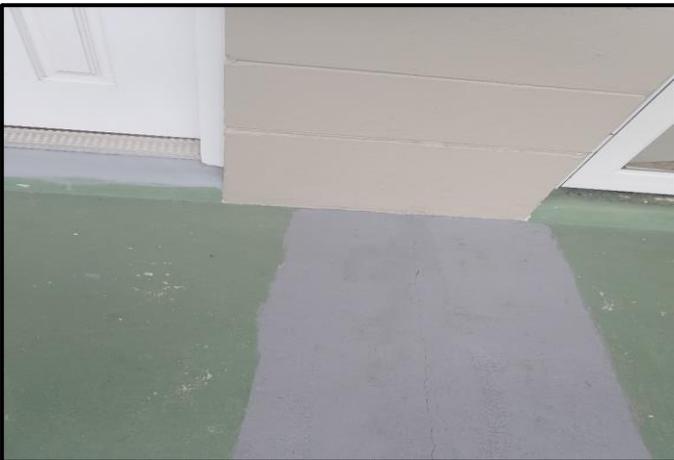
Photograph 07 - View of the surface patch to the exterior walkway at the front elevation of unit 69.

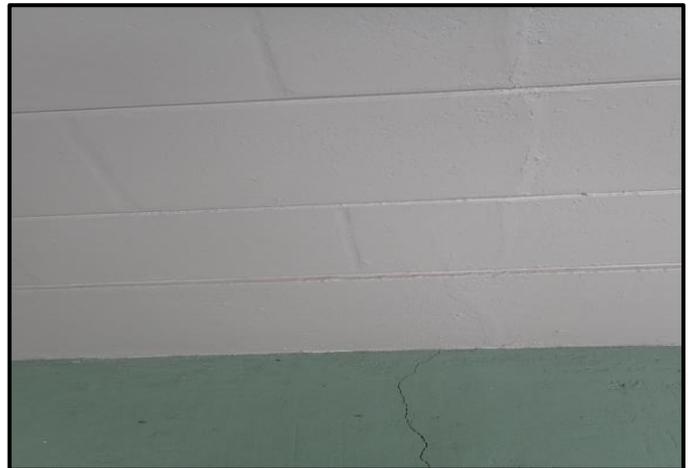
Photograph 08 - View of a previous repair to a vertical crack in the CMU wall at the front elevation of unit 53.

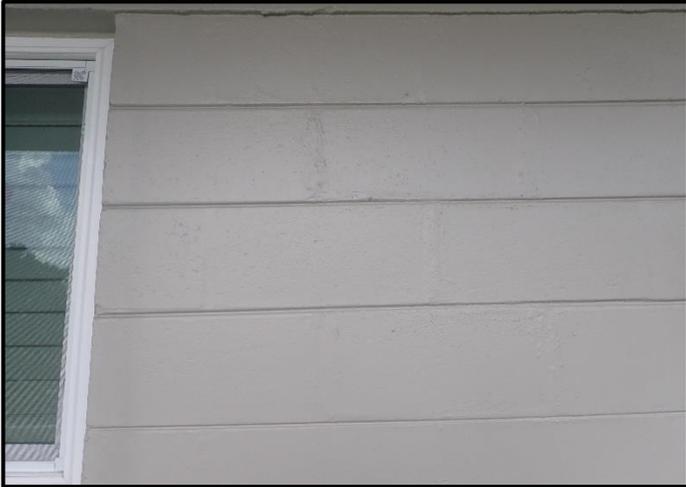
Photograph 09 - View of a previous repair to a mortar stair step crack at the front elevation of unit 60.

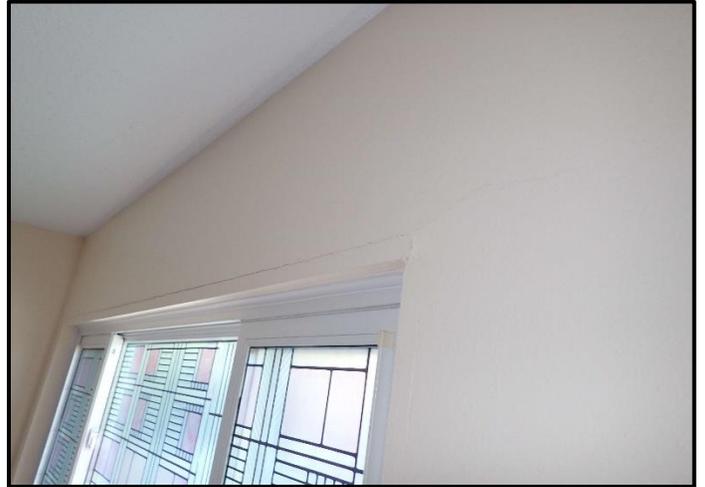
Photograph 10 - Horizontal crack on wall in unit 60.

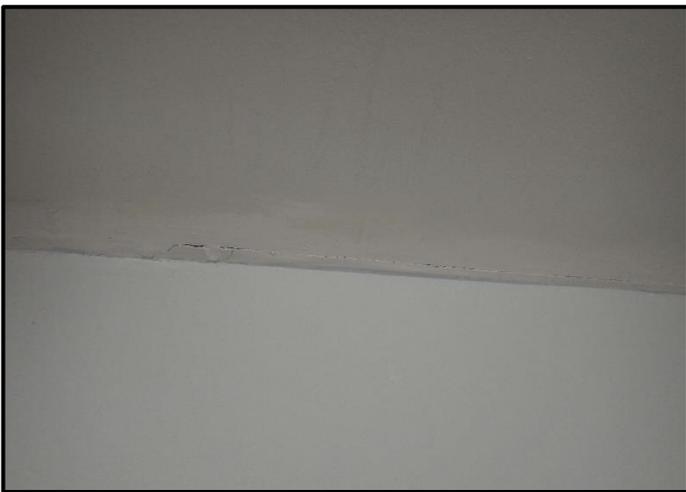
Photograph 11 - Crack on ceiling in unit 62.

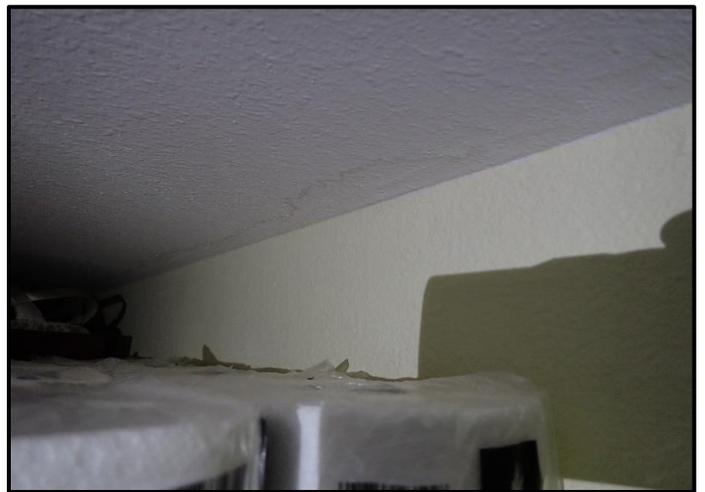
Photograph 12 - Moisture staining on ceiling in unit 39.
