Phase 1 Milestone Inspection Report

On Top of the World Clearwater

Building 57

ESi Project No: 98508

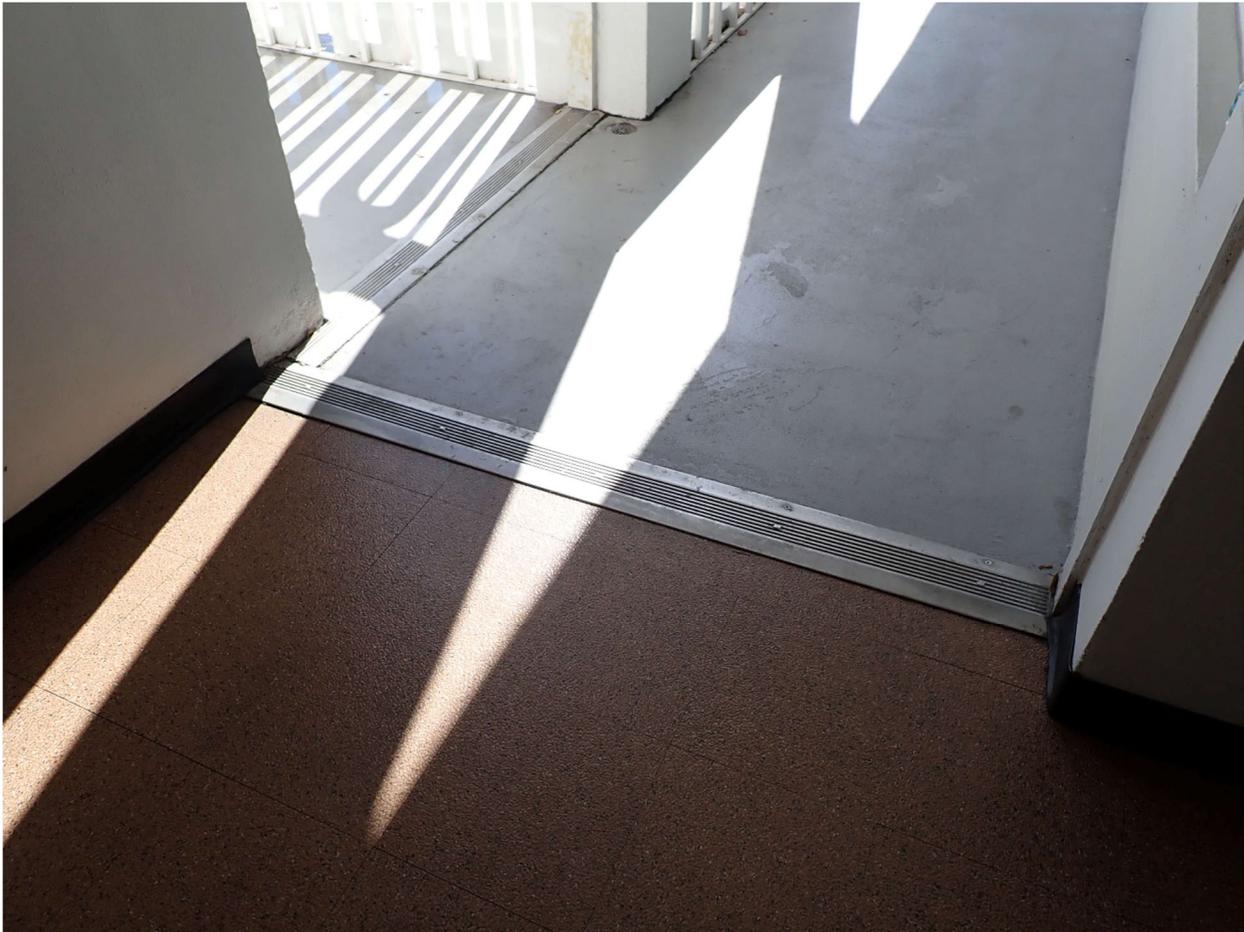
Figure 5. Representative expansion joint at wing/core intersection.

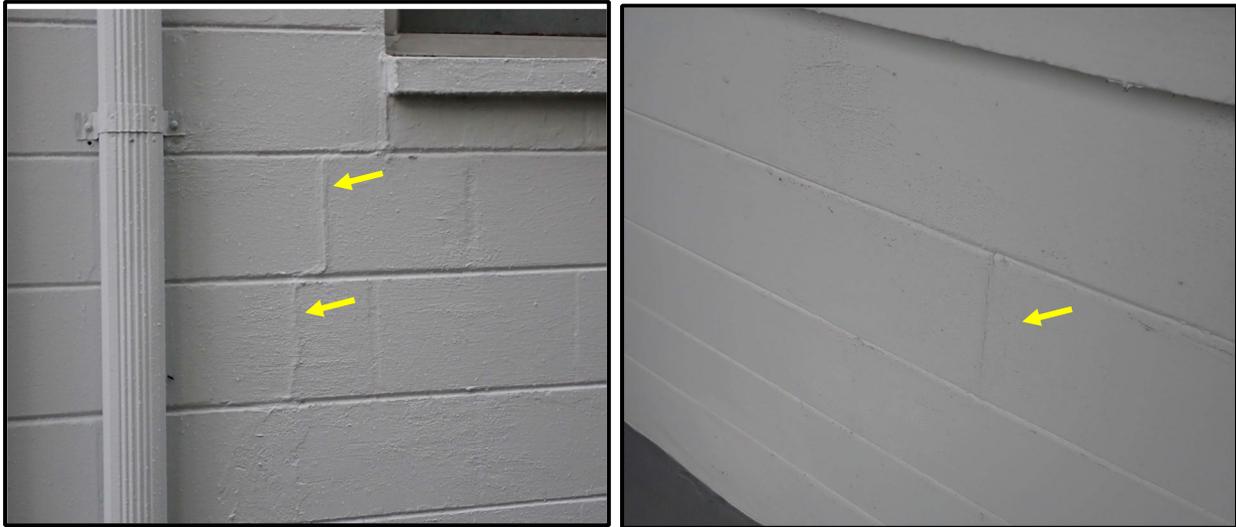
Stairstep cracks, both previously repaired and those appearing to be recent, on the CMU bearing walls of the wings particularly below windows and near the core were typically observed throughout the elevations of the building. Stairstep cracks are cracks in the mortar joints and form due to the movement of the structure, as mortar is a brittle material. The observed width and location of the cracks represent typical movement from a structure (commonly due to soil settlement) and do not appear to be indicative of structural damage. Recommendation for repairs and monitoring of the cracks is provided in Exhibit A. Representative photographs of this observation are shown below in **Figure 7**.

Figure 7. Representative photographs of step stair cracks at CMU walls.

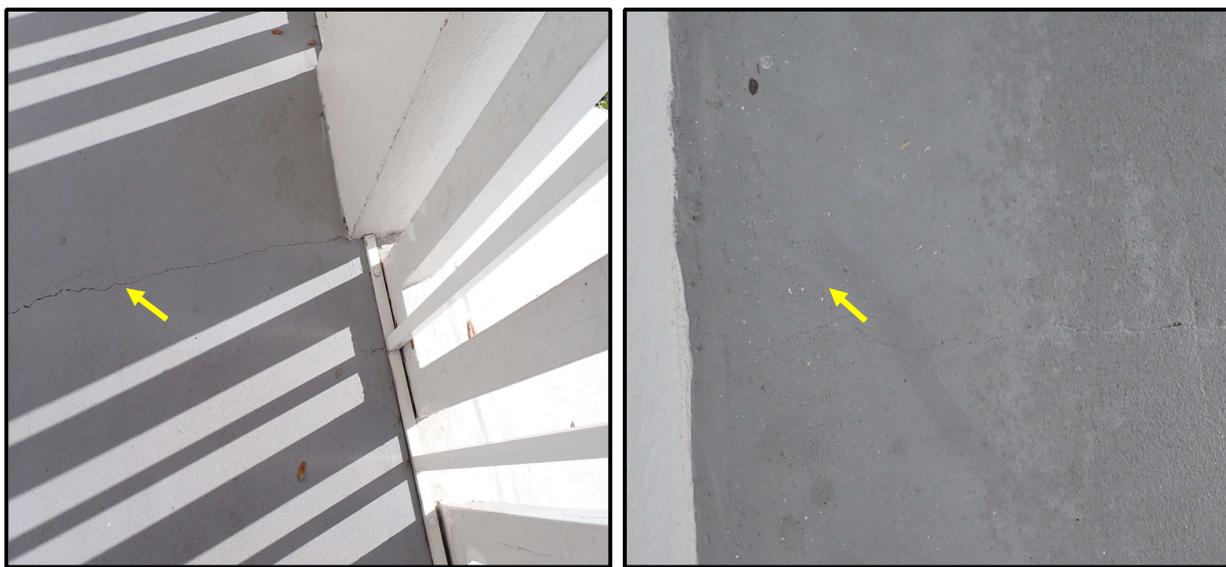
Cracks on the exterior hallway floor slabs were observed perpendicular to the length of the slab and the supporting wall. The observed cracks were typically hairline cracks and shallow. The cracks had weathered edges and dirt on the inside, representing they are historical in nature. The frequency and spacing of these cracks were not uniform. The observed cracks in the subject building are likely due to the expansion and contraction of the materials where control joints were not observed or due to the deflection of the slab at support locations and do not represent a structural damage or substantial deterioration. Recommendation for repairs and monitoring of the cracks is provided in Exhibit A. Representative photographs of this observation are shown below in **Figure 8**.

Figure 8. Representative photographs of shallow cracks at top surface of the exterior hallway.

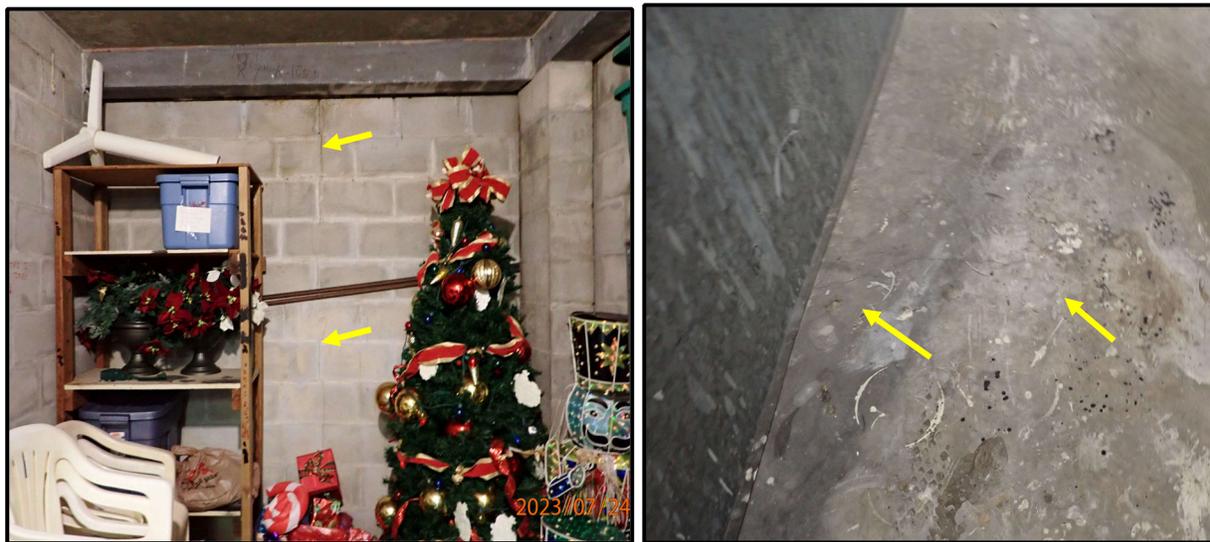
Vertical and horizontal cracking was observed on the building's core on the CMU walls of the storage rooms. CMU and mortar are brittle materials and are likely to crack when subjected to expansion and contraction and differential movement. The observed cracks are due to the movement of the core throughout its life. Similarly observed, were cracks on the concrete slab on grade on the first-floor electrical and storage rooms. The observed cracks are due to the expansion and contraction of the slab and typical settlement of the soils below the structure. Recommendations for repairs and monitoring of the cracks is provided in Exhibit A. Representative photographs of this observation are shown below in **Figure 9**.

Figure 9. Representative photographs of cracks on CMU walls and concrete slabs at common rooms in Core building.

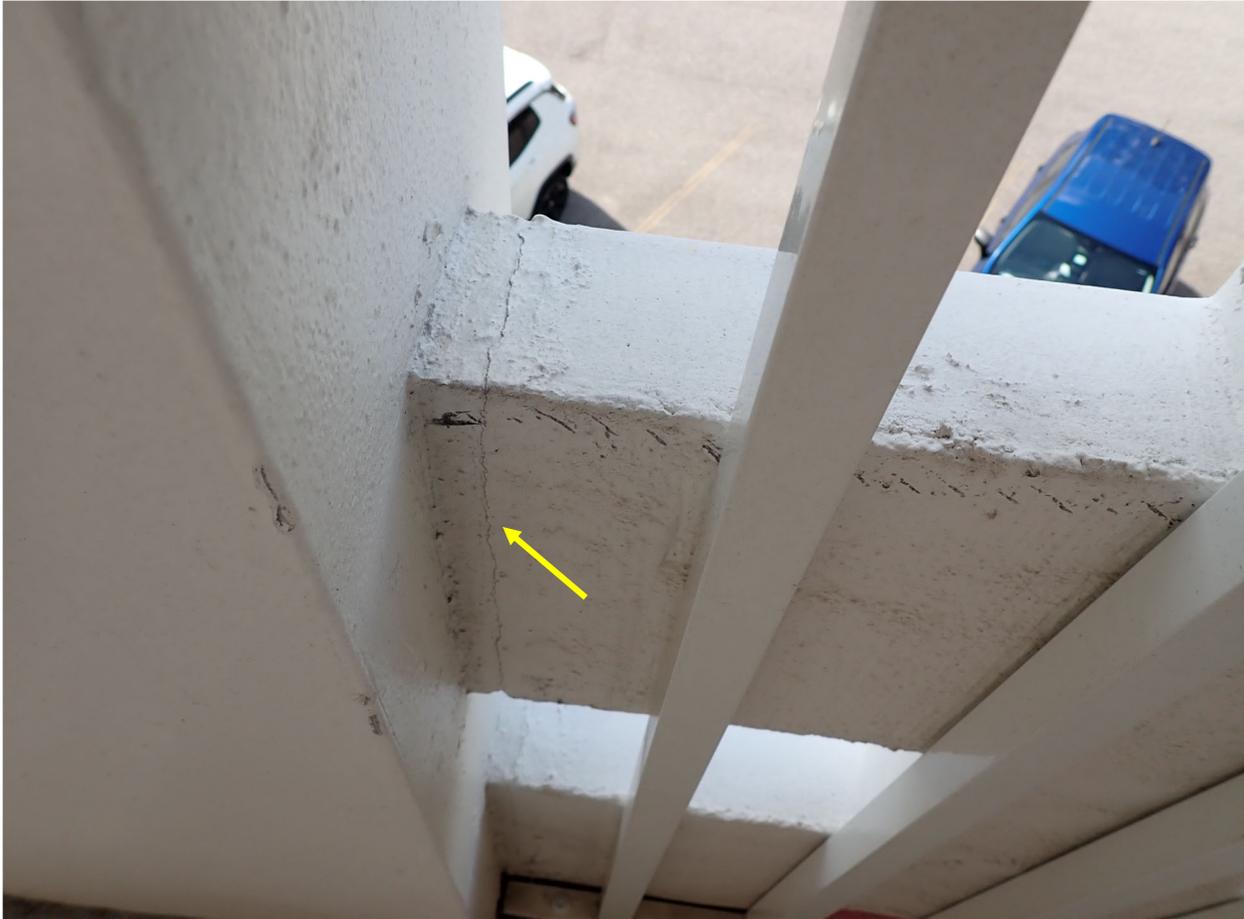
The building's exterior architectural features consisted of a decorative railing with exposed columns which extended from the roof to the slab. The railings and columns were constructed of a painted cementitious material. A secondary metal railing was installed in the interior of the decorative railing, which was in good condition. Evidence of deterioration of the decorative railings in the form of cracking was observed in few areas of the building (**Figure 10**). This is not structural damage, yet it is recommended that the decorative railing be repaired to prevent spalled pieces from detaching and falling.

Figure 10. Representative photograph of cracking of decorative railing

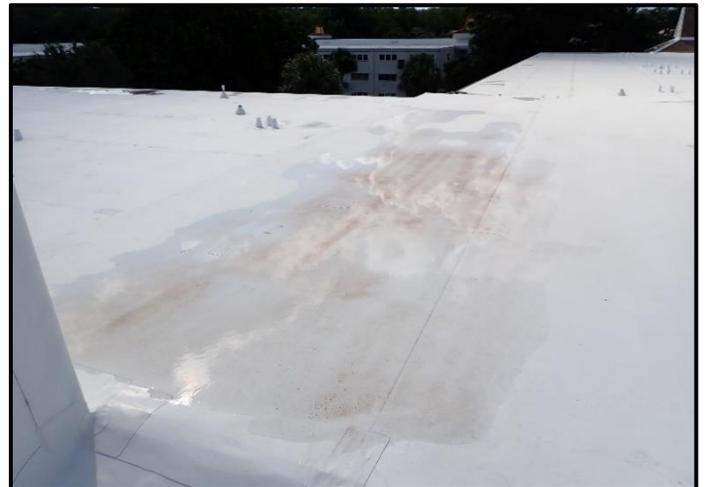
Photograph 04 - View of water ponding above the core roof.

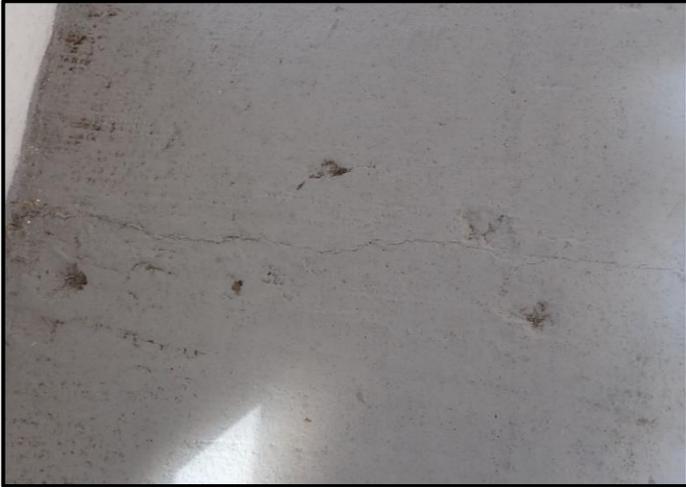
Photograph 05 - View of a crack in the elevated walkway surface perpendicular to the building near Unit 50.

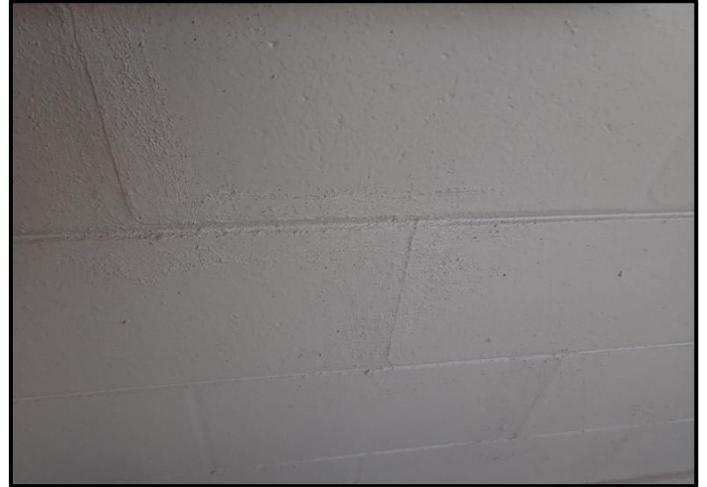
Photograph 06 - View of previous repair to stair step crack near Unit 52.

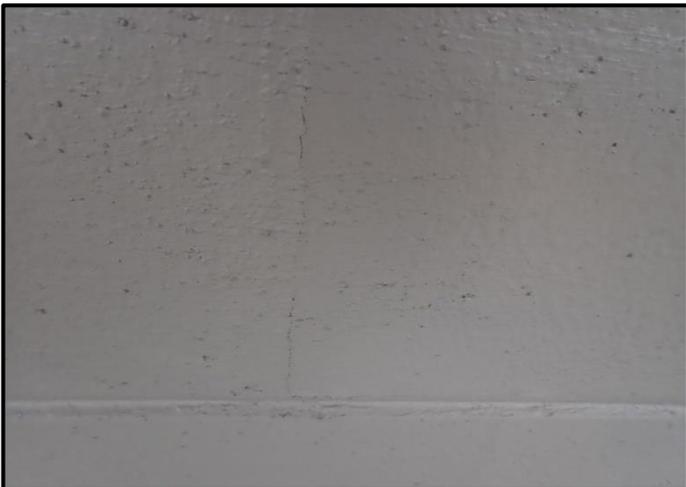
57	Re-opened mortar shallow hairline crack at previous repair to stair step mortar crack in exterior face of CMU wall.	Front elevation of units: 3rd story - 56 and 60. 2nd story - 30, 28 and 26. 1st story - 18, 8 and 2. Rear elevation of units: 2nd story - 23. 1st story - 19.	N	N	Y - Localized as noted in the location column.	N	Repair - Seal hairline cracks with high-strength epoxy or mortar.	N

Photograph 07 - View of previous repair to stair step crack with a hairline re-opening near Unit 56.

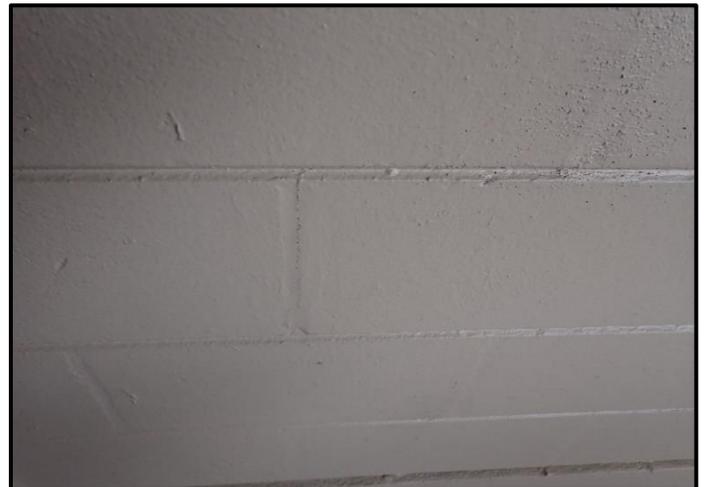
Photograph 08 - View of hairline stair step crack near Unit 53.

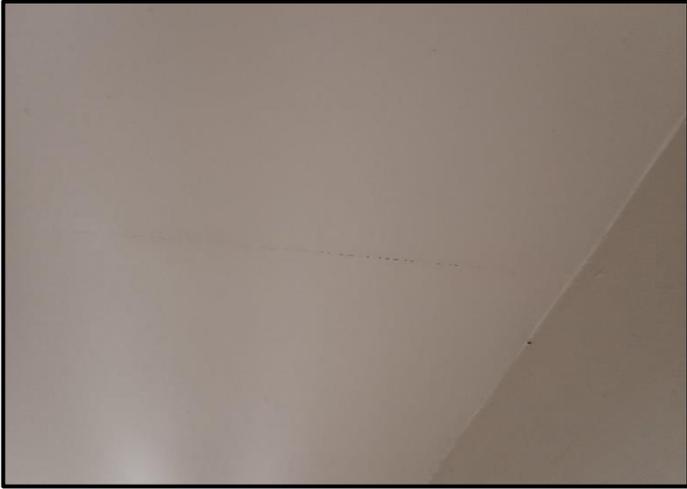
Photograph 09 - View of a ceiling finish crack near Unit 48.

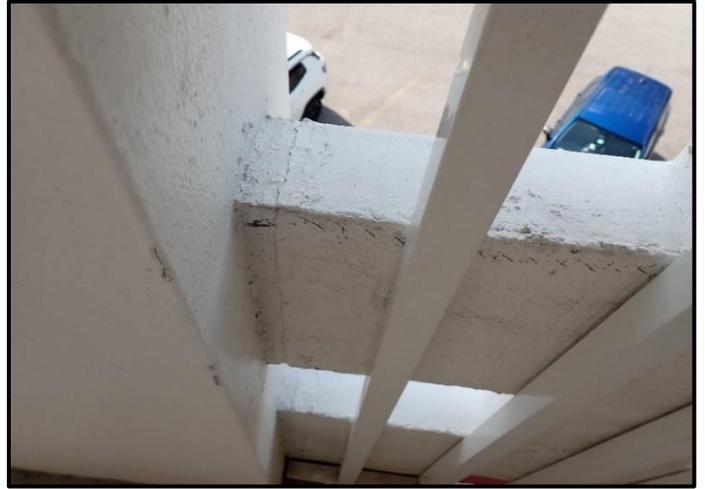
Photograph 10 - View of concrete railing crack near Unit 46.

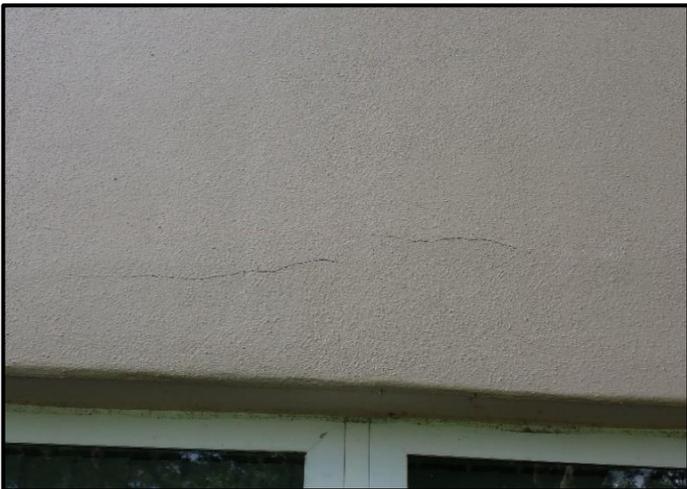
57	Horizontal crack on stucco finish above window and/or door.	Rear elevation of units: 2nd story - 33 and 35. 1st story - 2, 5 and 16.	N	N	Y - Localized as noted in the location column	N	Repair stucco finish. Inspect exposed CMU wall and repair any damaged areas.	N

Photograph 11 - View of stucco finish crack above window in rear elevation of Unit 2.

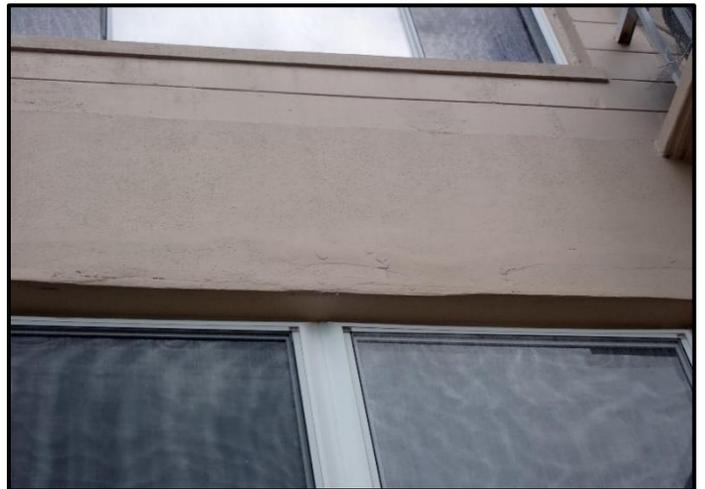
Photograph 12 - View of previous repair to stucco finish above window in rear elevation of Unit 11.

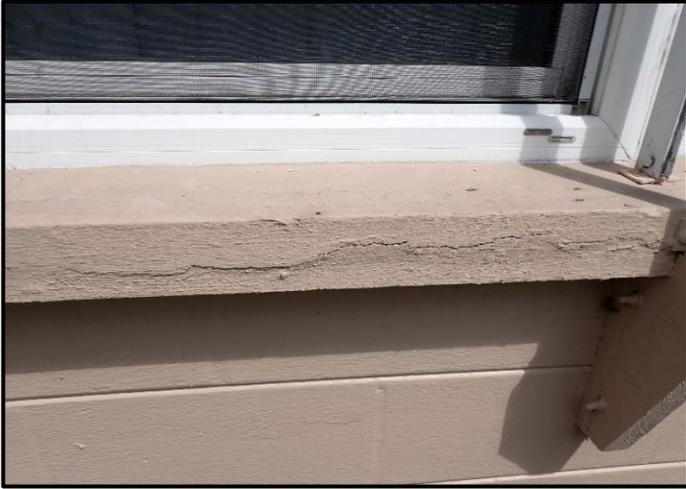
Photograph 13 - View of crack on window sill in rear elevation of Unit 1.

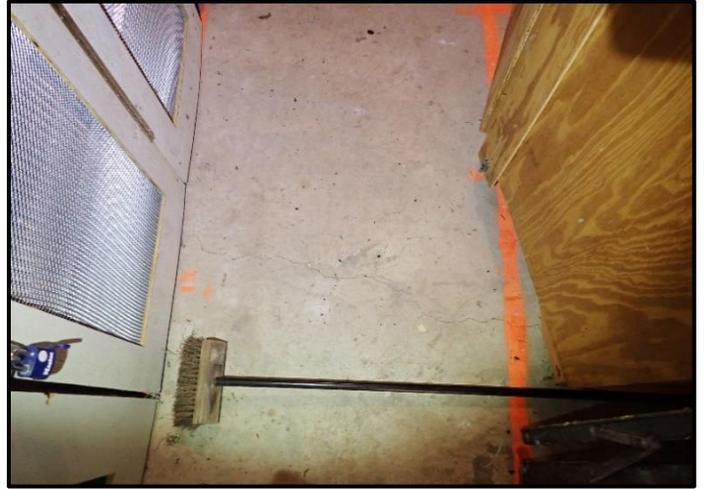
Photograph 14 - View of slab crack in 1st story north storage room.

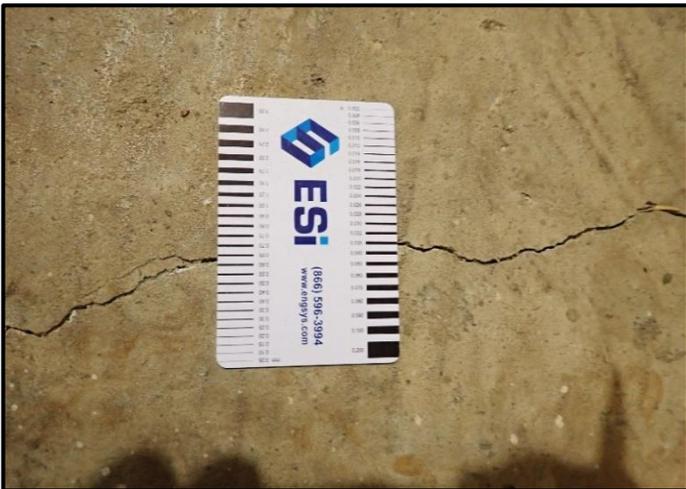
Building Number	Observation	Location	Structural damage (Y/N) If yes - extent	Substantial Structural Damage (Y/N) If yes - extent	Surface imperfection* (Y/N) If yes - extent	Dangerous as defined by the Florida Building Code? (Y/N)	Recommendations (maintenance, repair, replace, or monitor)	Further (Phase 2) inspection required? (Y/N)
57	Surface patch (previous repair) on stucco finish above window and/or door.	Rear elevation of units: 2nd story - 33, 35, 37 and 41. 1st story - 11, 18 and 20.	N	N	Y - Localized as noted in the location column.	N	Monitor.	N
57	Crack on the slab.	1st story north storage room, 1st story electrical room, 2nd story north storage room, 3rd story storage room and 3rd story roof access storage room.	N	N	Y - Localized. Crack measuring hairline width in 1st story north storage room, 2nd story north storage room, 3rd story storage room and 3rd story roof access storage room. Crack measuring hairline to approx. 0.035 inch in 1st story electrical room.	N	Repair - Seal crack with high-strength epoxy, if possible.	N

Photograph 15 - View of slab crack measuring 0.035 inch in 1st story electrical room.

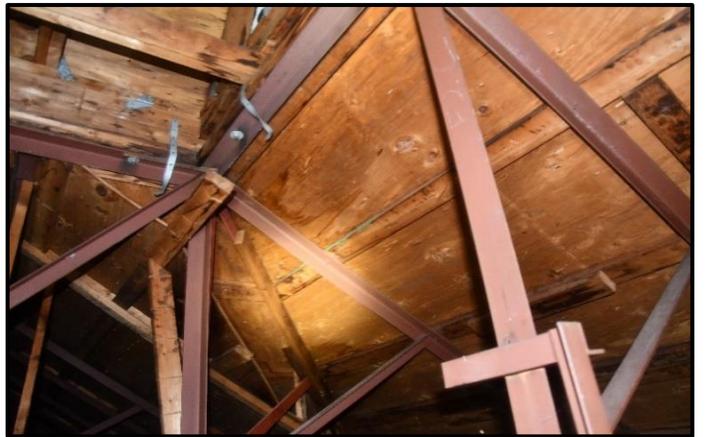
57	Water stains on the roof/wall framing.	Southeast stair tower access near Unit 60, southwest stair tower access near Unit 42 and northeast stair tower access near Unit 43.	N	N	Y - Localized as noted in the location column.	N	Monitor if not causing any leak below and replace damaged members. Repair source of leak if active leak found.	N

Photograph 16 - View of water stains on roof deck within the southwest roof hatch near Unit 42.

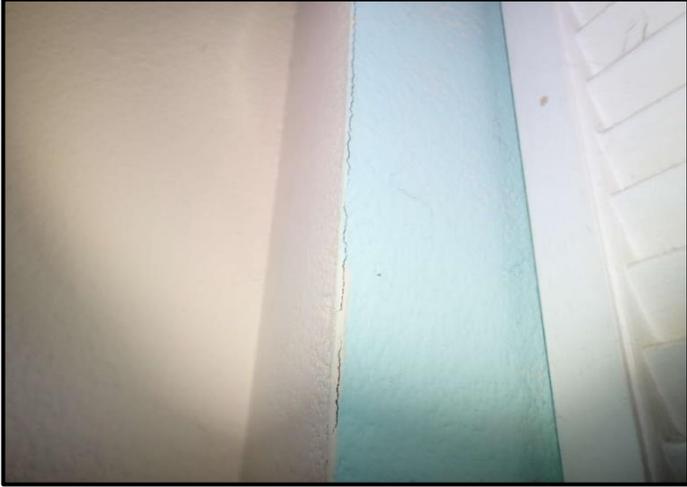
Photograph 17 - Vertical crack on wall in Unit 35.

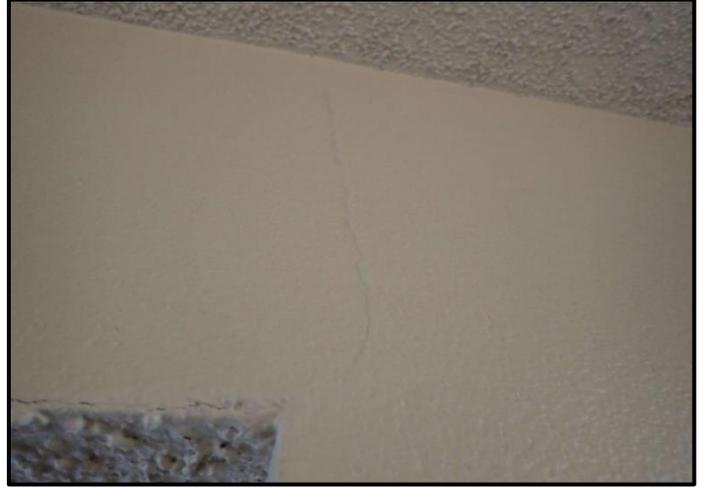
B57:45	Crack on wall and separation at cabinet interfaces in kitchen. Crack on wall in living room. Separation at ceiling to wall interface in hall bathroom.	No	As noted in observation.	No	Monitor cracks.

Photograph 18 - Vertical crack on wall in Unit 45.

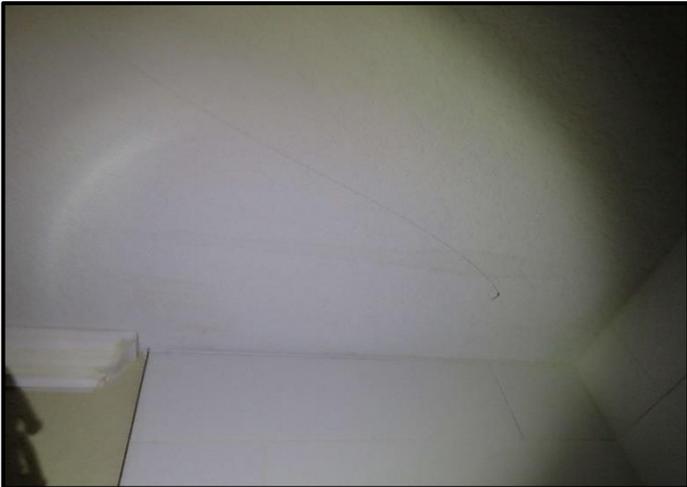
Building Unit	Observations	Substantial Structural Damage (Y/N) If yes - extent	Surface imperfection* (Y/N) If yes - extent	Further (Phase 2) inspection required? (Y/N)	Recommendations (maintenance, repair, replace, or monitor)
B57:3	Water stain on ceiling in hall bathroom. Separation at crown molding to ceiling/wall interface in Florida room.	No	As noted in observation.	No	Verify if moisture damage is due to active leak and if so, repair damage and source.
B57:4	Crack on ceiling in master bedroom.	No	As noted in observation.	No	Monitor crack.
B57:9	Master bath tile cracked.	No	No	Yes	No action.
B57:31	No evidence of structural damage or surface imperfections observed.	No	No	No	No action.
B57:35	Crack on the corner bead at the arch wall in master bedroom. Multiple water stains on the ceiling in various areas of Florida room.	No	As noted in observation.	No	Verify if moisture damage is due to active leak and if so, repair damage and source.

Photograph 19 - Crack on ceiling in Unit 3.
