Phase 1 Milestone Inspection Report

On Top of the World Clearwater

Building 59

ESi Project No: 98508

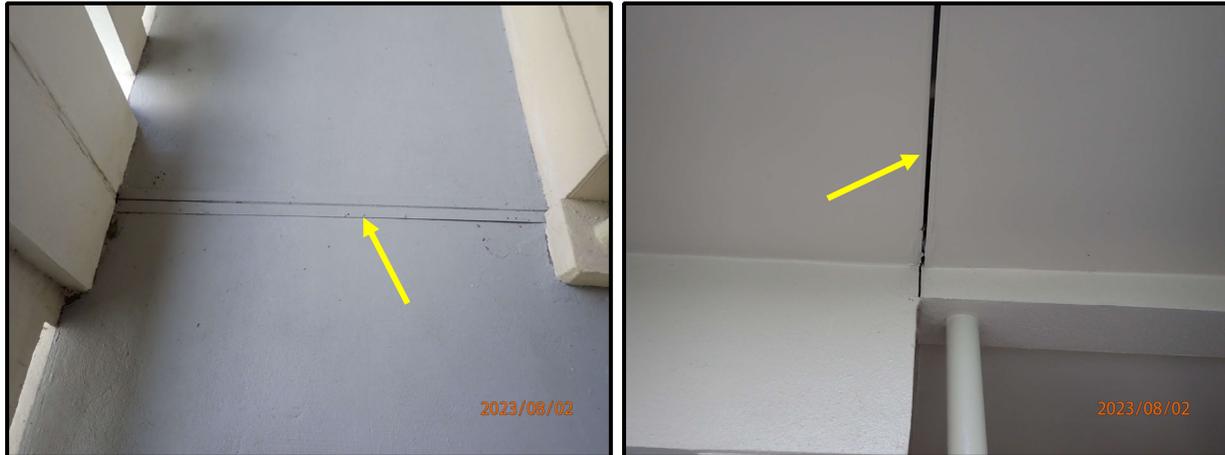
Figure 5. Representative photographs of building expansion joints at exterior corridor at top and bottom of slab.

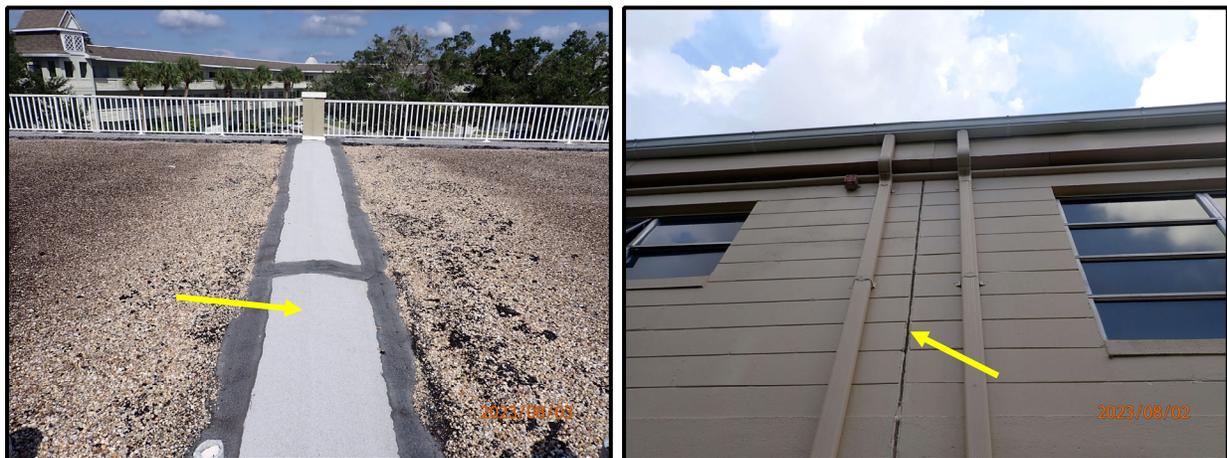
Figure 6. Representative photographs of building expansion joints at roof and rear wall.

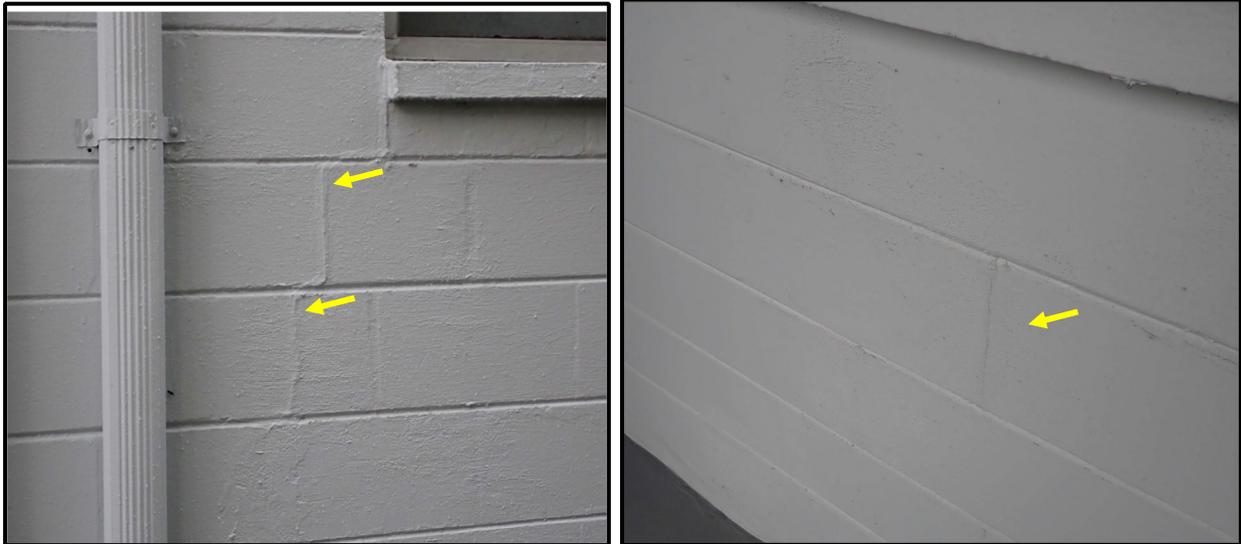
Stairstep cracks, both previously repaired and those appearing to be recent, on the CMU bearing walls of the wings particularly below windows and near the core were typically observed throughout the elevations of the building. Stairstep cracks are cracks in the mortar joints and form due to the movement of the structure, as mortar is a brittle material. The observed width and location of the cracks represent typical movement from a structure (commonly due to soil settlement) and do not appear to be indicative of structural damage. Recommendation for repairs and monitoring of the cracks is provided in Exhibit A. Representative photographs of this observation are shown below in **Figure 5**.

Figure 5. Representative photographs of step stair cracks at CMU walls.

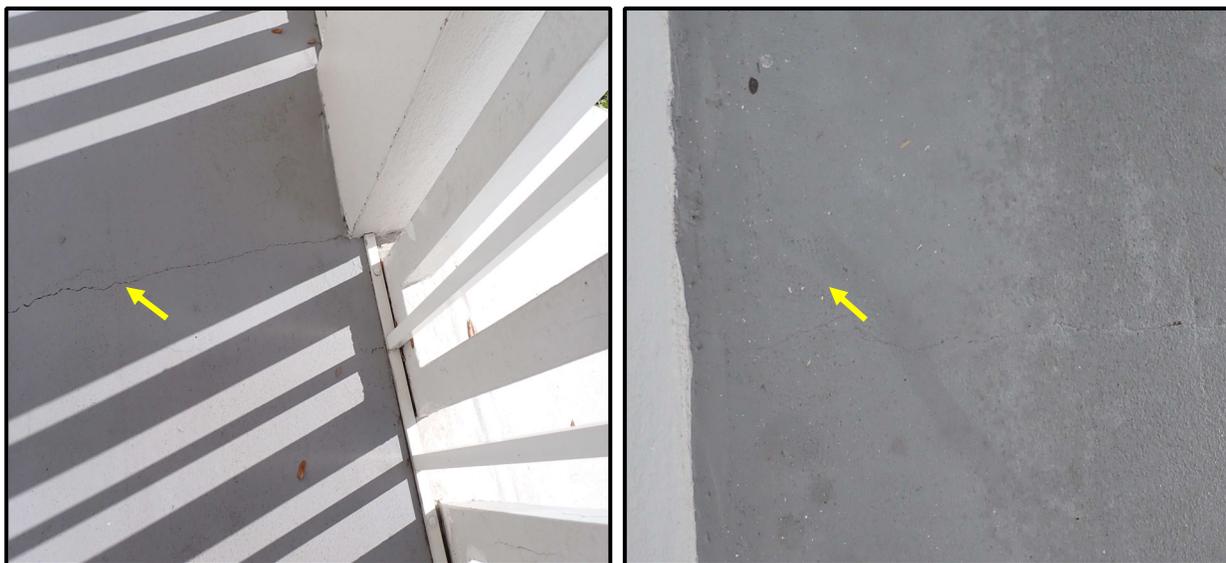
Cracks on the exterior hallway floor slabs were observed perpendicular to the length of the slab and the supporting wall. The observed cracks were typically hairline cracks and shallow. The cracks had weathered edges and dirt on the inside, representing they are historical in nature. The frequency and spacing of these cracks were not uniform. The observed cracks in the subject building are likely due to the expansion and contraction of the materials where control joints were not observed or due to the deflection of the slab at support locations and do not represent a structural damage or substantial deterioration. Recommendation for repairs and monitoring of the cracks is provided in Exhibit A. Representative photographs of this observation are shown below in **Figure 6**.

Figure 6. Representative photographs of shallow cracks at top surface of the exterior hallway.

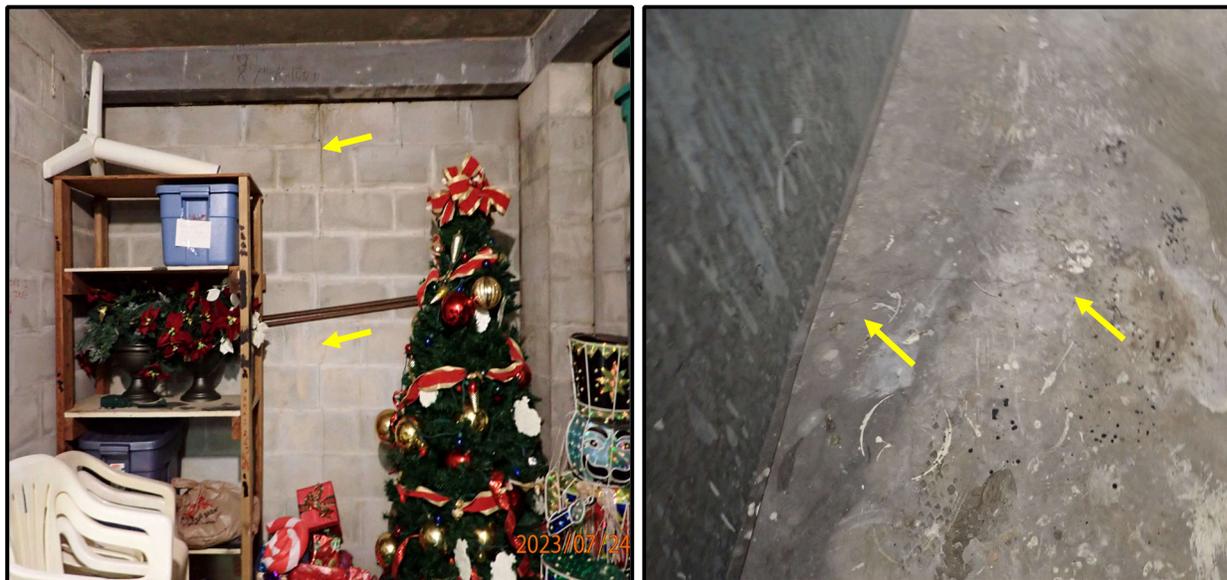
Vertical and horizontal cracking was observed on the building's core on the CMU walls of the storage rooms. CMU and mortar are brittle materials and are likely to crack when subjected to expansion and contraction and differential movement. The observed cracks are due to the movement of the core throughout its life. Similarly observed, were cracks on the concrete slab on grade on the first-floor electrical and storage rooms. The observed cracks are due to the expansion and contraction of the slab and typical settlement of the soils below the structure. Recommendations for repairs and monitoring of the cracks is provided in Exhibit A. Representative photographs of this observation are shown below in **Figure 7**.

Figure 7. Representative photographs of cracks on CMU walls and concrete slabs at common rooms in Core building.

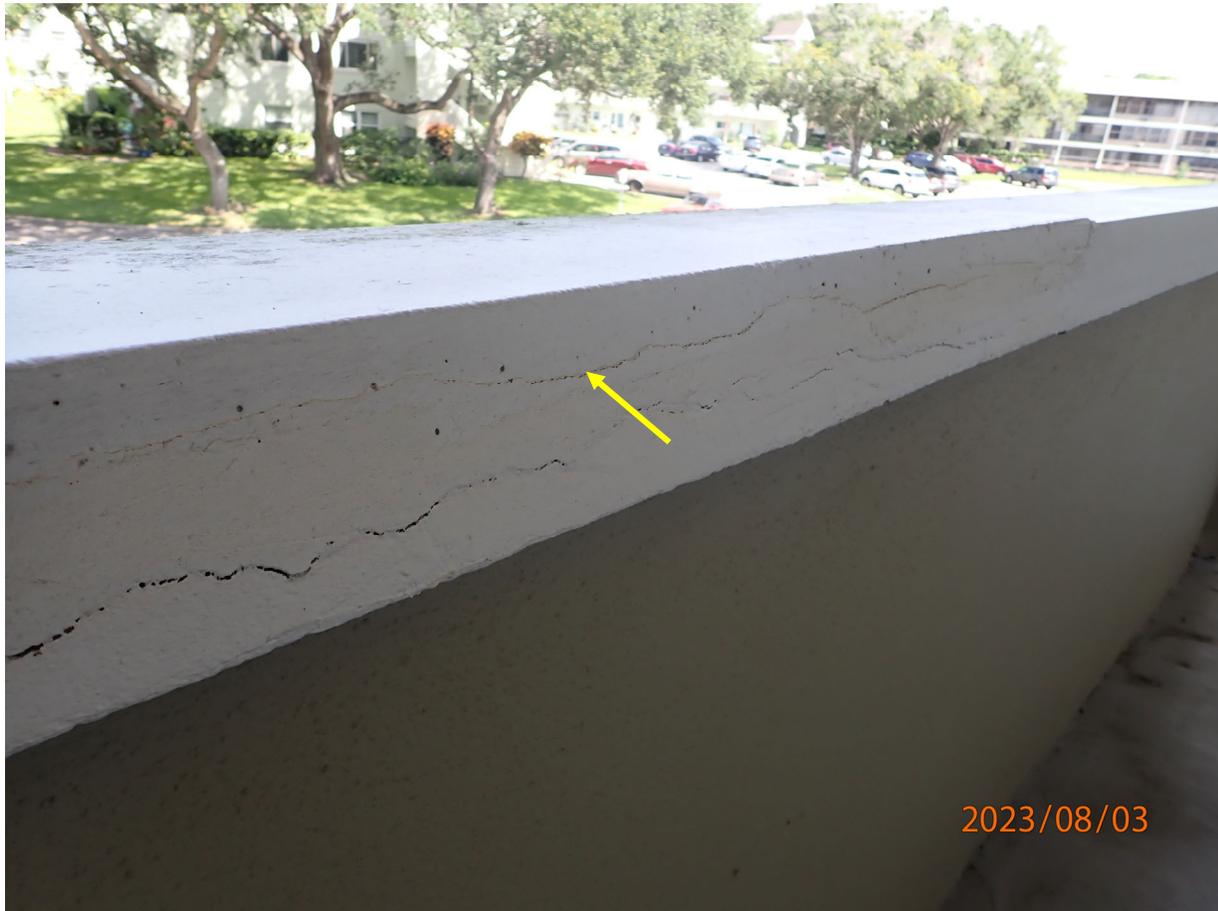
The building's exterior architectural features consisted of a decorative railing with exposed columns which extended from the roof to the slab. The railings and columns were constructed of a combination of metal railing sections and painted cementitious material. The metal railing was in good condition. Evidence of deterioration of the decorative railings in the form of cracking was observed throughout the building (**Figure 8**). This is not structural damage, yet it is recommended that the decorative railing be repaired to prevent spalled pieces from detaching and falling.

Figure 8. Representative photograph of cracking of decorative railing

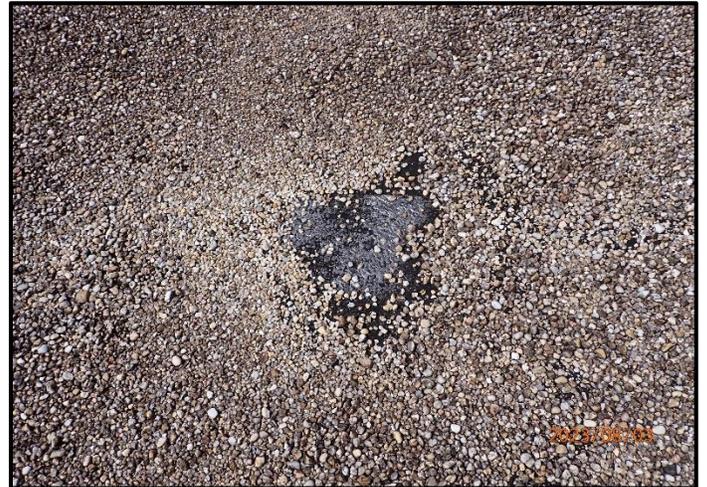
Photograph 04 - View of missing gravel ballast and exposed asphalt on the roof.

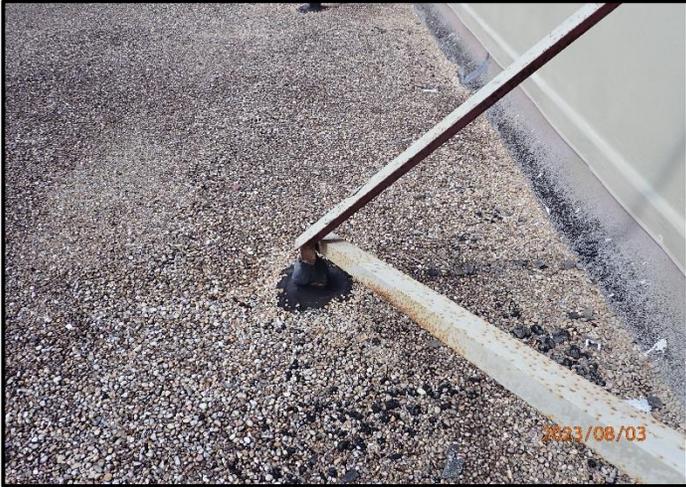
Photograph 05 - View of surface corrosion and paint delamination on the metal supports for the roof facades.

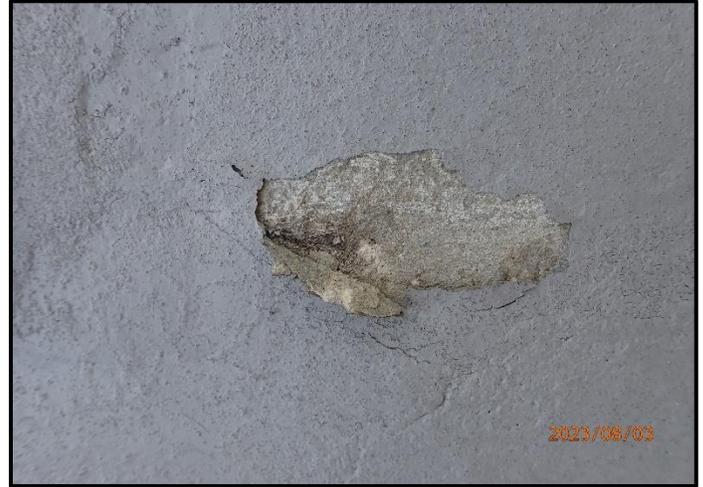
Photograph 06 - View of exterior walkway surface spall or delamination at the front elevation of unit 71.

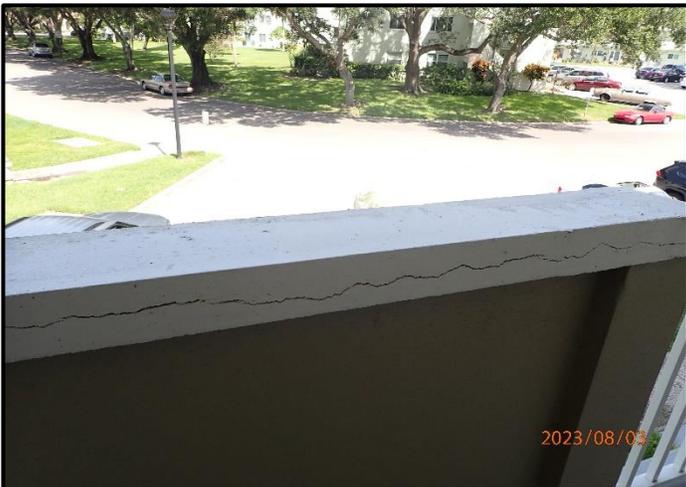
Photograph 07 - View of typical condition of cracks in top ledge of exterior walkway concrete railing.

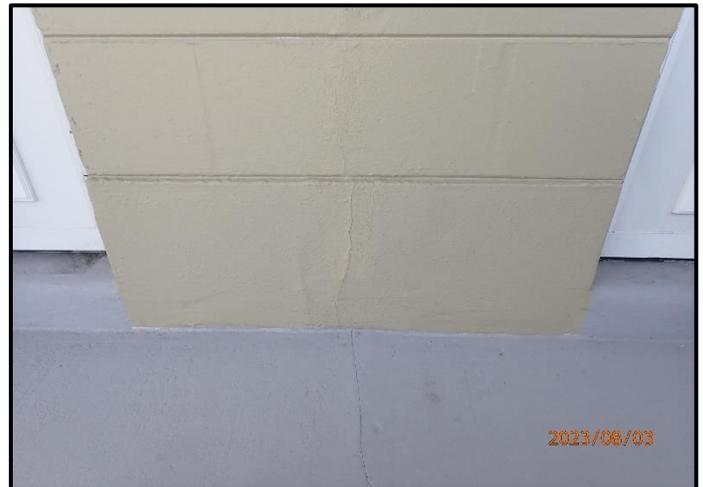
Photograph 08 - View of previous repair to a vertical in the CMU wall at the front elevation of unit 43.

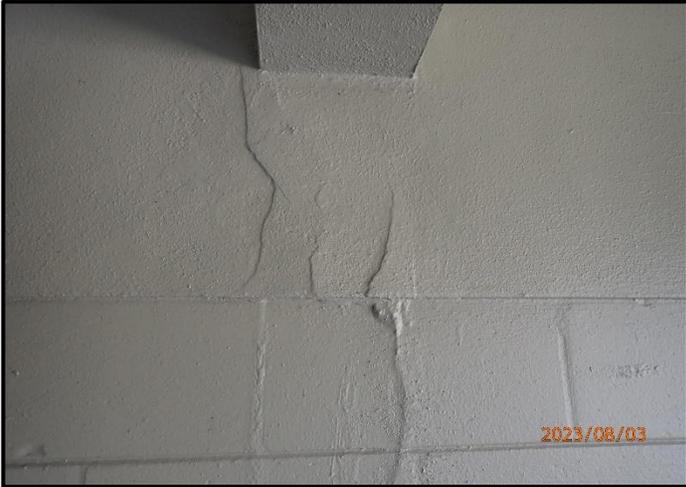
Photograph 09 - View of stucco cladding delamination at the north center stair 1st floor.

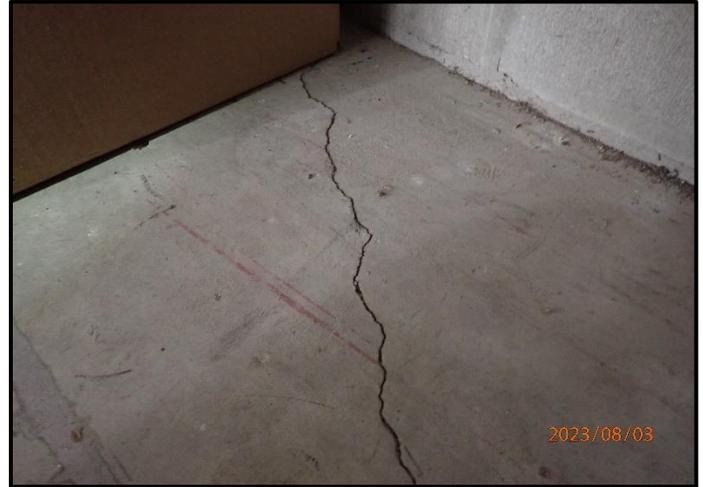
Photograph 10 - View of the 0.06 inch width slab crack in the 1st floor storage room.

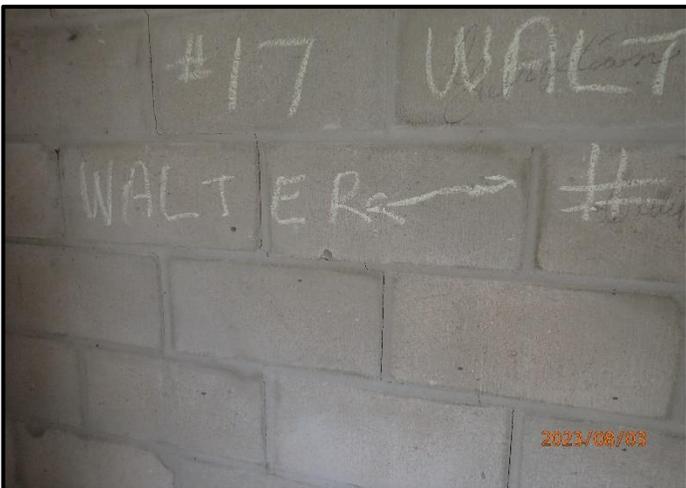
Photograph 11 - View of a stair step mortar crack in the 1st floor storage room.

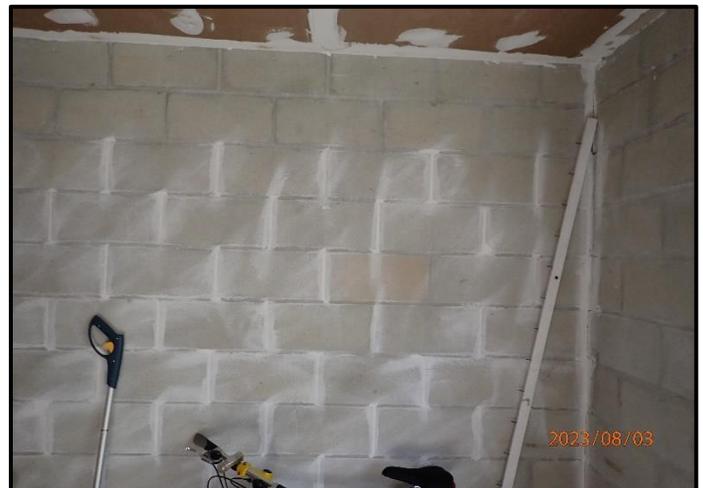
Photograph 12 - View of previous repairs to vertical mortar joints in the roof access room.
