Phase 1 Milestone Inspection Report

On Top of the World Clearwater

Building 61

ESi Project No: 98508

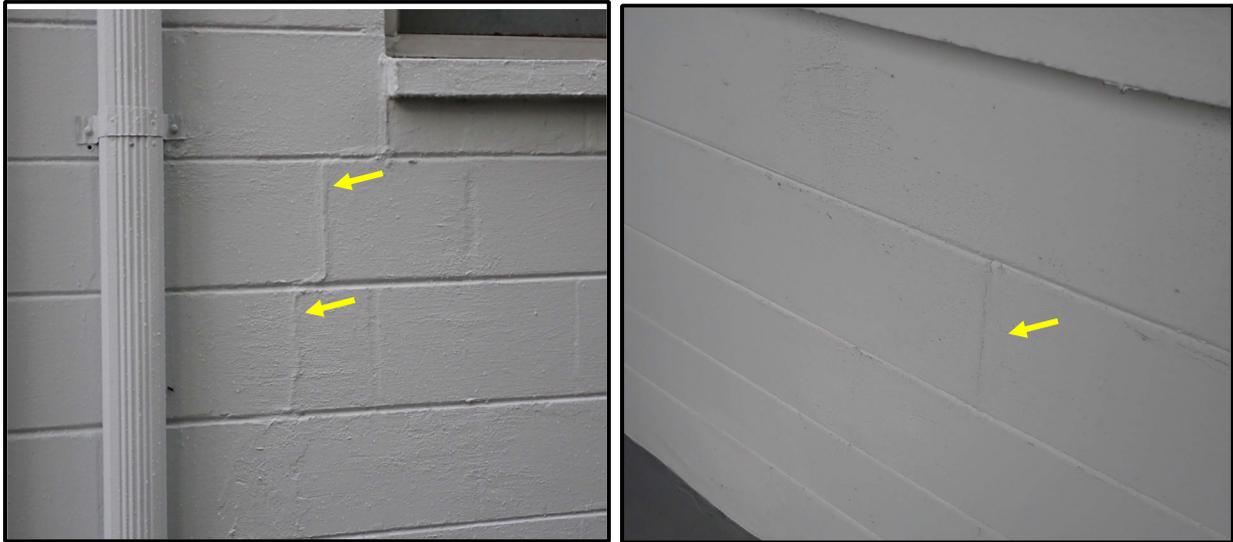
Stairstep cracks, both previously repaired and those appearing to be recent, on the CMU bearing walls of the wings particularly below windows and near the core were typically observed throughout the elevations of the building. Stairstep cracks are cracks in the mortar joints and form due to the movement of the structure, as mortar is a brittle material. The observed width and location of the cracks represent typical movement from a structure (commonly due to soil settlement) and do not appear to be indicative of structural damage. Recommendation for repairs and monitoring of the cracks is provided in Exhibit A. Representative photographs of this observation are shown below in **Figure 7**.

Figure 7. Representative photographs of step stair cracks at CMU walls.

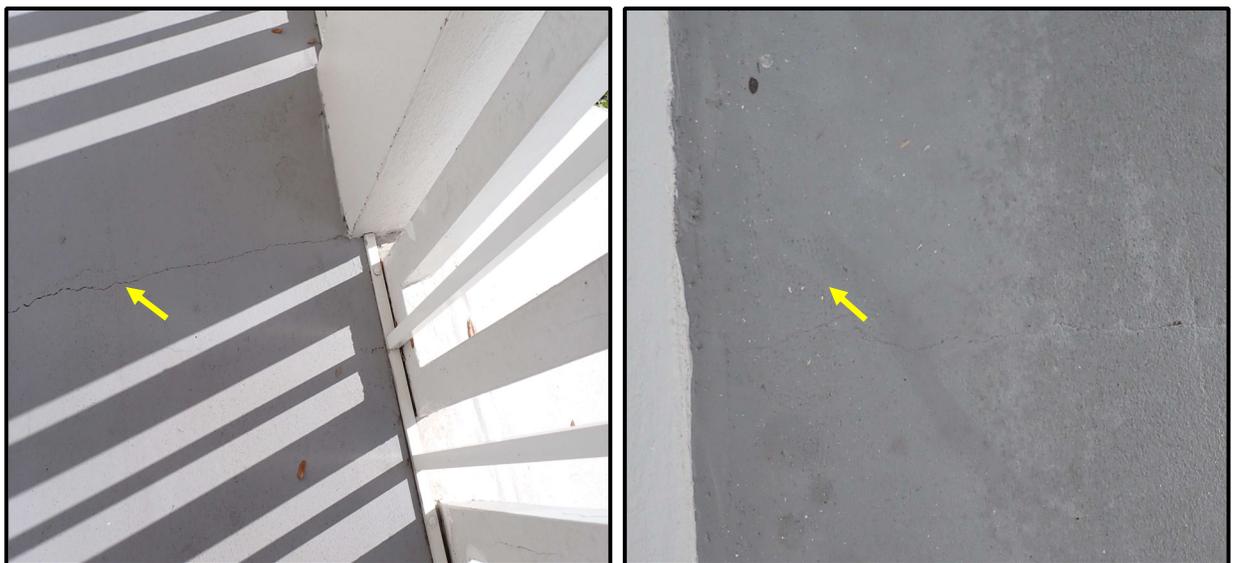
Cracks on the exterior hallway floor slabs were observed perpendicular to the length of the slab and the supporting wall. The observed cracks were typically hairline cracks and shallow. The cracks had weathered edges and dirt on the inside, representing they are historical in nature. The frequency and spacing of these cracks were not uniform. The observed cracks in the subject building are likely due to the expansion and contraction of the materials where control joints were not observed or due to the deflection of the slab at support locations and do not represent a structural damage or substantial deterioration. Recommendation for repairs and monitoring of the cracks is provided in Exhibit A. Representative photographs of this observation are shown below in **Figure 8**.

Figure 8. Representative photographs of shallow cracks at top surface of the exterior hallway.

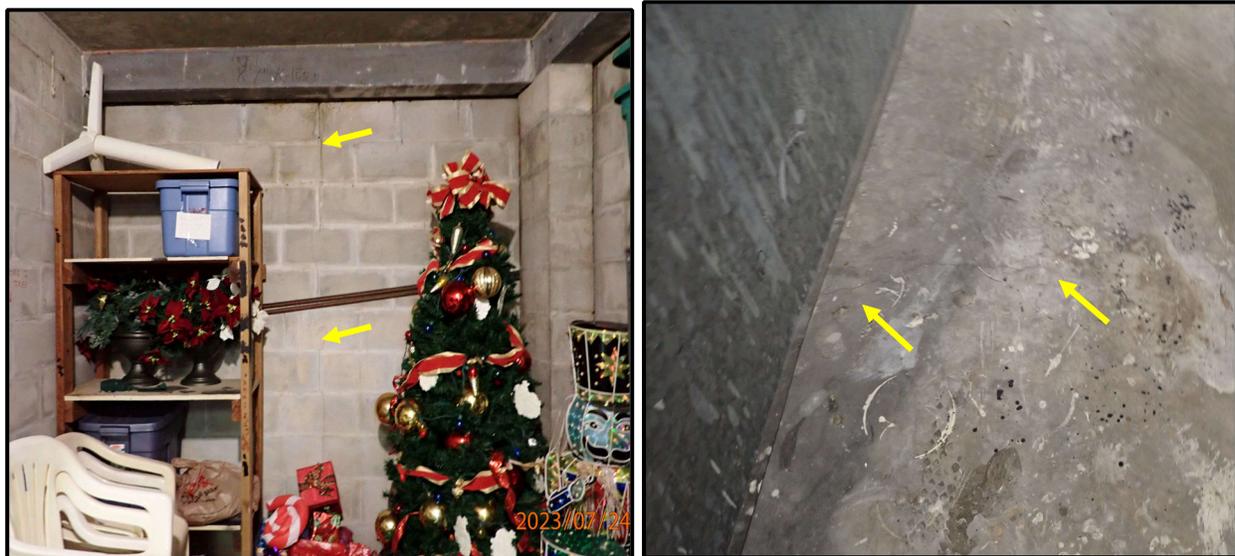
Vertical and horizontal cracking was observed on the building's core on the CMU walls of the storage rooms. CMU and mortar are brittle materials and are likely to crack when subjected to expansion and contraction and differential movement. The observed cracks are due to the movement of the core throughout its life. Similarly observed, were cracks on the concrete slab on grade on the first-floor electrical and storage rooms. The observed cracks are due to the expansion and contraction of the slab and typical settlement of the soils below the structure. Recommendations for repairs and monitoring of the cracks is provided in Exhibit A. Representative photographs of this observation are shown below in **Figure 9**.

Figure 9. Representative photographs of cracks on CMU walls and concrete slabs at common rooms in Core building.

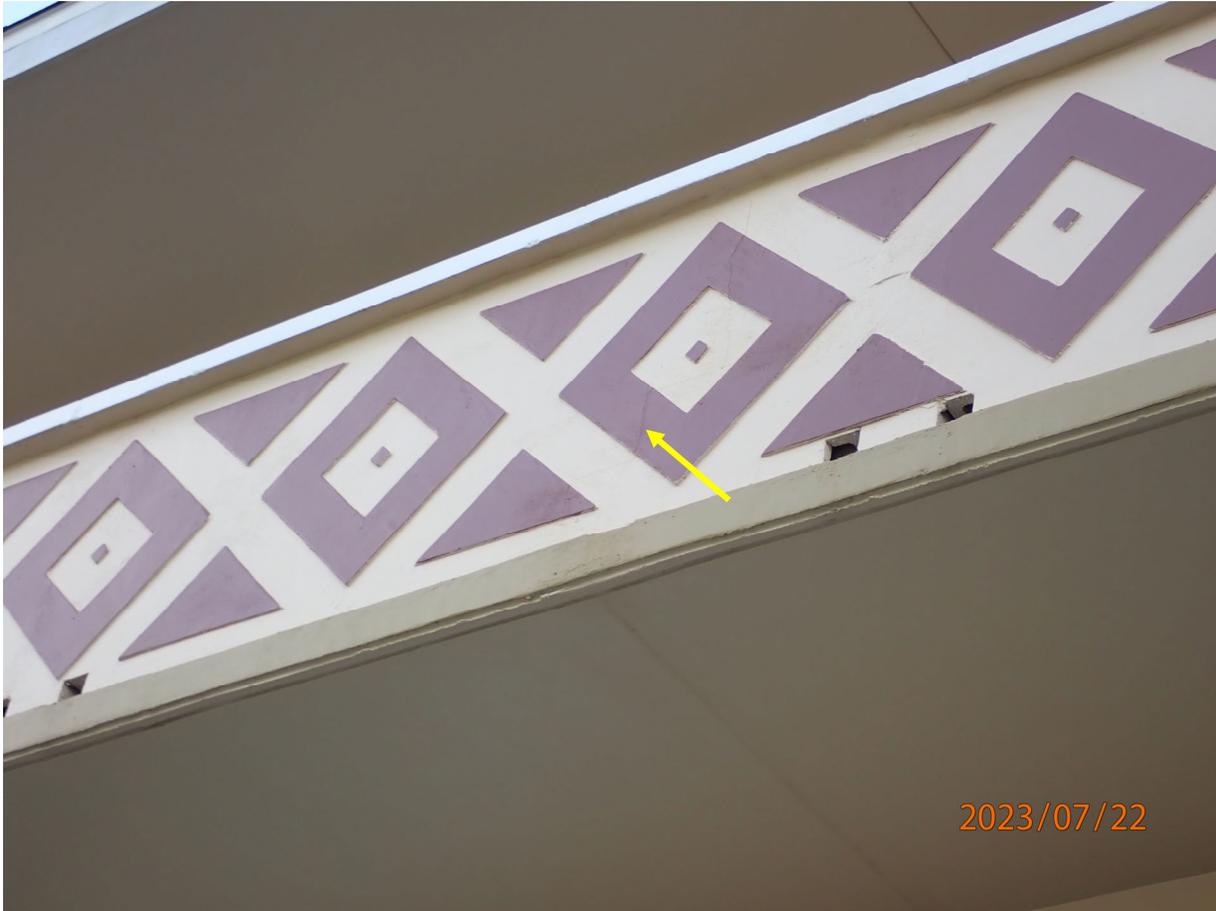
The building's exterior architectural features consisted of a decorative railing with exposed columns which extended from the roof to the slab. The railings and columns were constructed of a painted cementitious material. A secondary metal railing was installed in the interior of the decorative railing, which was in good condition. Evidence of deterioration of the decorative railings in the form of cracking was observed throughout the building (Figure 10). This is not structural damage, yet it is recommended that the decorative railing be repaired to prevent spalled pieces from detaching and falling.

Figure 10. Representative photograph of cracking of decorative railing

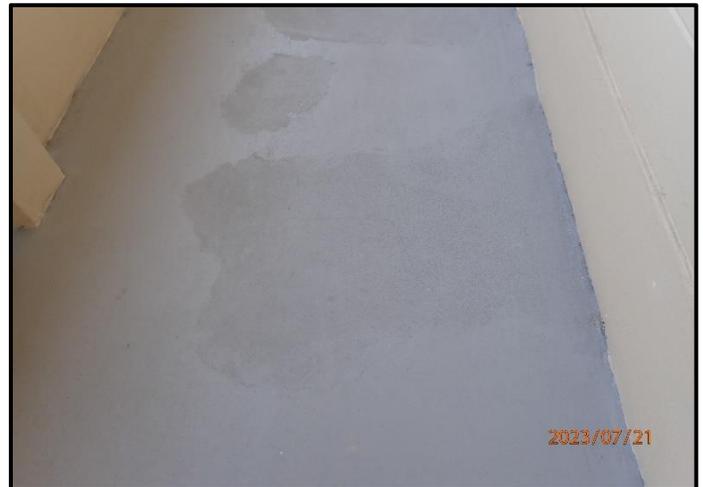
Photograph 04 - View of previous repairs to the exterior walkway surface at the front elevation of unit 38.

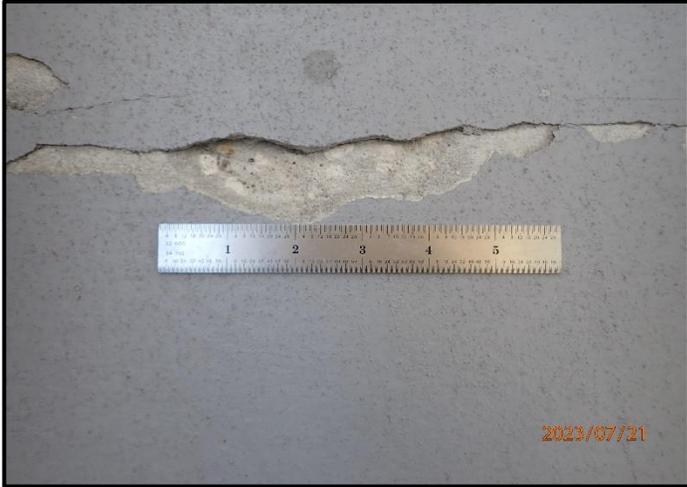
61	Exterior walkway surface chip, spall, or delamination - localized to less than 1 SF area.	Front elevation of units: 60, 37, 38, 36.	No	No	Y - Localized as noted in the Location column.	No	Repair - Remove loose or spalled surface, patch and resurface with resurfacing mixture.	No

Photograph 05 - Close up view of spalled exterior walkway surface at the front elevation of 36.

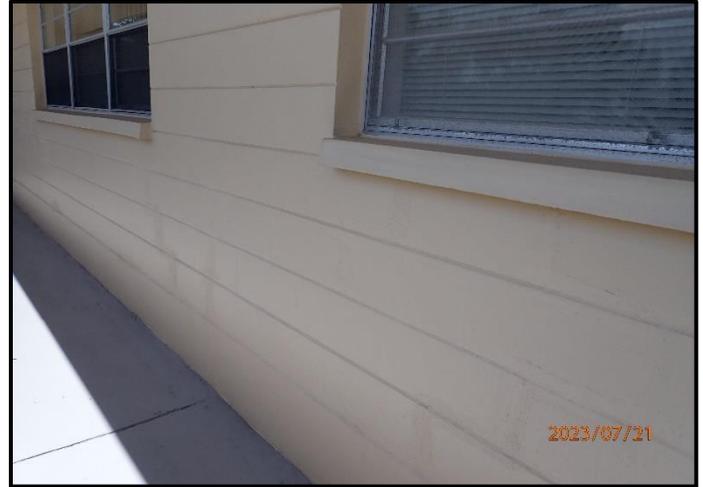
Photograph 06 - View of previous mortar repairs to stair step cracks at the front elevation of unit 45.

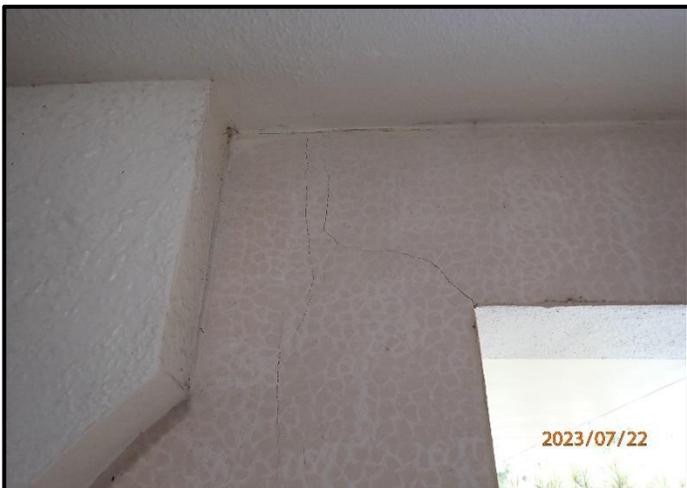
Photograph 07 - View of a stair step crack in stucco wall cladding at the first floor core.

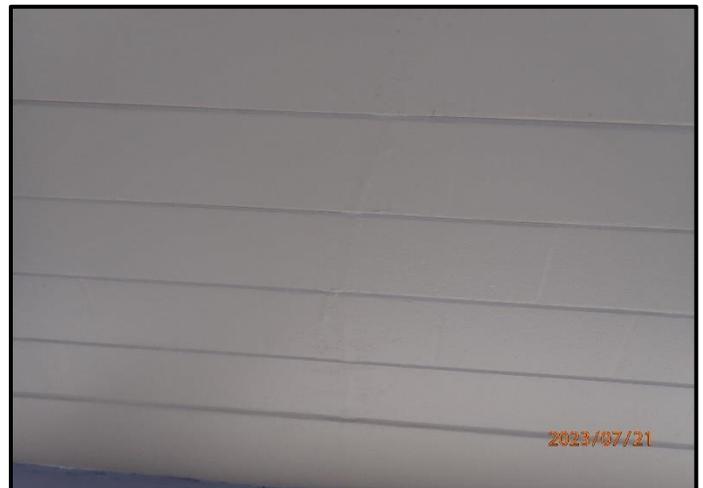
Photograph 08 - View of a vertical previous repair at the front elevation of unit 39.

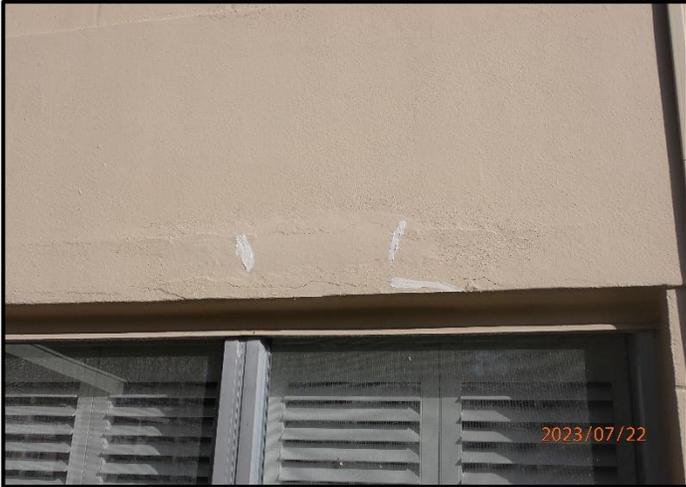
61	Surface patch (Previous repair) to stucco wall cladding common on rear elevation above windows and doors. Delamination of stucco at previous repair common.	Rear elevation above windows and doors.	No	No	Y - Localized as noted in the Location column.	No	Repair - Remove loose or delaminated stucco and patch with new stucco wall cladding.	No

Photograph 09 - View of cracked and delaminated stucco at a previous repair above a window on the rear elevation.

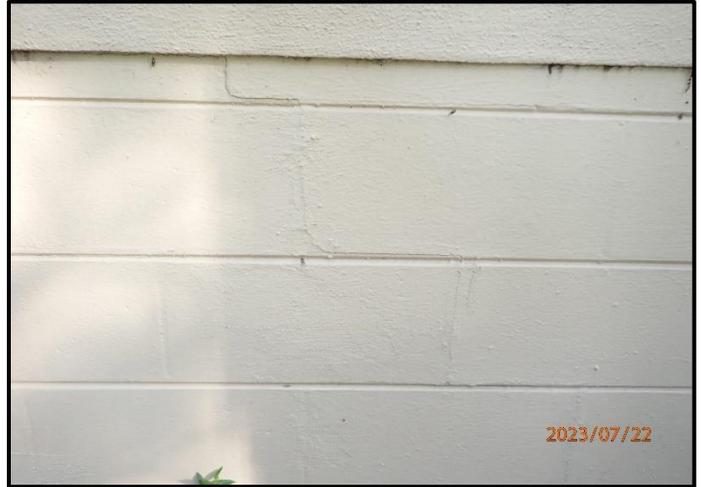
Photograph 10 - Close up view of a hairline stair step crack in the CMU wall at the rear elevation of unit 2.

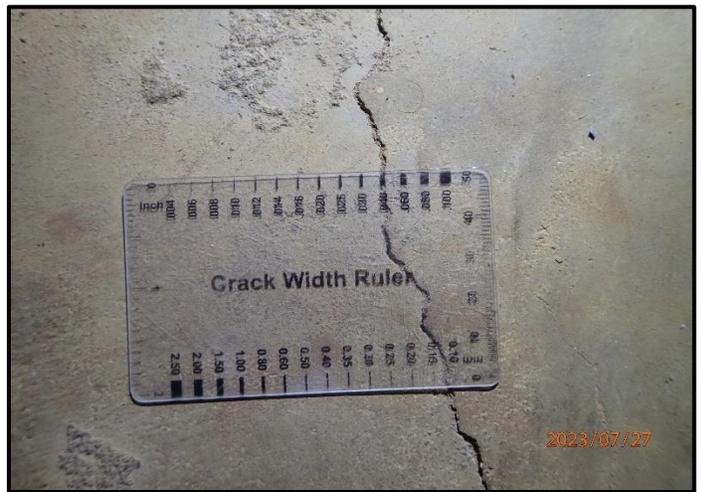
61	Shallow crack in concrete slab. 0.04" width.	Electrical room.	No	No	Y - Localized as noted in the Location column.	No	Repair - Seal crack with high-strength epoxy.	No

Photograph 12 - Close up view of a slab crack in the electrical room.

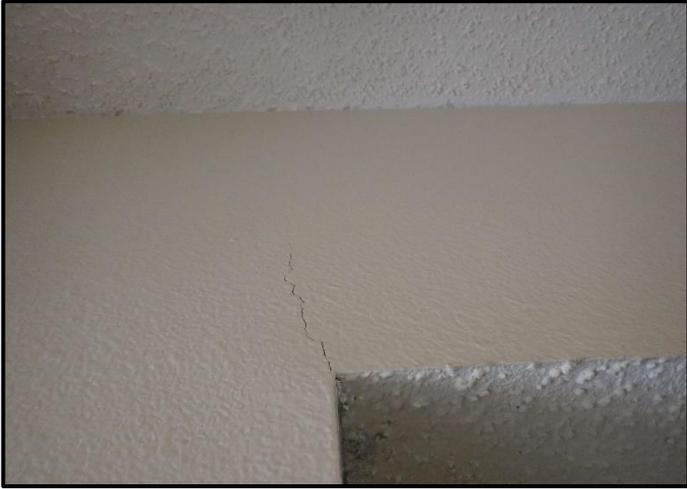
Photograph 13 - Hairline crack on wall in unit 48.
