# **Phase 1 Milestone Inspection Report**

**On Top of the World Clearwater**

**Building 65**

**ESi Project No: 98508**

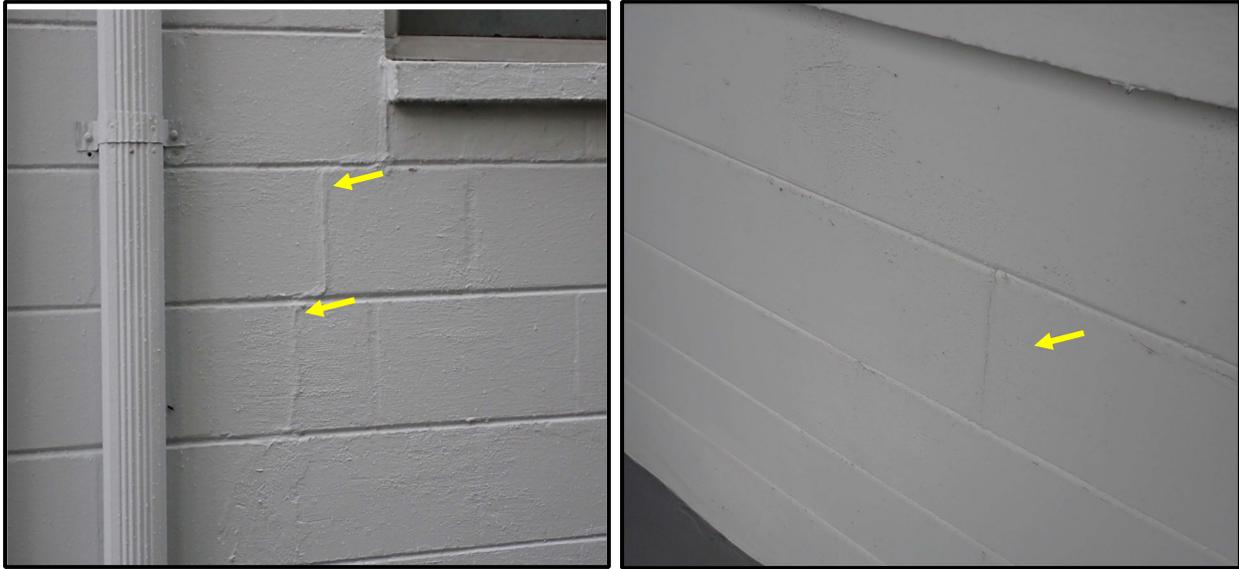
Stairstep cracks, both previously repaired and those appearing to be recent, on the CMU bearing walls of the wings particularly below windows and near the core were typically observed throughout the elevations of the building. Stairstep cracks are cracks in the mortar joints and form due to the movement of the structure, as mortar is a brittle material. The observed width and location of the cracks represent typical movement from a structure (commonly due to soil settlement) and do not appear to be indicative of structural damage. Recommendation for repairs and monitoring of the cracks is provided in Exhibit A. Representative photographs of this observation are shown below in **Figure 5**.

**Figure 5. Representative photographs of step stair cracks at CMU walls.**

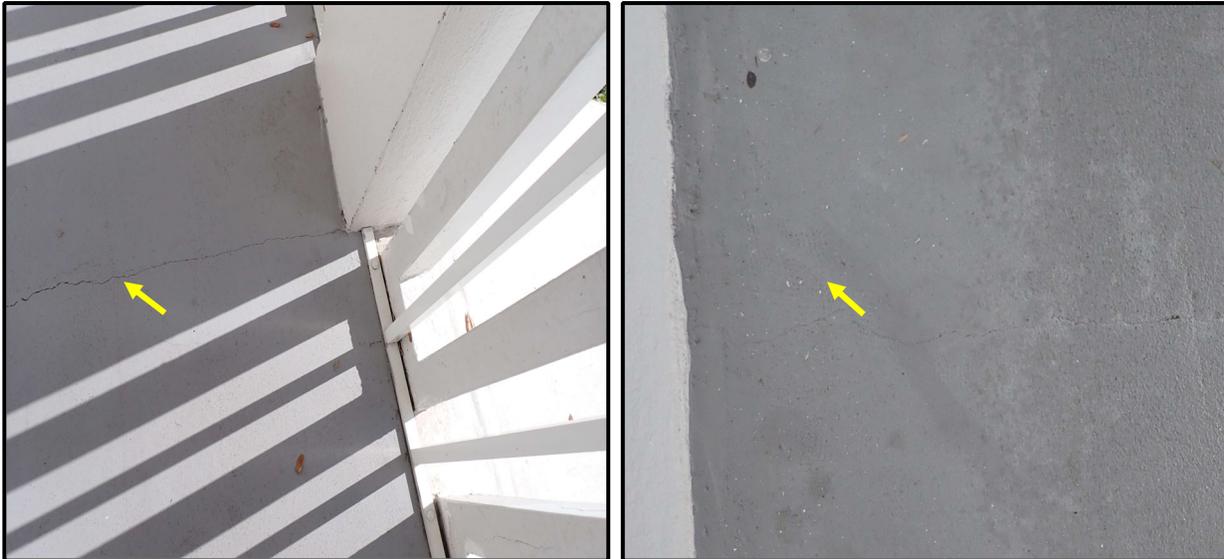
Cracks on the exterior hallway floor slabs were observed perpendicular to the length of the slab and the supporting wall. The observed cracks were typically hairline cracks and shallow. The cracks had weathered edges and dirt on the inside, representing they are historical in nature. The frequency and spacing of these cracks were not uniform. The observed cracks in the subject building are likely due to the expansion and contraction of the materials where control joints were not observed or due to the deflection of the slab at support locations and do not represent a structural damage or substantial deterioration. Recommendation for repairs and monitoring of the cracks is provided in Exhibit A. Representative photographs of this observation are shown below in **Figure 6**.

**Figure 6. Representative photographs of shallow cracks at top surface of the exterior hallway.**

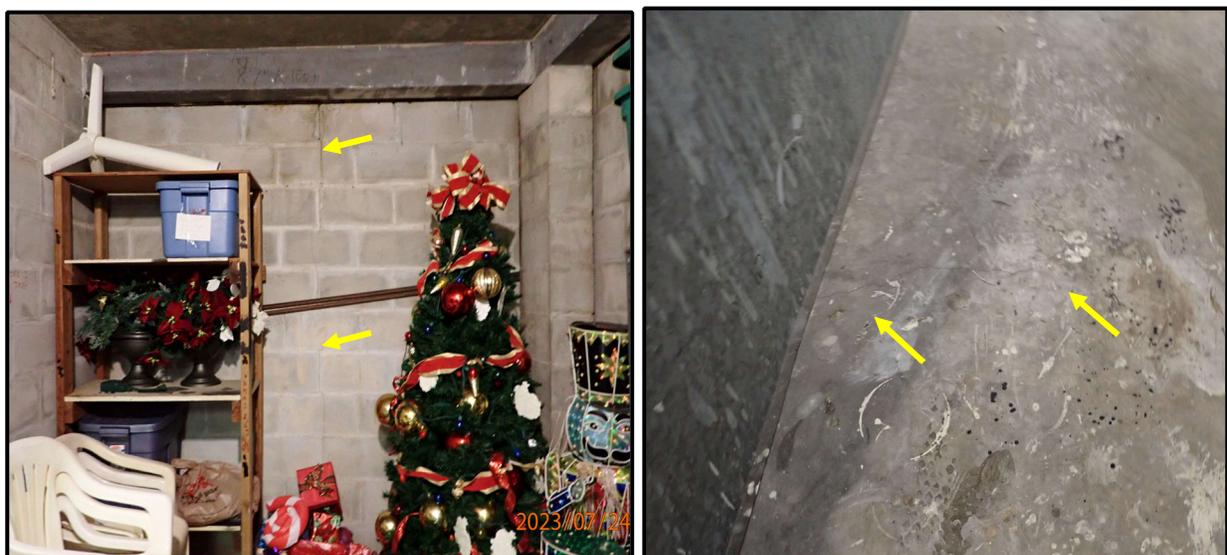
Vertical and horizontal cracking was observed on the building's core on the CMU walls of the storage rooms. CMU and mortar are brittle materials and are likely to crack when subjected to expansion and contraction and differential movement. The observed cracks are due to the movement of the core throughout its life. Similarly observed, were cracks on the concrete slab on grade on the first-floor electrical and storage rooms. The observed cracks are due to the expansion and contraction of the slab and typical settlement of the soils below the structure. Recommendations for repairs and monitoring of the cracks is provided in Exhibit A. Representative photographs of this observation are shown below in **Figure 7**.

**Figure 7. Representative photographs of cracks on CMU walls and concrete slabs at common rooms in Core building.**

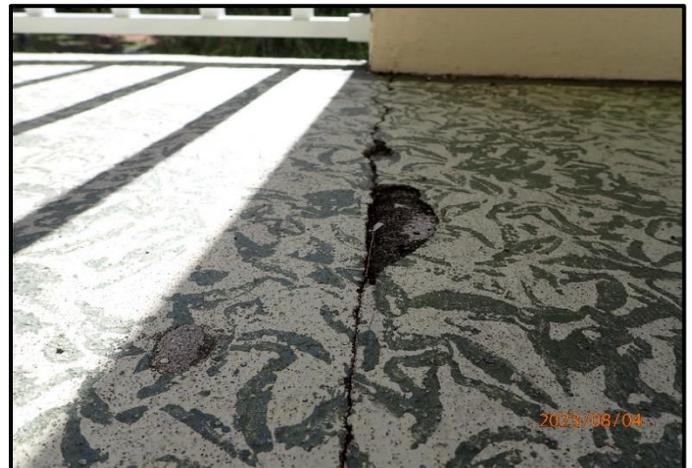
Photograph 04 - View of typical condition of crack in exterior walkway with spalling or delaminated walkway surface.

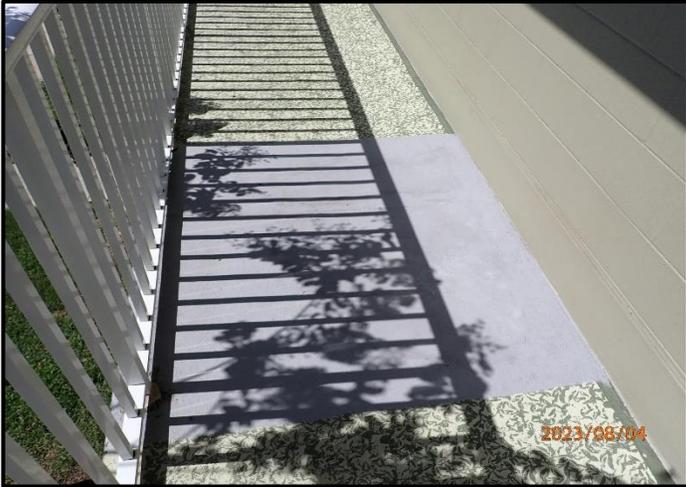
Photograph 05 - View of the exterior walkway surface previous repair at the front elevation of unit 28.

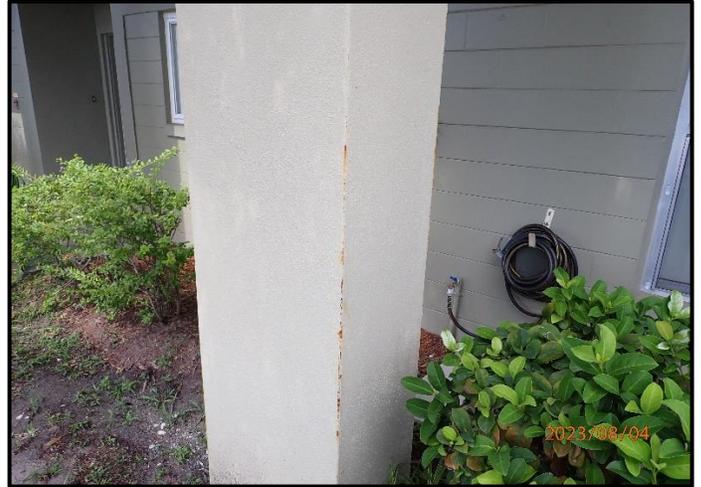
Photograph 06 - View of the typical condition of stucco metal lath corrosion at column corners at the subject building.

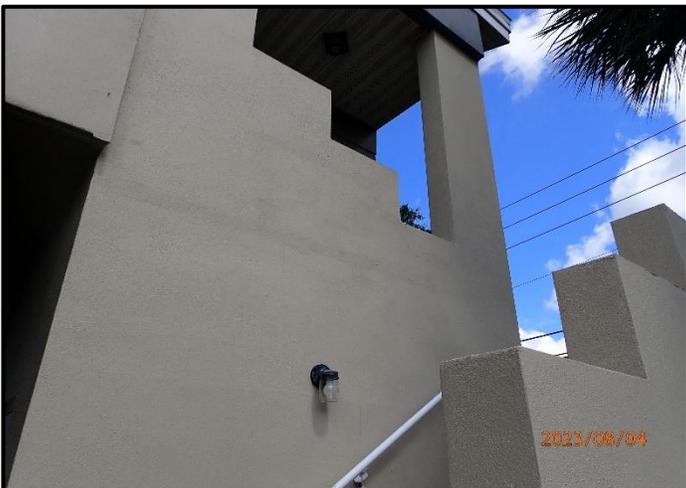
Photograph 07 - View of horizontal previous repairs to stucco wall cladding at the north stair.

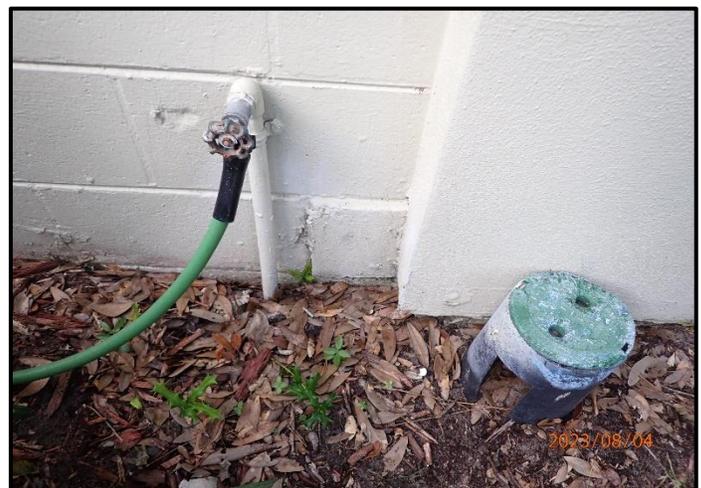
Photograph 08 - View of the displaced CMU block at the bottom course of the wall at the rear elevation of unit 20.

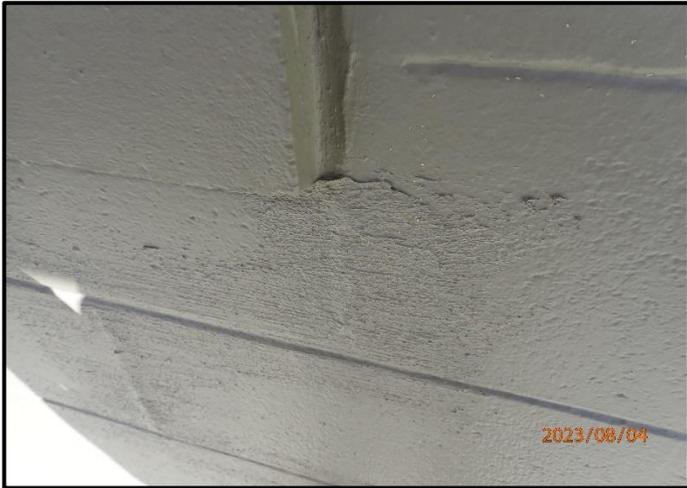
Photograph 09 - Close up view of a previous repair to a stair step mortar crack at the front elevation of unit 34.

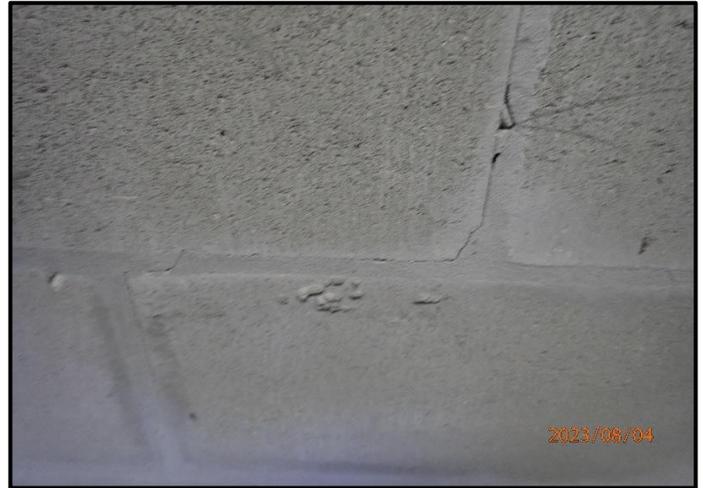
Photograph 10 - Close up view of a stair step mortar crack in the fire panel room.

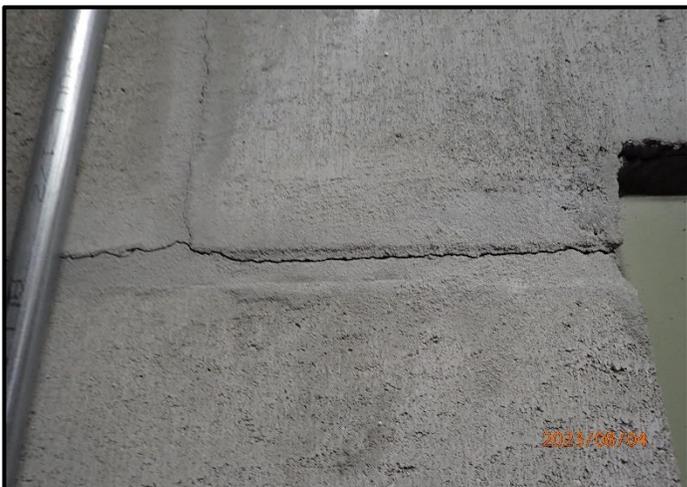
Photograph 11 - Close up view of a stair step mortar crack in the fire panel room.

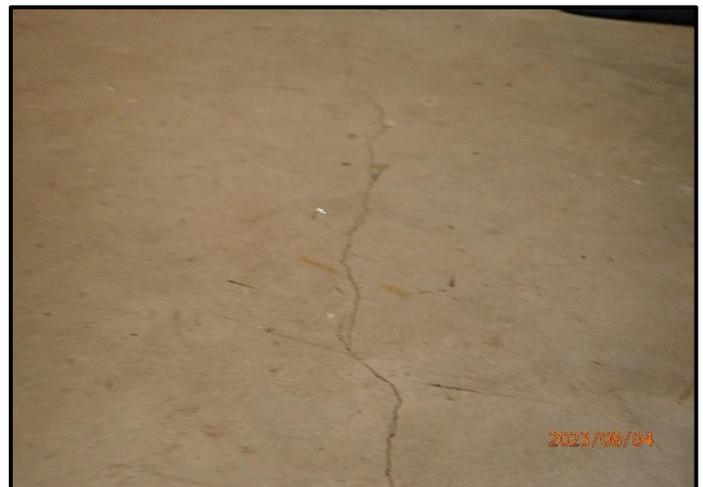
65	Shallow crack in concrete slab. 0.02".	2nd floor storage.	No	No	Y - Localized as noted in the Location column.	No	Repair - Seal crack with high-strength epoxy.	No

Photograph 12 - Close up view of a crack in the concrete slab in the 2nd floor storage room.

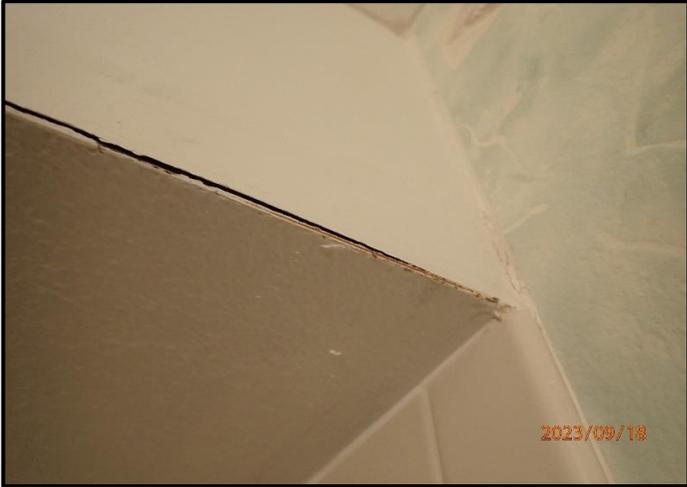
Photograph 13 - Crack at intersection of ceiling and wall in unit 2.

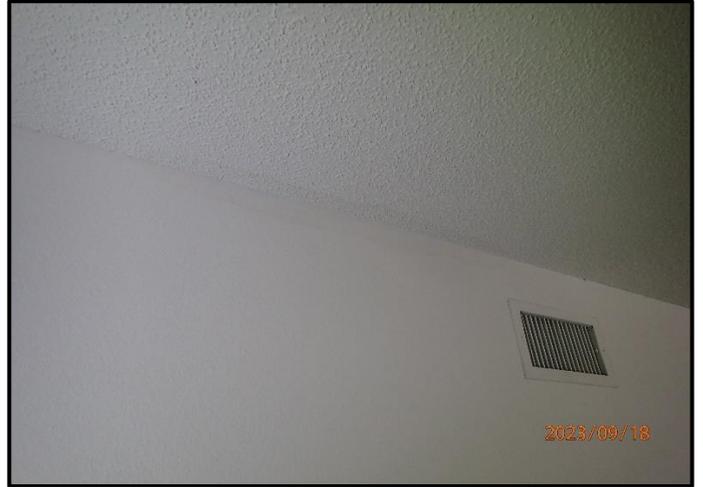
Moisture staining on the finishes was observed in locations noted in Exhibit B. The moisture staining does not represent structural damage or deterioration. It was also observed that some of these stains were historical, and that the source of the moisture had been repaired. At areas where the moisture source is unknown, it is recommended that the location is investigated and that the source be repaired.

Photograph 14 - Moisture staining at wall and ceiling joint in unit 20.
