Phase 1 Milestone Inspection Report

On Top of the World Clearwater

Building 73

ESi Project No: 98508

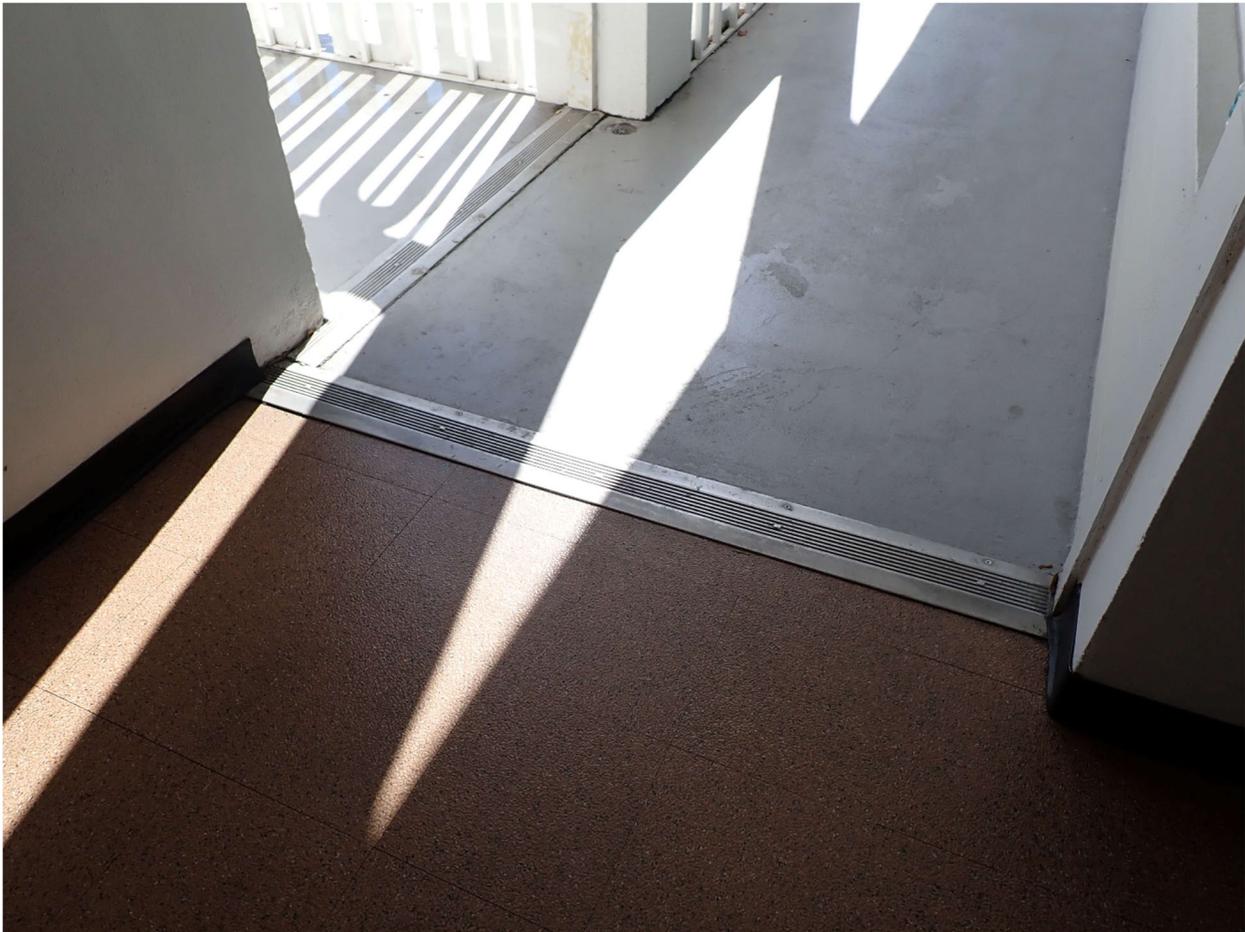
Figure 5. Representative expansion joint at wing/core intersection.

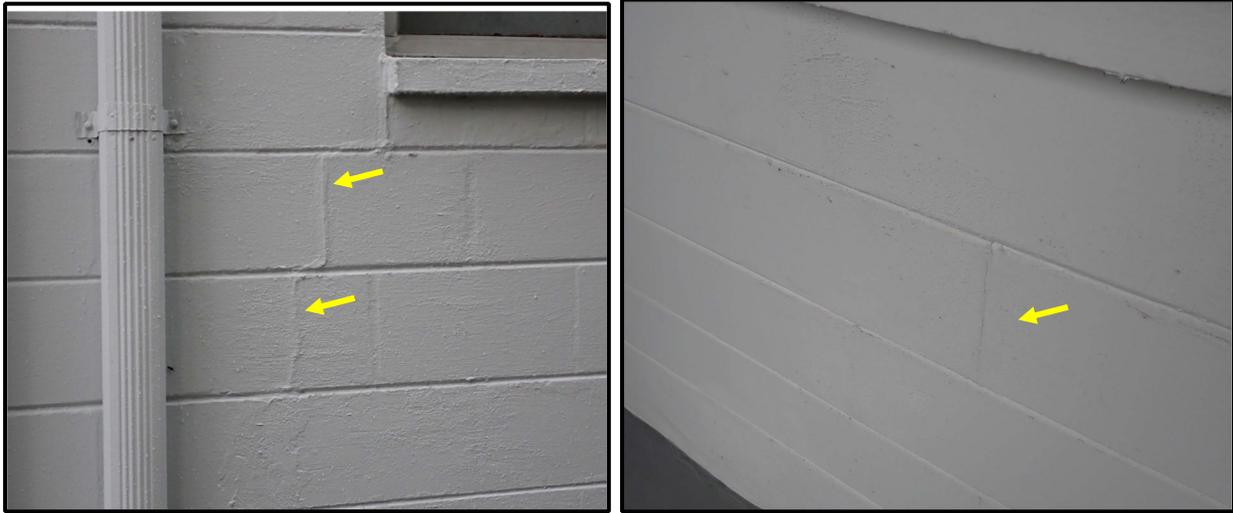
Stairstep cracks, both previously repaired and those appearing to be recent, on the CMU bearing walls of the wings particularly below windows and near the core were typically observed throughout the elevations of the building. Stairstep cracks are cracks in the mortar joints and form due to the movement of the structure, as mortar is a brittle material. The observed width and location of the cracks represent typical movement from a structure (commonly due to soil settlement) and do not appear to be indicative of structural damage. Recommendation for repairs and monitoring of the cracks is provided in Exhibit A. Representative photographs of this observation are shown below in **Figure 7**.

Figure 7. Representative photographs of step stair cracks at CMU walls.

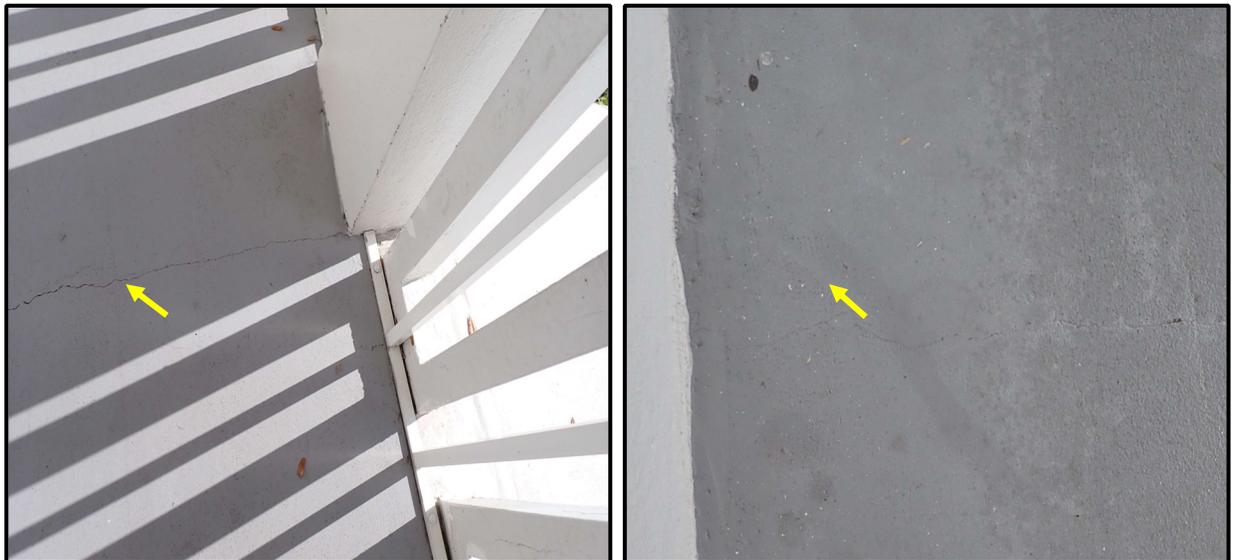
Cracks on the exterior hallway floor slabs were observed perpendicular to the length of the slab and the supporting wall. The observed cracks were typically hairline cracks and shallow. The cracks had weathered edges and dirt on the inside, representing they are historical in nature. The frequency and spacing of these cracks were not uniform. The observed cracks in the subject building are likely due to the expansion and contraction of the materials where control joints were not observed or due to the deflection of the slab at support locations and do not represent a structural damage or substantial deterioration. Recommendation for repairs and monitoring of the cracks is provided in Exhibit A. Representative photographs of this observation are shown below in **Figure 8**.

Figure 8. Representative photographs of shallow cracks at top surface of the exterior hallway.

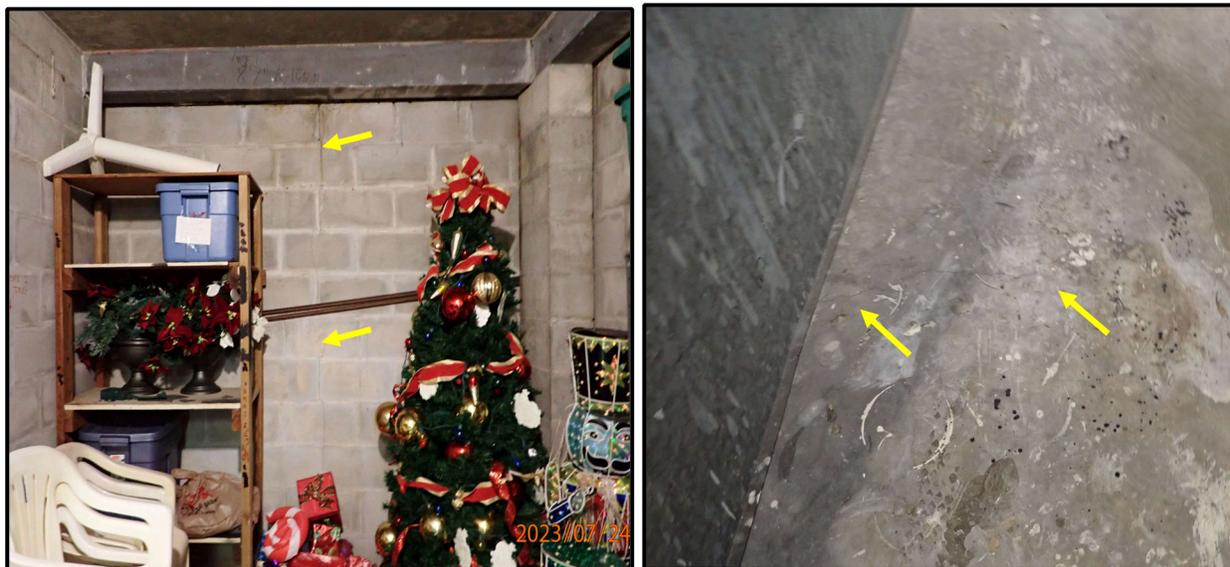
Vertical and horizontal cracking was observed on the building's core on the CMU walls of the storage rooms. CMU and mortar are brittle materials and are likely to crack when subjected to expansion and contraction and differential movement. The observed cracks are due to the movement of the core throughout its life. Similarly observed, were cracks on the concrete slab on grade on the first-floor electrical and storage rooms. The observed cracks are due to the expansion and contraction of the slab and typical settlement of the soils below the structure. Recommendations for repairs and monitoring of the cracks is provided in Exhibit A. Representative photographs of this observation are shown below in **Figure 9**.

Figure 9. Representative photographs of cracks on CMU walls and concrete slabs at common rooms in Core building.

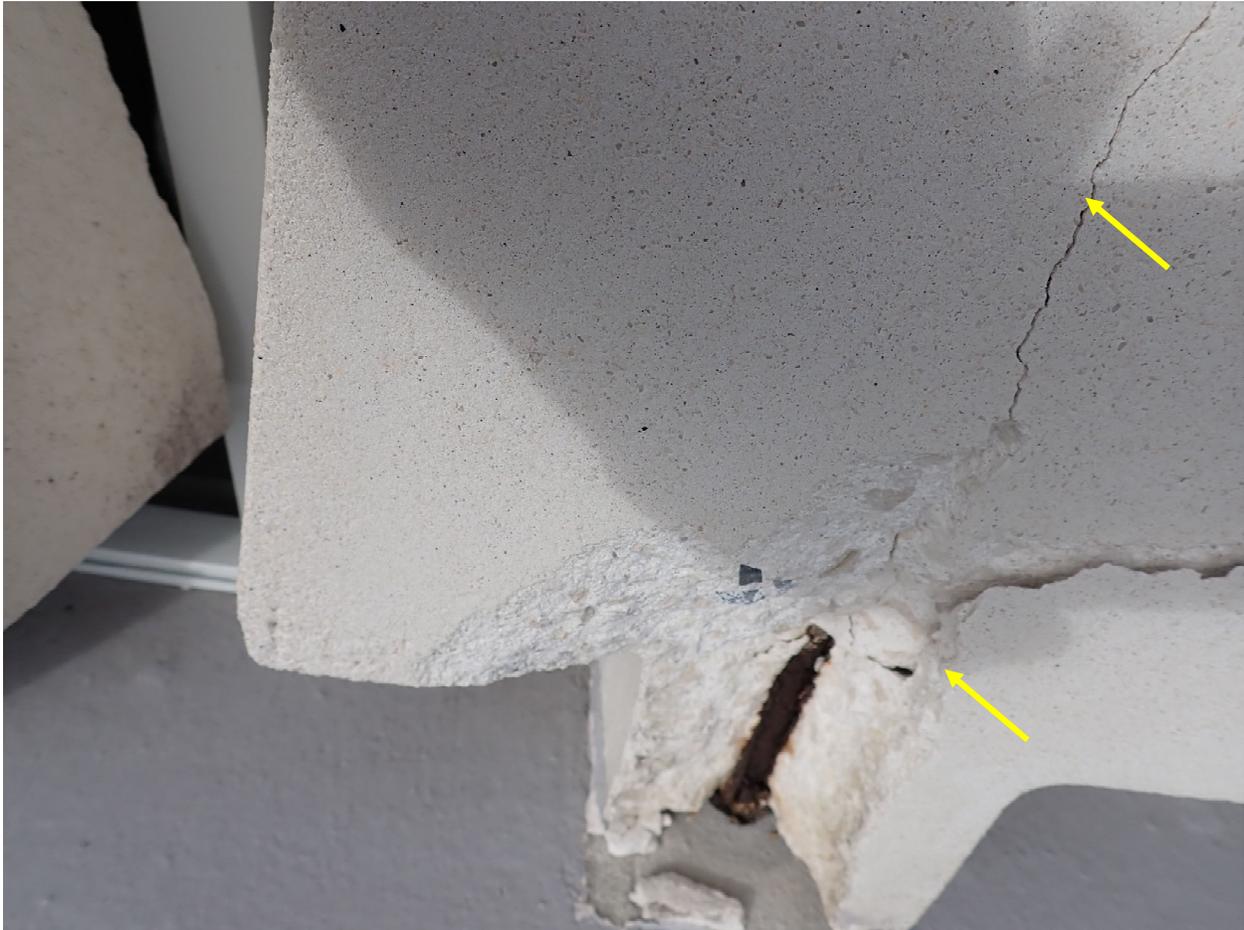
The building's exterior architectural features consisted of a decorative railing with exposed columns which extended from the roof to the slab. The railings and columns were constructed of a painted cementitious material. A secondary metal railing was installed in the interior of the decorative railing, which was in good condition. Evidence of deterioration of the decorative railings in the form of cracking was observed throughout the building (**Figure 10**). This is not structural damage, yet it is recommended that the decorative railing be repaired to prevent spalled pieces from detaching and falling.

Figure 10. Photograph of cracking of decorative railing

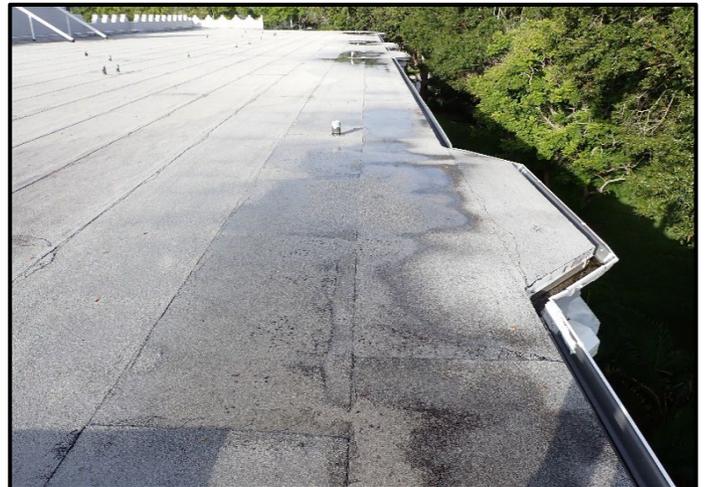
Photograph 04 - View of water ponding above the southwest wing roof.

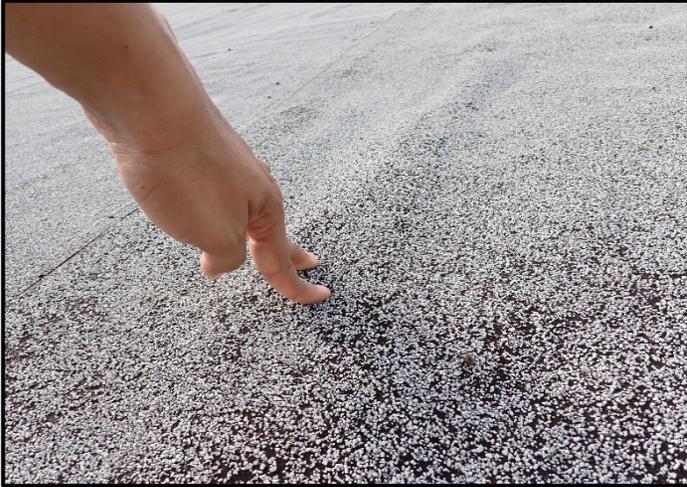
Photograph 05 - View of delaminated portion of membrane in southeast wing roof.

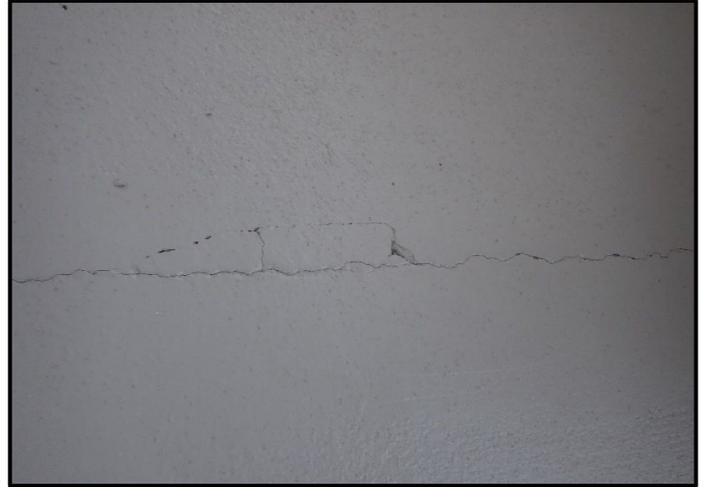
Photograph 06 - View of a crack in the elevated walkway surface perpendicular to the building near Unit 54.

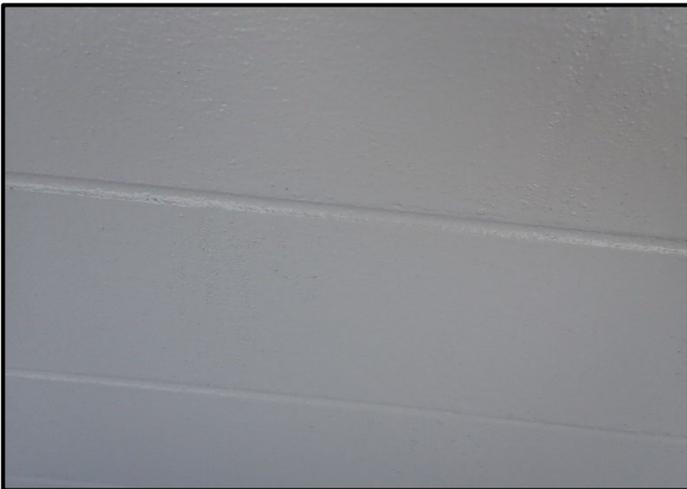
Photograph 07 - View of previous repair to stair step crack near Unit 52.

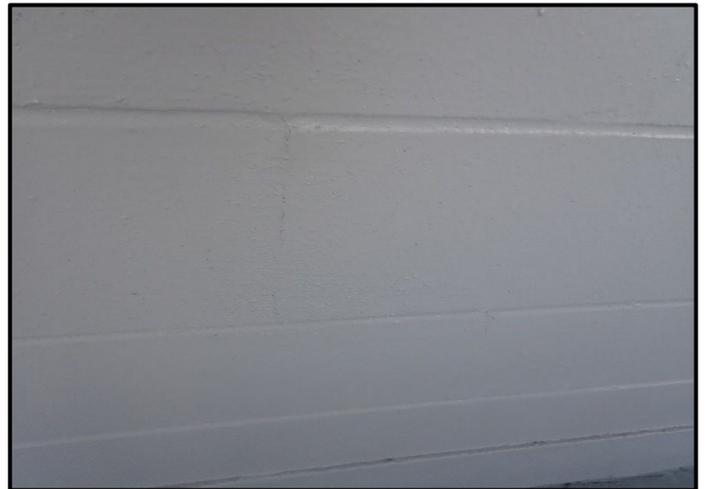
Photograph 08 - View of previous repair to stair step crack with a hairline re-opening near Unit 48.

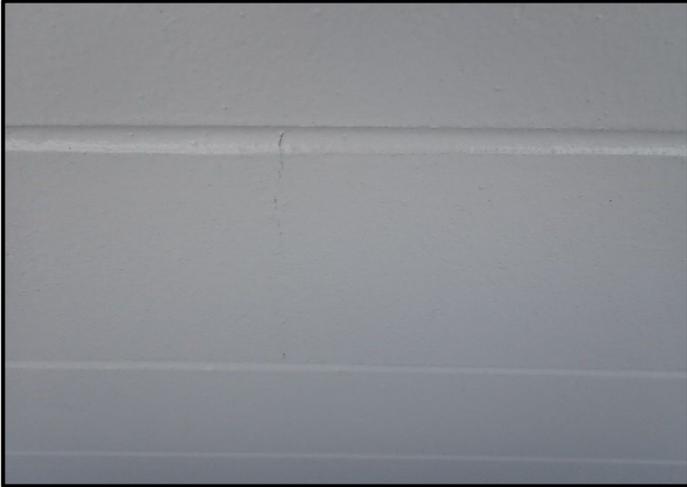
Photograph 09 - View of hairline stair step crack near Unit 43.

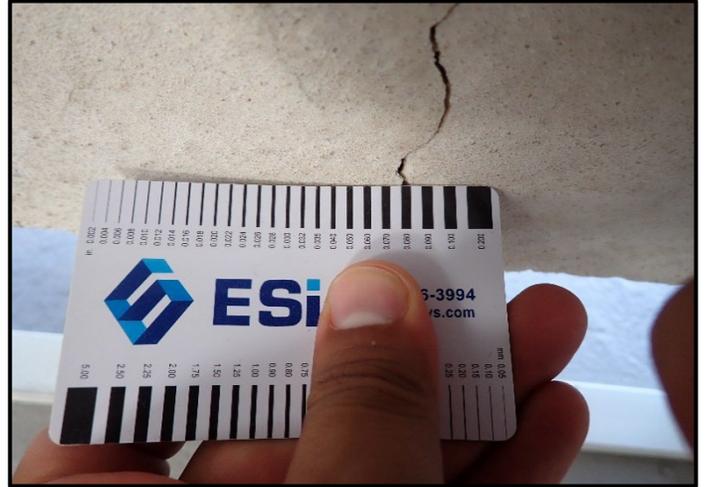
Photograph 10 - View of concrete railing crack near Unit 54.

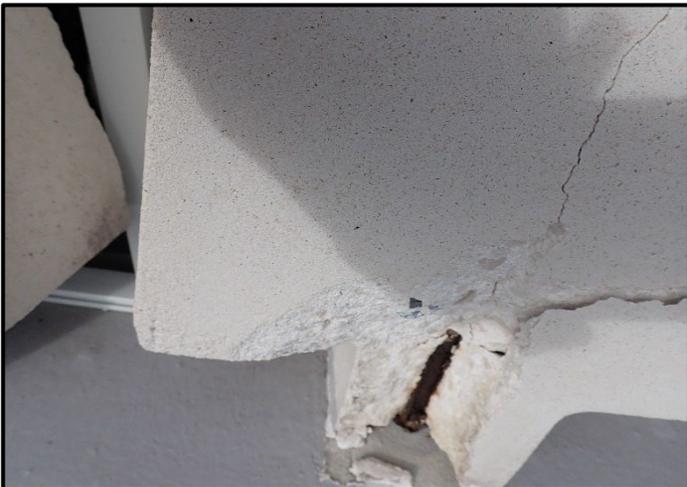
Photograph 11 - View of spalling concrete railing near Unit 57.

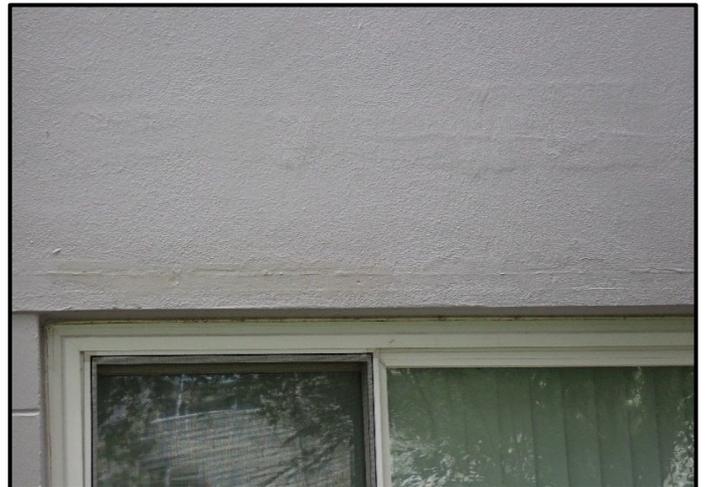
Photograph 12 - View of previous repair on stucco above window in rear elevation of Unit 2.

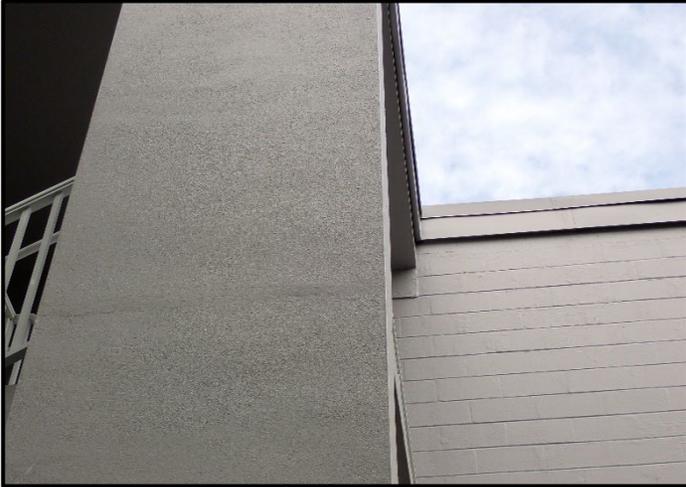
Photograph 13 - View of previous repair to horizontal crack on column in side elevation near Unit 36.

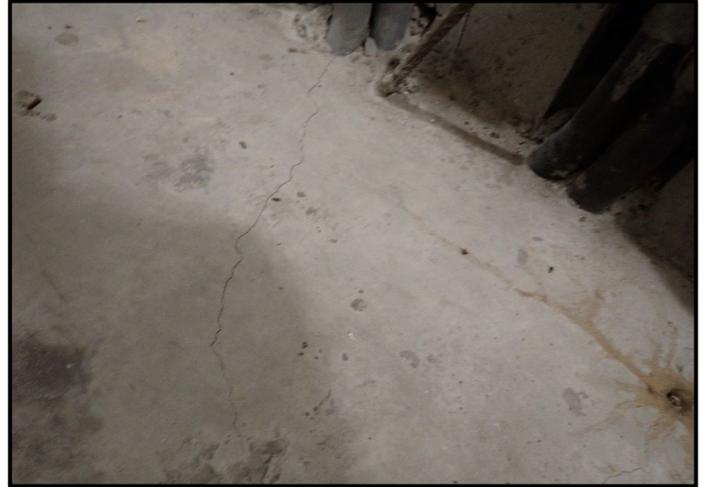
Photograph 14 - View of slab crack in first story electrical room.

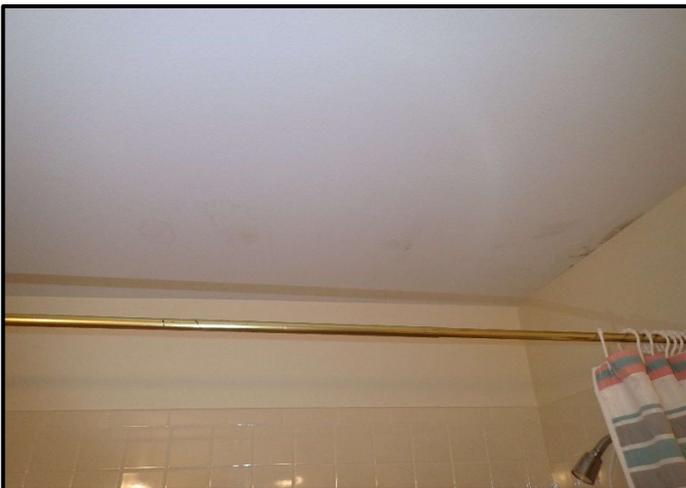
Photograph 15 - Moisture staining on ceiling in Unit 20.

Moisture staining on the finishes was observed in locations noted in Exhibit B. The moisture staining does not represent a structural damage or deterioration. It was also observed that some of these stains were historical, and that the source of the moisture had been repaired. At areas where the moisture source is unknown, it is recommended that the location is investigated and that the source be repaired.

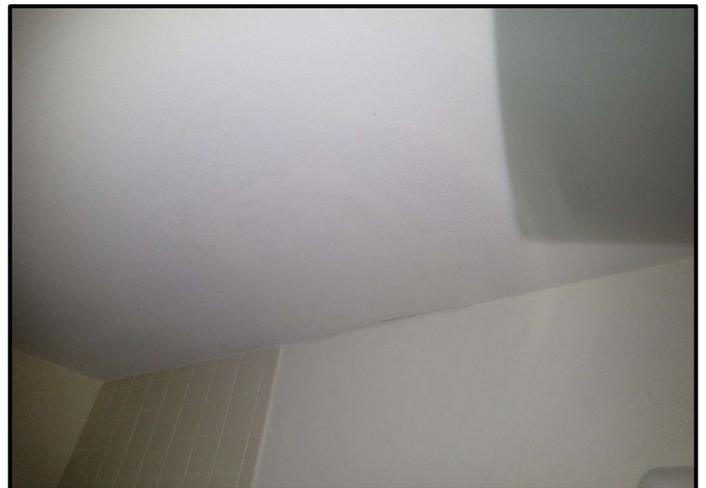
Photograph 16 - Moisture staining on ceiling in Unit 39.

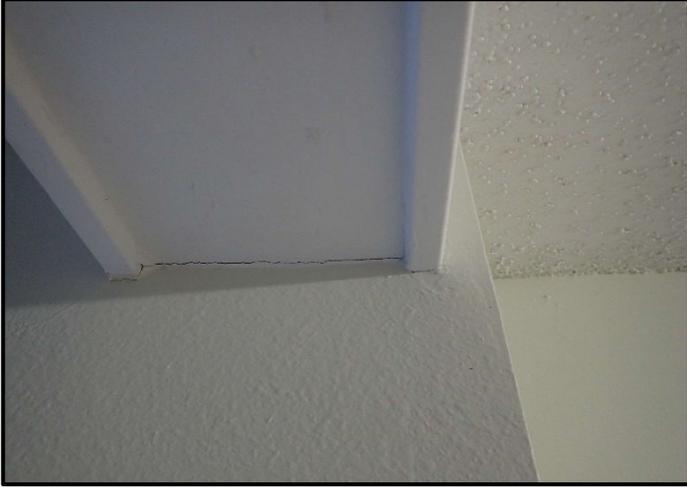
Photograph 17 - Crack at ceiling and wall joint in Unit 53.
