Phase 1 Milestone Inspection Report

On Top of the World Clearwater

Building 75

ESi Project No: 98508

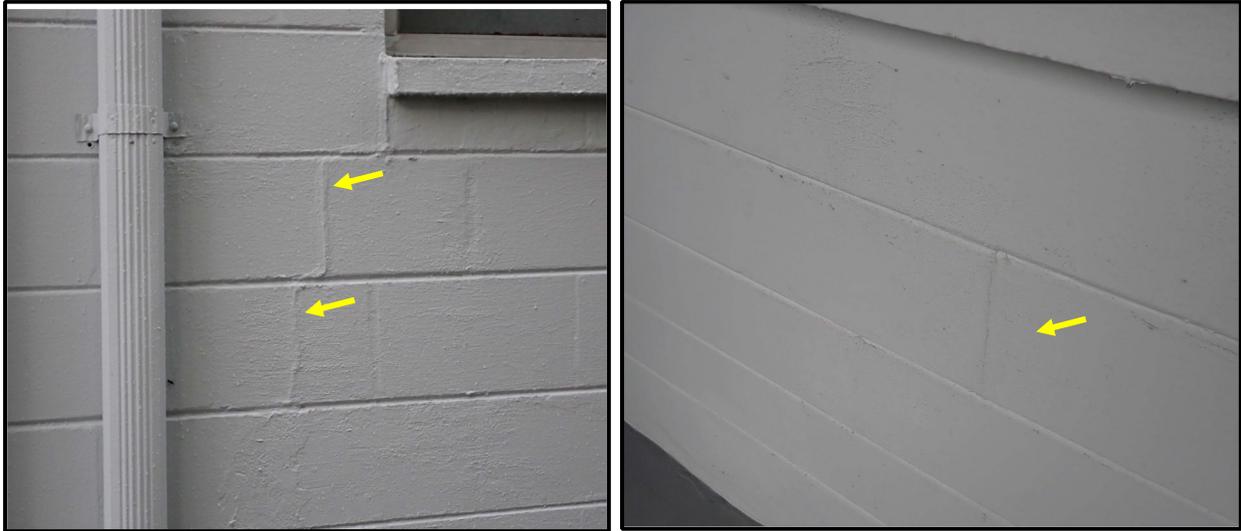
Stairstep cracks, both previously repaired and those appearing to be recent, on the CMU bearing walls of the wings particularly below windows and near the core were typically observed throughout the elevations of the building. Stairstep cracks are cracks in the mortar joints and form due to the movement of the structure, as mortar is a brittle material. The observed width and location of the cracks represent typical movement from a structure (commonly due to soil settlement) and do not appear to be indicative of structural damage. Recommendation for repairs and monitoring of the cracks is provided in Exhibit A. Representative photographs of this observation are shown below in **Figure 7**.

Figure 7. Representative photographs of step stair cracks at CMU walls.

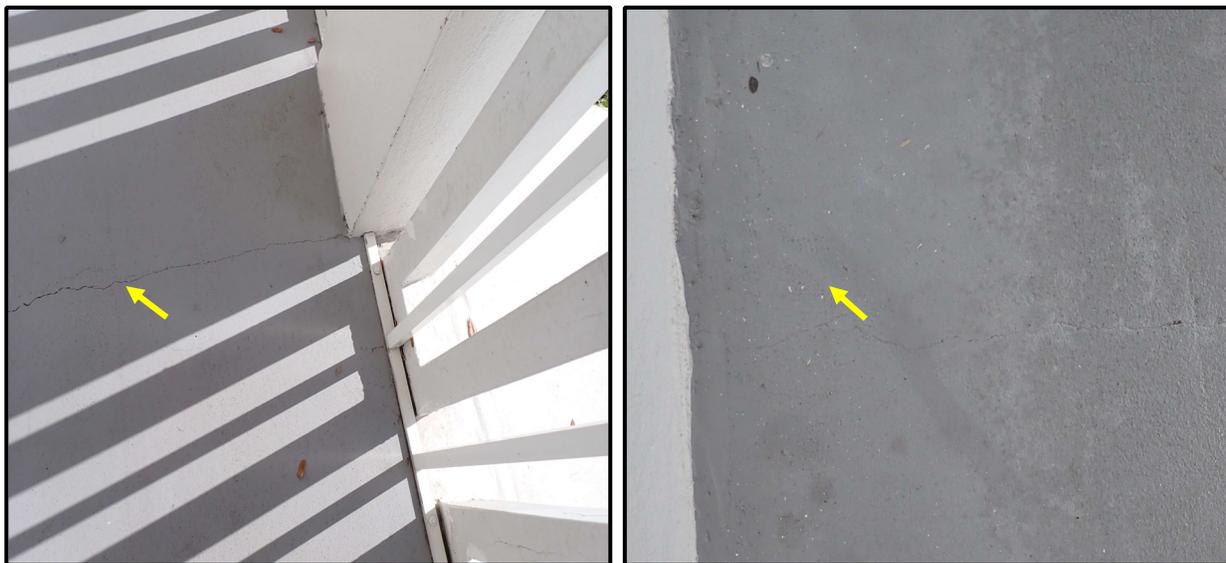
Cracks on the exterior hallway floor slabs were observed perpendicular to the length of the slab and the supporting wall. The observed cracks were typically hairline cracks and shallow. The cracks had weathered edges and dirt on the inside, representing they are historical in nature. The frequency and spacing of these cracks were not uniform. The observed cracks in the subject building are likely due to the expansion and contraction of the materials where control joints were not observed or due to the deflection of the slab at support locations and do not represent a structural damage or substantial deterioration. Recommendation for repairs and monitoring of the cracks is provided in Exhibit A. Representative photographs of this observation are shown below in **Figure 8**.

Figure 8. Representative photographs of shallow cracks at top surface of the exterior hallway.

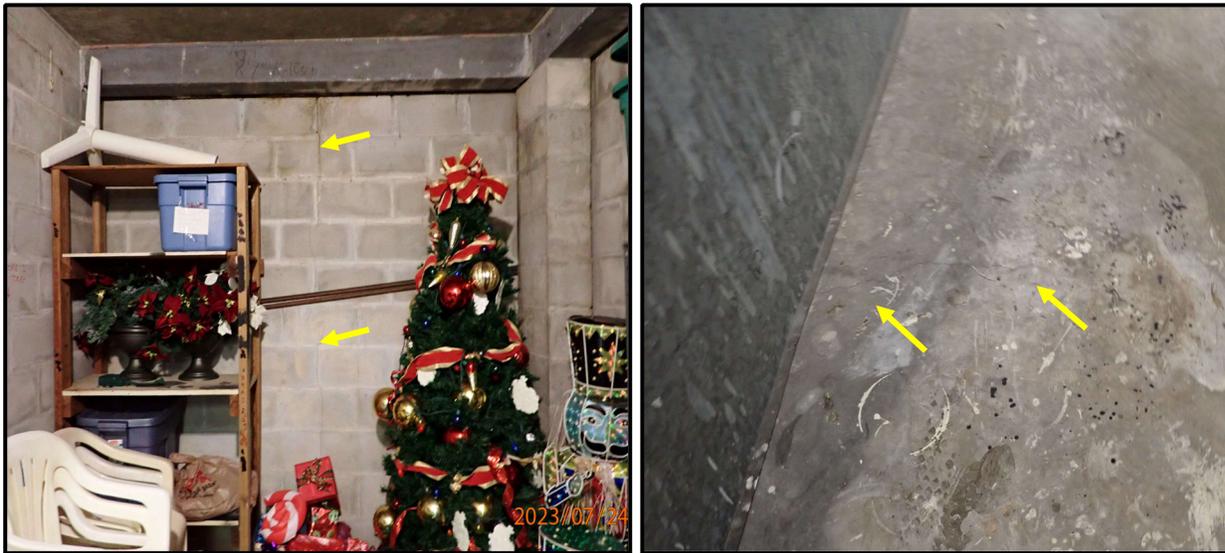
Vertical and horizontal cracking was observed on the building's core on the CMU walls of the storage rooms. CMU and mortar are brittle materials and are likely to crack when subjected to expansion and contraction and differential movement. The observed cracks are due to the movement of the core throughout its life. Similarly observed, were cracks on the concrete slab on grade on the first-floor electrical and storage rooms. The observed cracks are due to the expansion and contraction of the slab and typical settlement of the soils below the structure. Recommendations for repairs and monitoring of the cracks is provided in Exhibit A. Representative photographs of this observation are shown below in **Figure 9**.

Figure 9. Representative photographs of cracks on CMU walls and concrete slabs at common rooms in Core building.

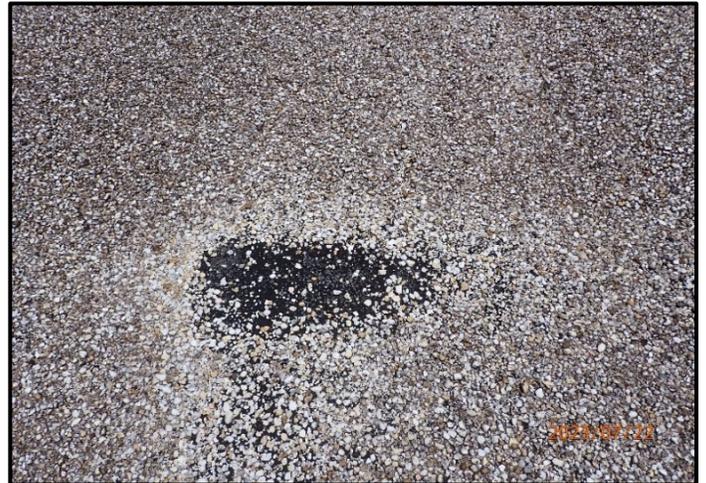
Photograph 04 - View of a location on the roof with missing gravel ballast and exposed asphalt.

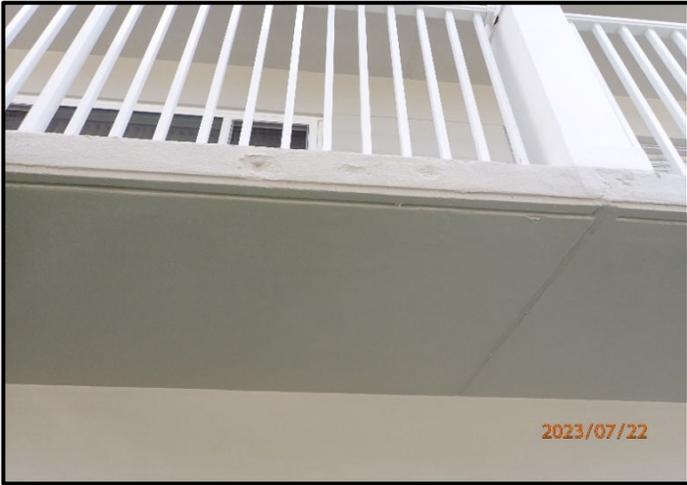
Photograph 05 - View of spalls at the edge of the exterior walkway.

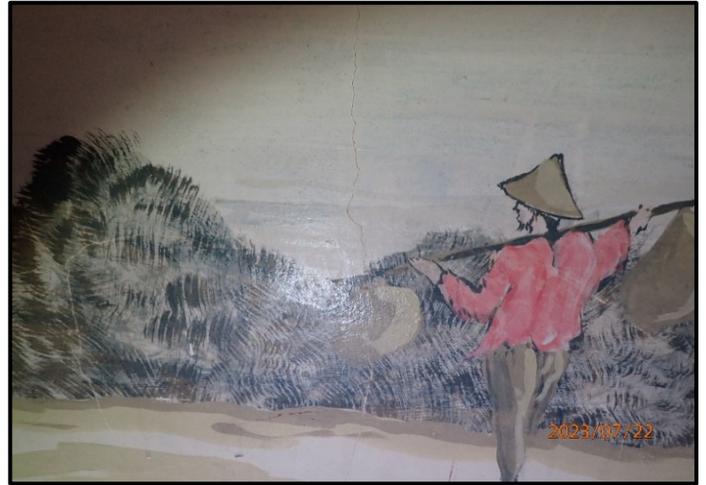
Photograph 06 - Close up view of a vertical crack in stucco wall cladding in the 1st floor core.

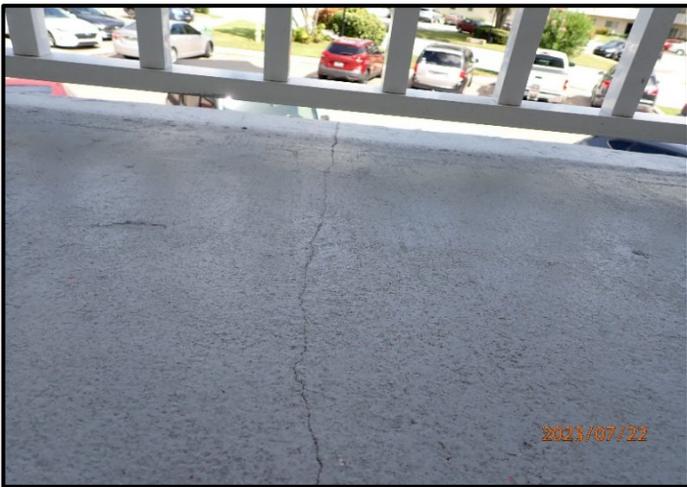
Photograph 07 - View of a hairline crack in the exterior walkway surface in front of unit 25.

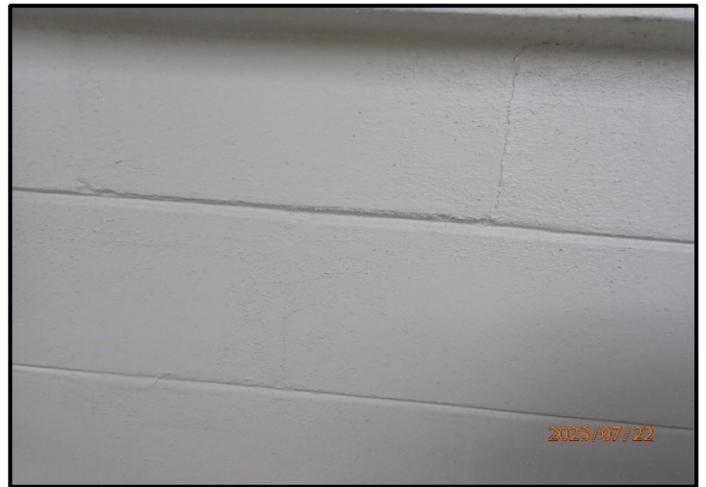
Photograph 08 - View of a previously repaired stair step crack with a re-opened hairline crack at the front elevation of unit 4.

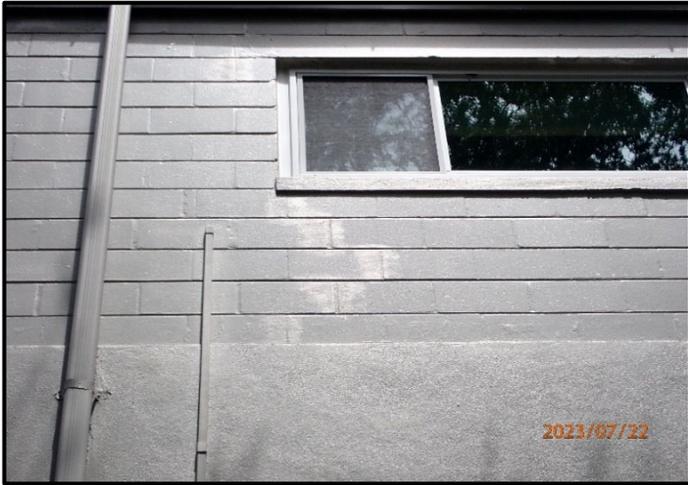
Photograph 09 - View of a previously repaired stair step crack on the rear elevation of Unit 47.

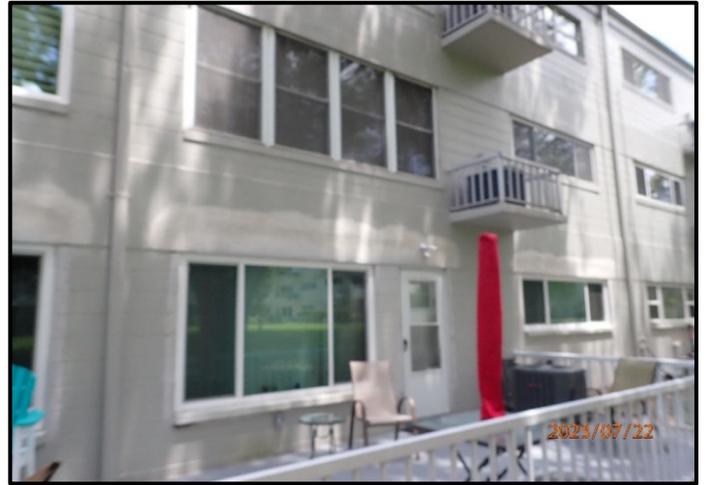
Photograph 10 - View of previous stucco repairs above windows on the rear elevation of the subject building.

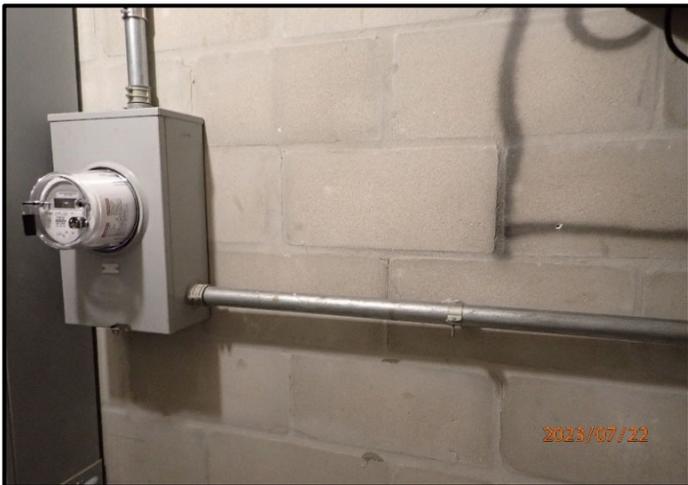
Photograph 11 - View of a stair step mortar crack in the CMU wall in the electrical room.

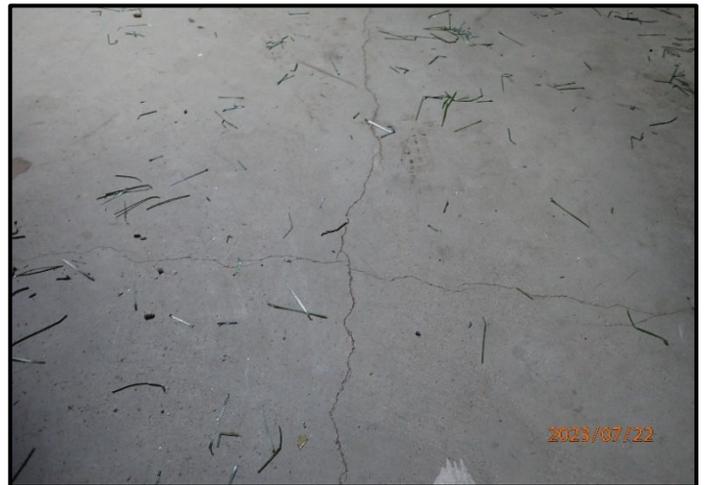
Photograph 12 - View of concrete slab cracks in the roof access room.

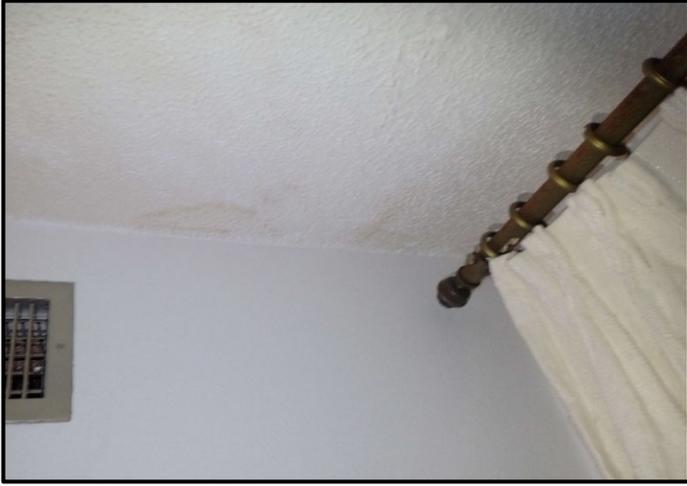
Photograph 13 - Moisture staining on ceiling in Unit 17.

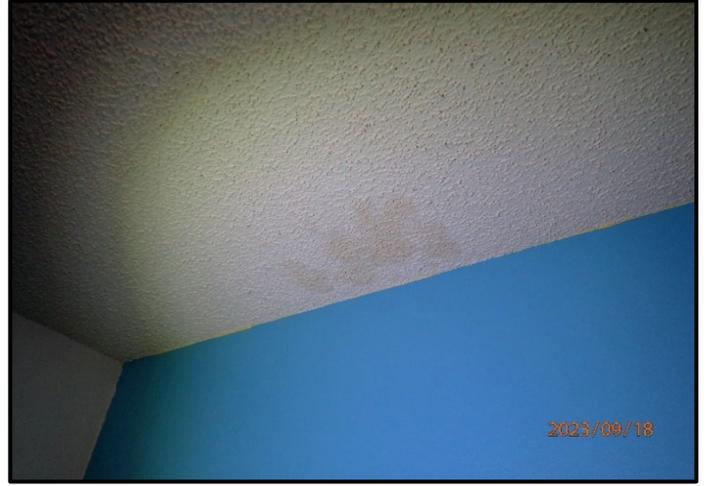
Photograph 14 - Moisture staining on ceiling in Unit 12.
