Phase 1 Milestone Inspection Report

On Top of the World Clearwater

Building 78

ESi Project No: 98508

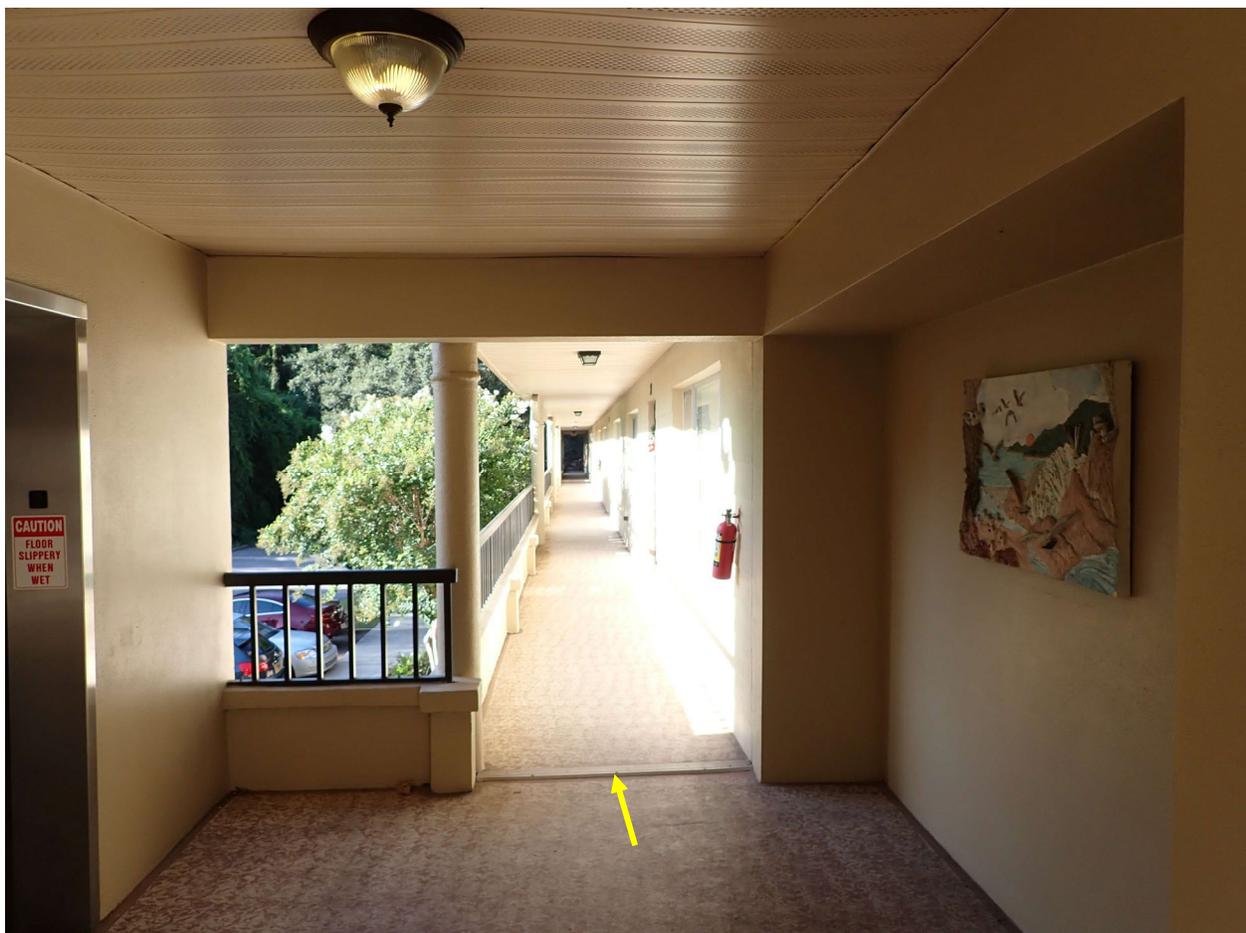
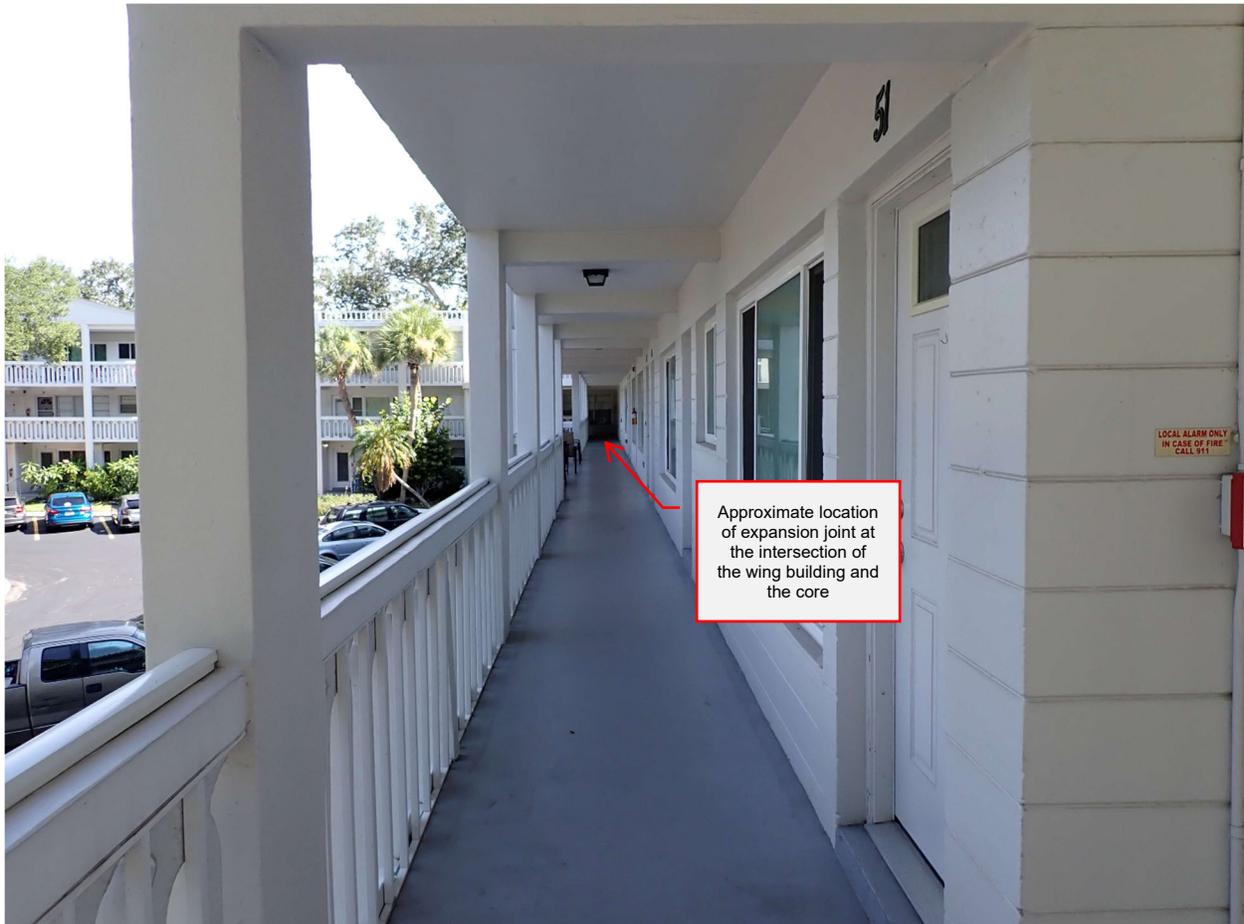
Above grade, the wings and core are structurally independent such that each building is separate and there is a flexible expansion/contraction joint where the structures meet (**Figure 5** and **Figure 6**). Below grade at the foundation level, the walls of the building's wings and the core's columns share a foundation footing.

Figure 5. Expansion joint at wing/core intersection.

Figure 6. Representative approximate location of expansion joint at wing/core intersection in representative building.

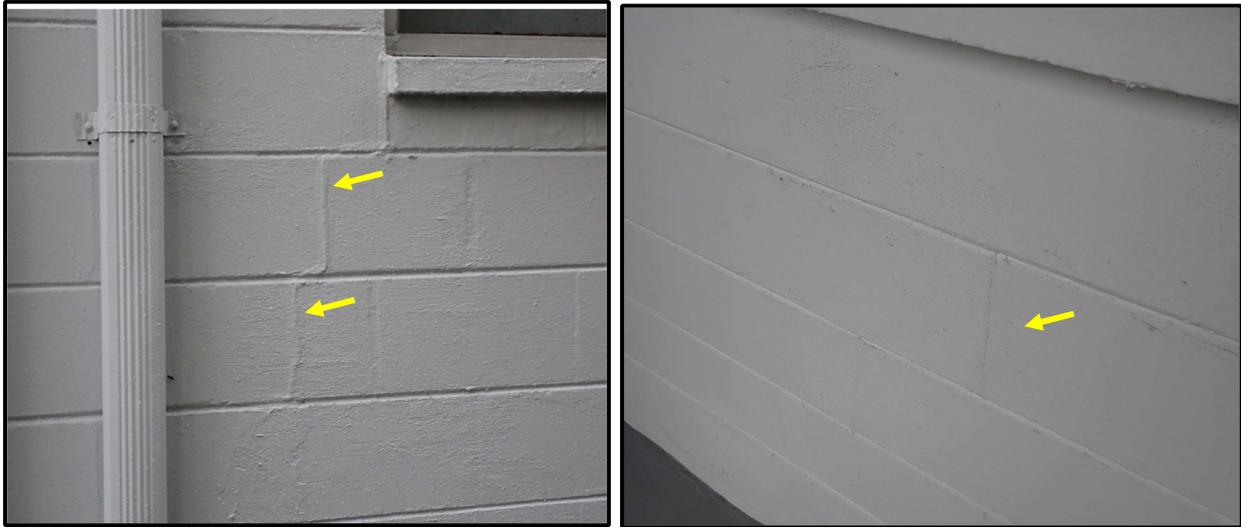
Stairstep cracks, both previously repaired and those appearing to be recent, on the CMU bearing walls of the wings particularly below windows and near the core were typically observed throughout the elevations of the building. Stairstep cracks are cracks in the mortar joints and form due to the movement of the structure, as mortar is a brittle material. The observed width and location of the cracks represent typical movement from a structure (commonly due to soil settlement) and do not appear to be indicative of structural damage. Recommendation for repairs and monitoring of the cracks is provided in Exhibit A. Representative photographs of this observation are shown below in **Figure 7**.

Figure 7. Representative photographs of step stair cracks at CMU walls.

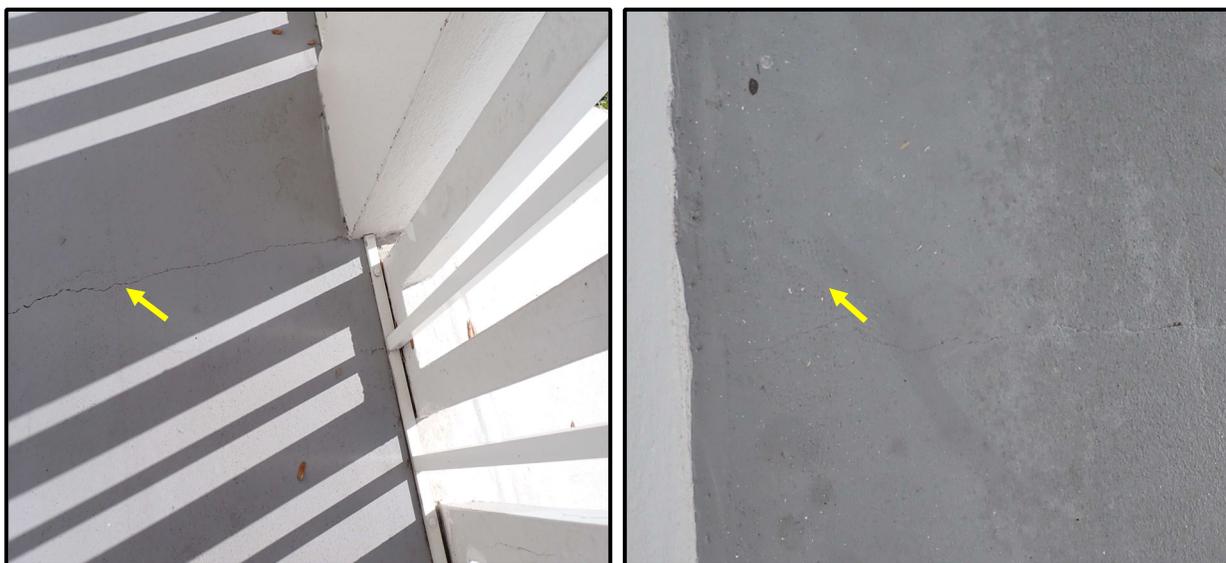
Cracks on the exterior hallway floor slabs were observed perpendicular to the length of the slab and the supporting wall. The observed cracks were typically hairline cracks and shallow. The cracks had weathered edges and dirt on the inside, representing they are historical in nature. The frequency and spacing of these cracks were not uniform. The observed cracks in the subject building are likely due to the expansion and contraction of the materials where control joints were not observed or due to the deflection of the slab at support locations and do not represent a structural damage or substantial deterioration. Recommendation for repairs and monitoring of the cracks is provided in Exhibit A. Representative photographs of this observation are shown below in **Figure 8**.

Figure 8. Representative photographs of shallow cracks at top surface of the exterior hallway.

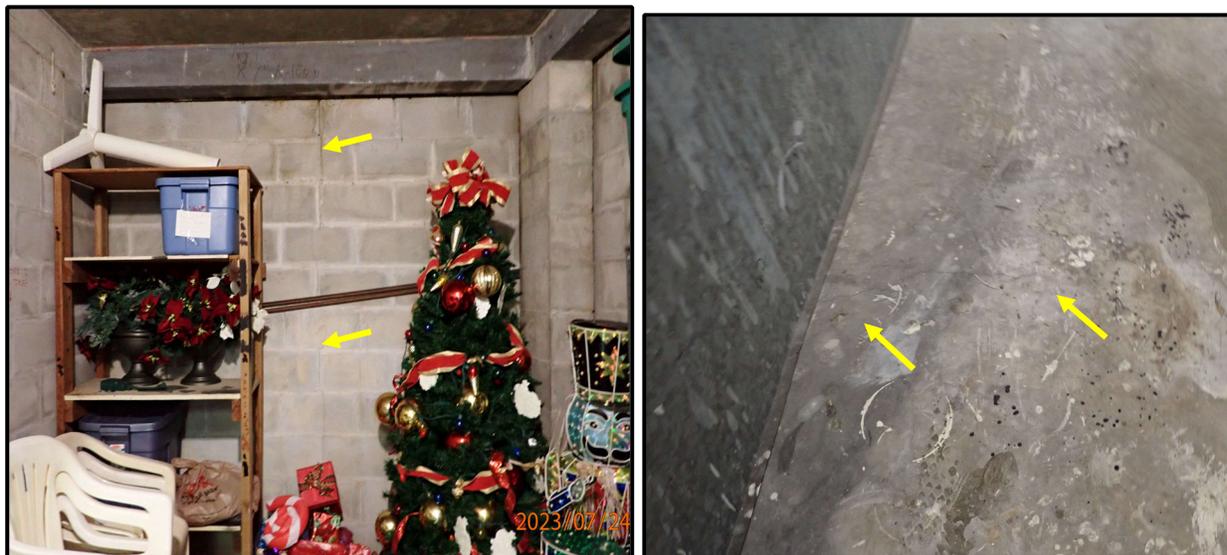
Vertical and horizontal cracking was observed on the building's core on the CMU walls of the storage rooms. CMU and mortar are brittle materials and are likely to crack when subjected to expansion and contraction and differential movement. The observed cracks are due to the movement of the core throughout its life. Similarly observed, were cracks on the concrete slab on grade on the first-floor electrical and storage rooms. The observed cracks are due to the expansion and contraction of the slab and typical settlement of the soils below the structure. Recommendations for repairs and monitoring of the cracks is provided in Exhibit A. Representative photographs of this observation are shown below in Figure 9.

Figure 9. Representative photographs of cracks on CMU walls and concrete slabs at common rooms in Core building.

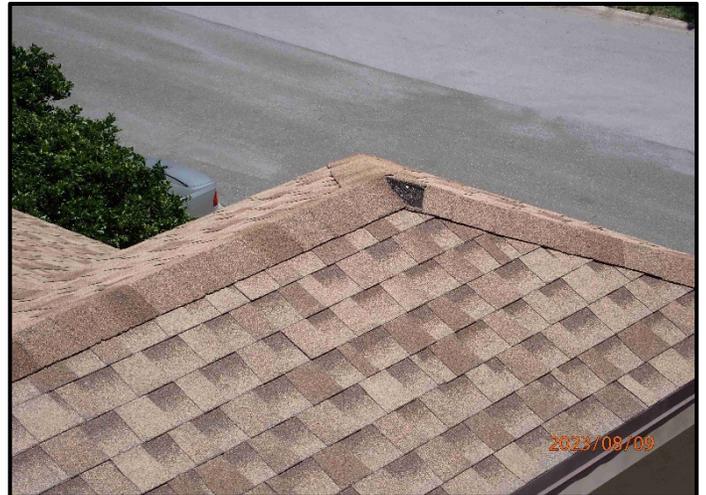
Photograph 04 - View of a torn hip cap in the southeast portion of the front roof slope.

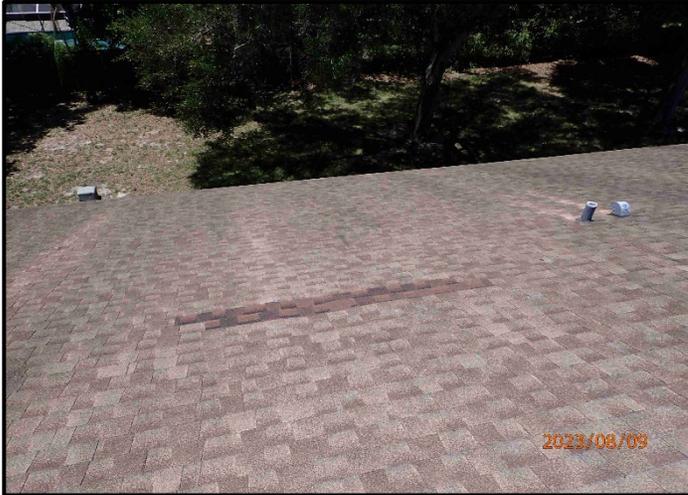
Photograph 05 - View of replaced shingles in the rear roof slope.

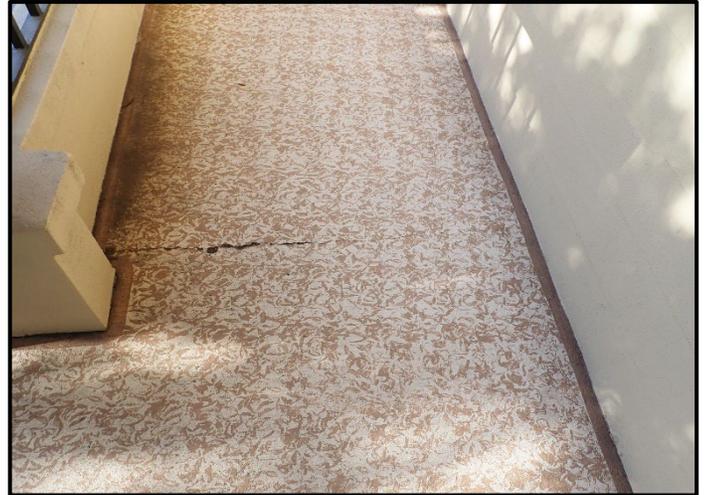
Photograph 06 - View of a crack in the elevated walkway surface perpendicular to the building near Unit 34.

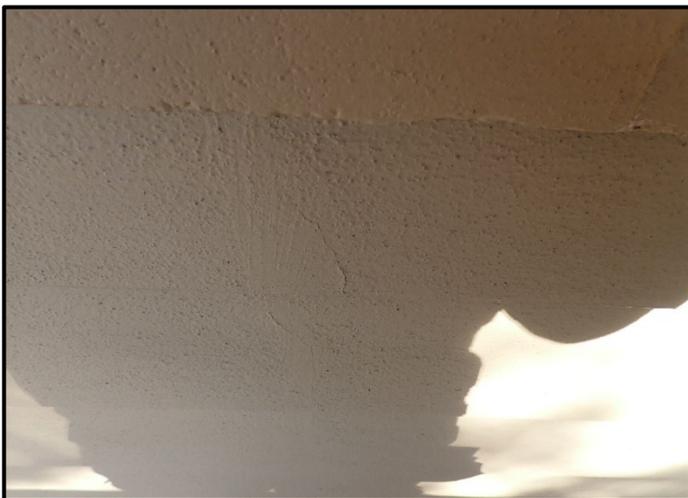
Photograph 07 - View of previous repair to a stair step crack with a hairline re-opening near Unit 34.

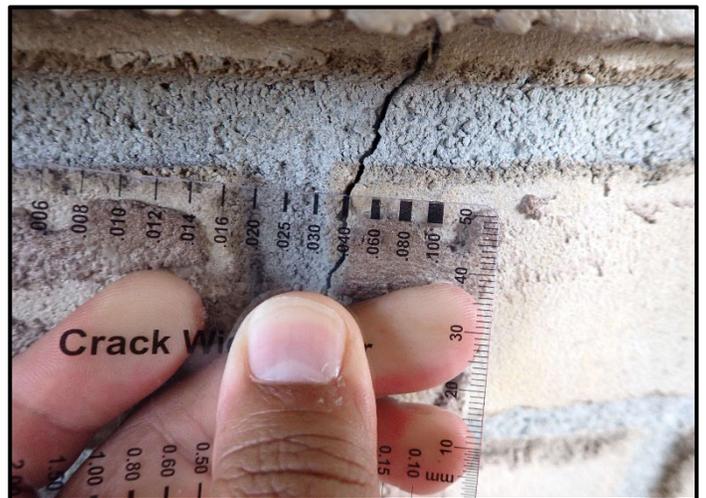
Photograph 08 - View of a vertical crack through brick veneer and mortar near Unit 18.

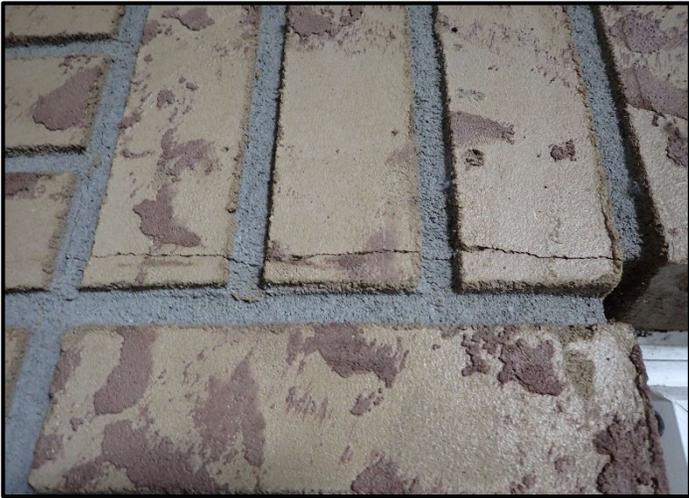
Photograph 09 - View of a horizontal crack through brick veneer and mortar near Unit 2.

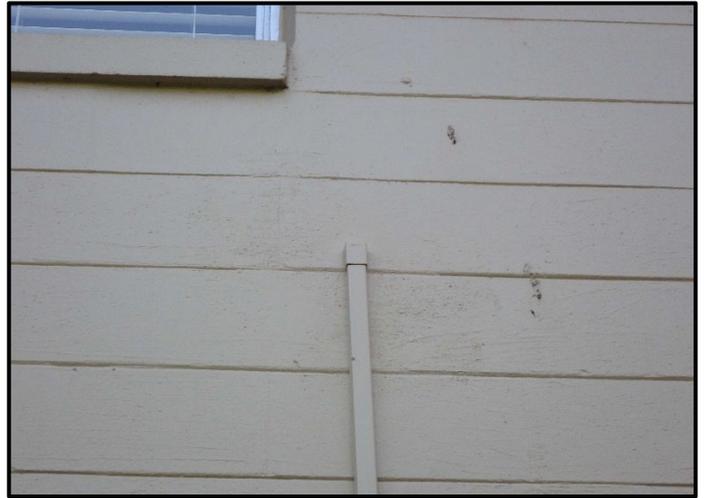
Photograph 10 - View of previous repair to stair step crack in rear elevation of Unit 22.

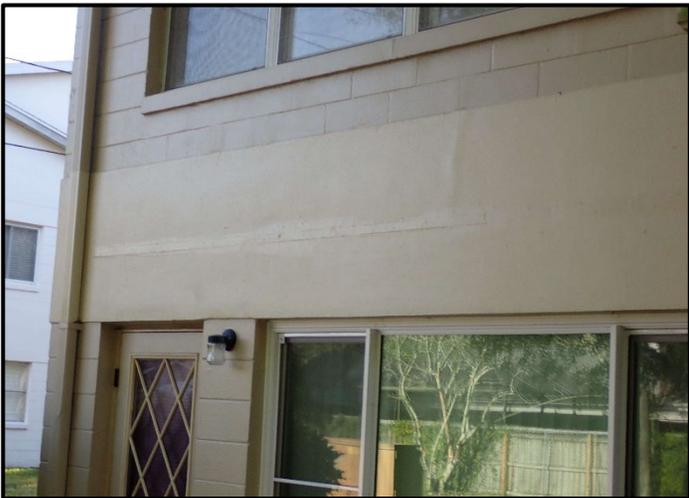
Photograph 11 - View of previous repair to stucco above door & window in rear elevation of Unit 18.

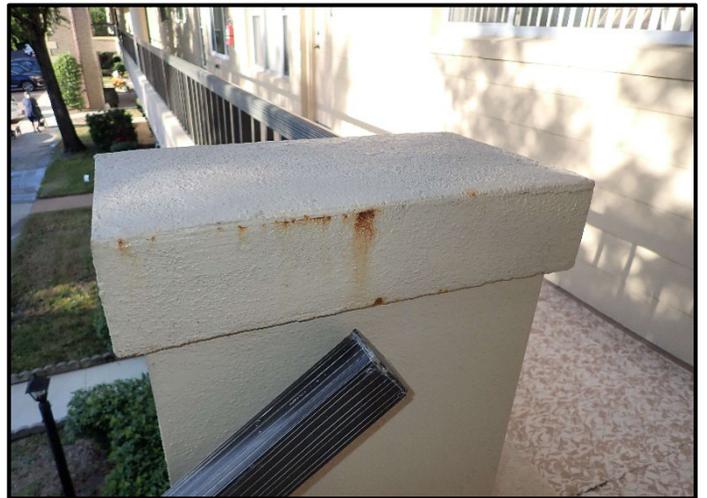
Photograph 12 - View of rust on concrete column located at the 2nd story north stairway.

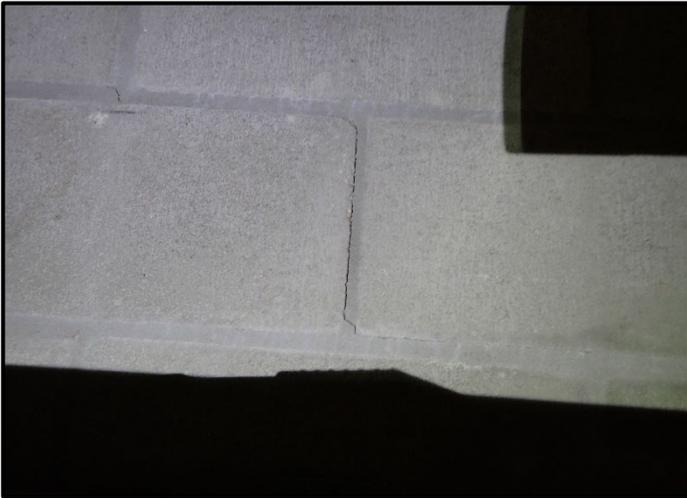
Photograph 13 - View of a stair step mortar crack on the right wall in 1st story elevator machine room.

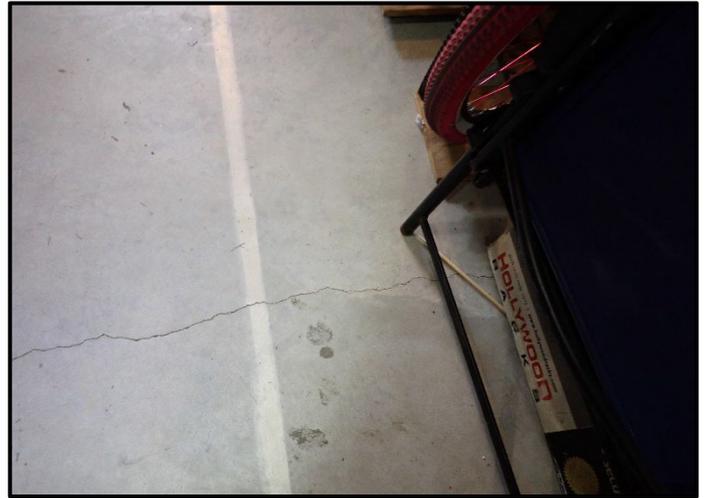
Photograph 14 - View of a slab crack in 2nd story storage room.

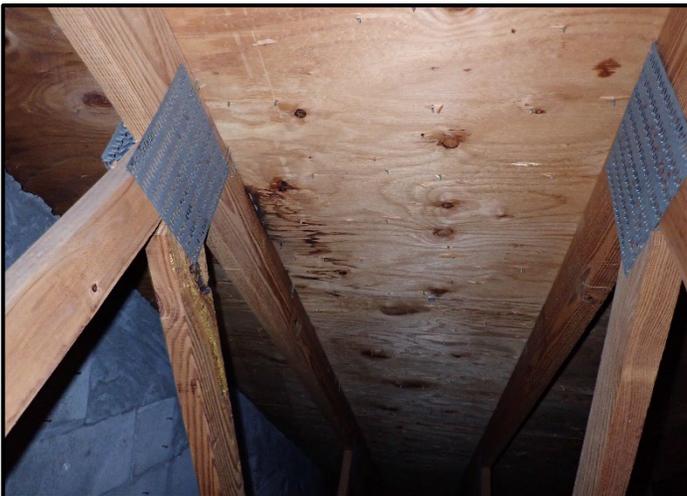
Photograph 15 - View of water stains on roof deck above the 2nd story storage room.

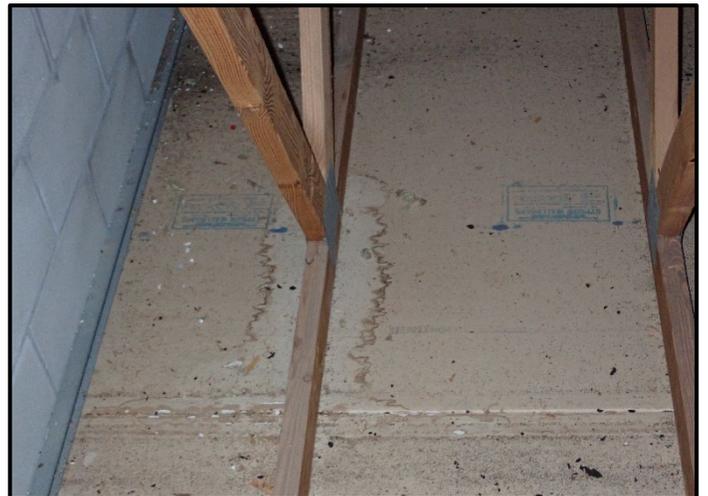
Photograph 16 - View of water stains on topside of drywall above the 2nd story storage room.

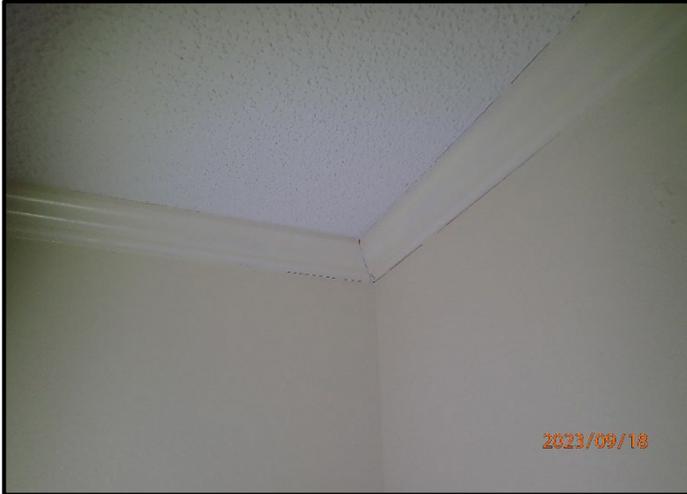
Photograph 17 - Cracking at ceiling and molding intersection in Unit 2.

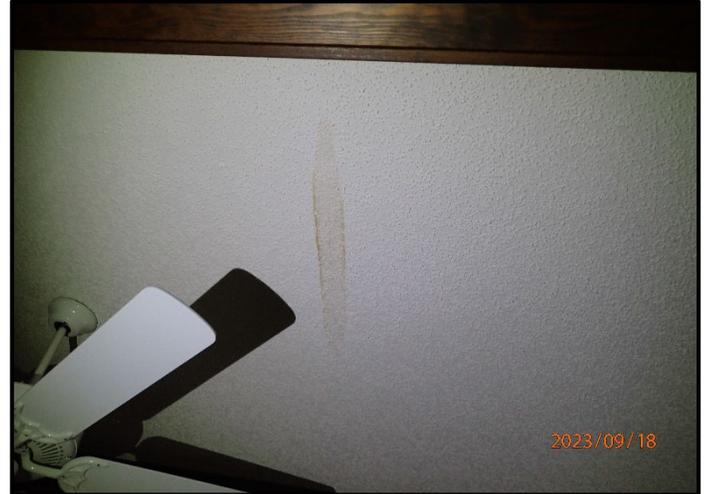
Moisture staining on the finishes was observed in locations noted in Exhibit B. The moisture staining does not represent a structural damage or deterioration. It was also observed that some of these stains were historical, and that the source of the moisture had been repaired. At areas where the moisture source is unknown, it is recommended that the location is investigated and that the source be repaired.

Photograph 18 - Moisture staining on ceiling of Unit 20.
