Phase 1 Milestone Inspection Report

On Top of the World Clearwater

Building 80

ESi Project No: 98508

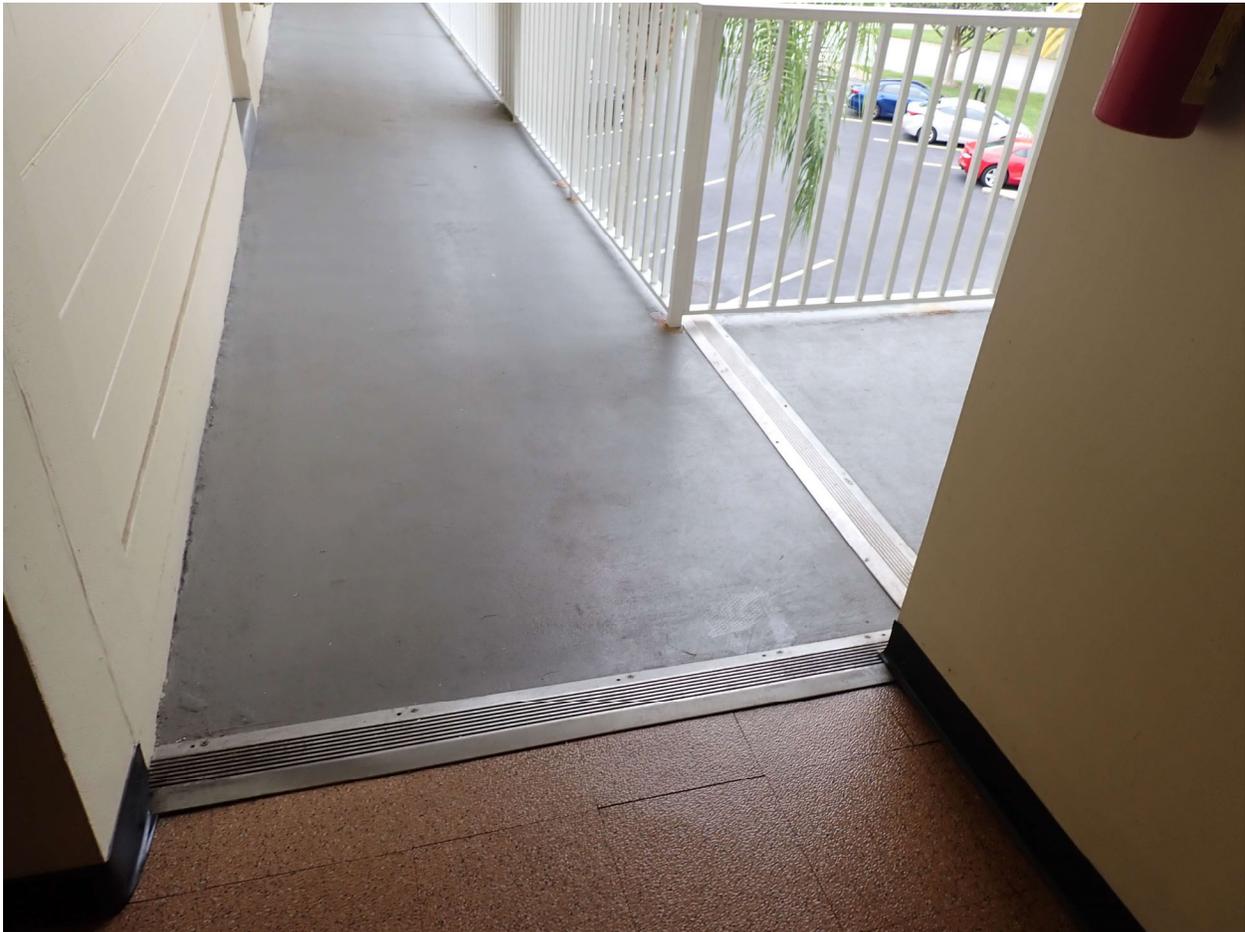
Figure 5. Representative expansion joint at wing/core intersection.

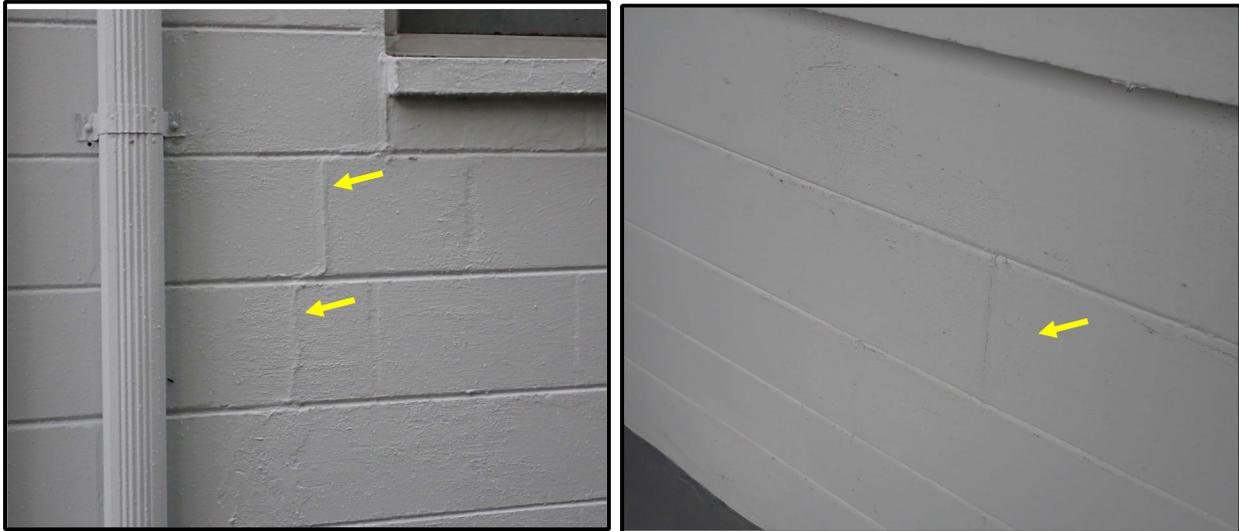
Stairstep cracks, both previously repaired and those appearing to be recent, on the CMU bearing walls of the wings particularly below windows and near the core were typically observed throughout the elevations of the building. Stairstep cracks are cracks in the mortar joints and form due to the movement of the structure, as mortar is a brittle material. The observed width and location of the cracks represent typical movement from a structure (commonly due to soil settlement) and do not appear to be indicative of structural damage. Recommendation for repairs and monitoring of the cracks is provided in Exhibit A. Representative photographs of this observation are shown below in **Figure 7**.

Figure 7. Representative photographs of step stair cracks at CMU walls.

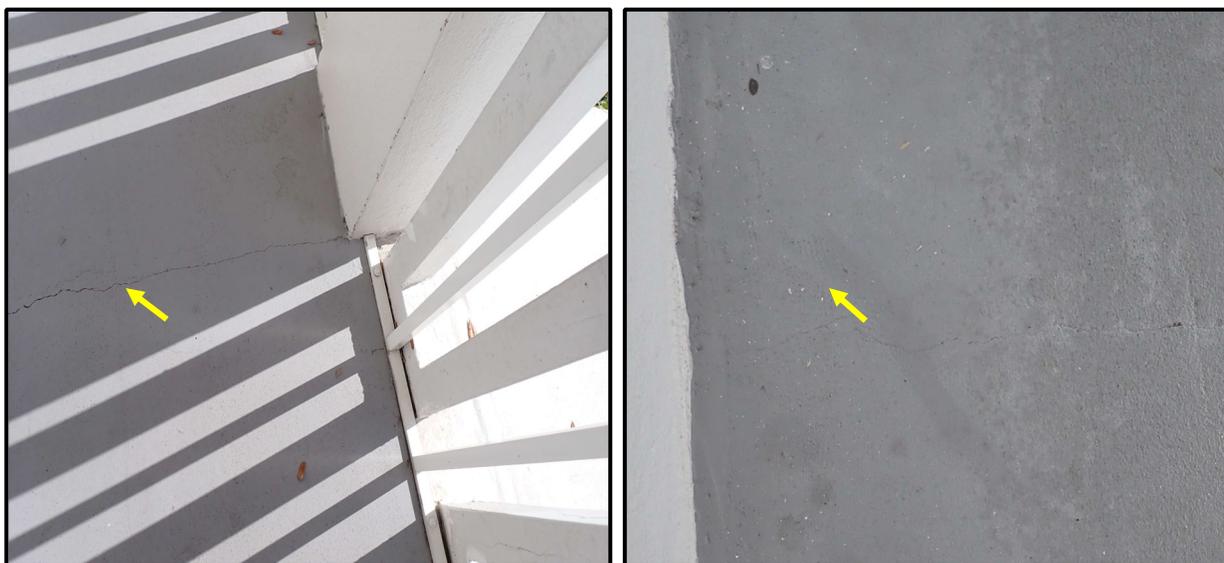
Cracks on the exterior hallway floor slabs were observed perpendicular to the length of the slab and the supporting wall. The observed cracks were typically hairline cracks and shallow. The cracks had weathered edges and dirt on the inside, representing they are historical in nature. The frequency and spacing of these cracks were not uniform. The observed cracks in the subject building are likely due to the expansion and contraction of the materials where control joints were not observed or due to the deflection of the slab at support locations and do not represent a structural damage or substantial deterioration. Recommendation for repairs and monitoring of the cracks is provided in Exhibit A. Representative photographs of this observation are shown below in **Figure 8**.

Figure 8. Representative photographs of shallow cracks at top surface of the exterior hallway.

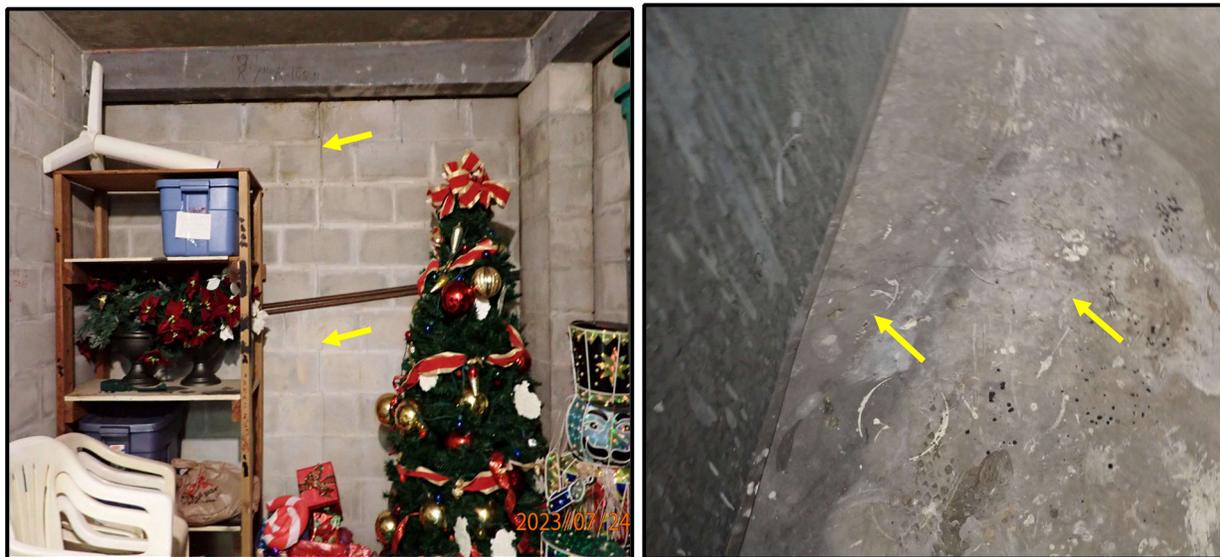
Vertical and horizontal cracking was observed on the building's core on the CMU walls of the storage rooms. CMU and mortar are brittle materials and are likely to crack when subjected to expansion and contraction and differential movement. The observed cracks are due to the movement of the core throughout its life. Similarly observed, were cracks on the concrete slab on grade on the first-floor electrical and storage rooms. The observed cracks are due to the expansion and contraction of the slab and typical settlement of the soils below the structure. Recommendations for repairs and monitoring of the cracks is provided in Exhibit A. Representative photographs of this observation are shown below in **Figure 9**.

Figure 9. Representative photographs of cracks on CMU walls and concrete slabs at common rooms in Core building.

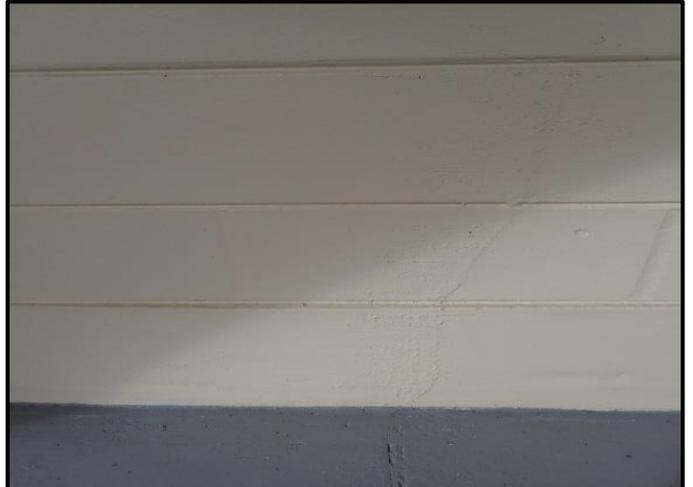
Photograph 04 - View of a surface patch (previous repair) to a vertical crack in the CMU wall at the front elevation of unit 53.

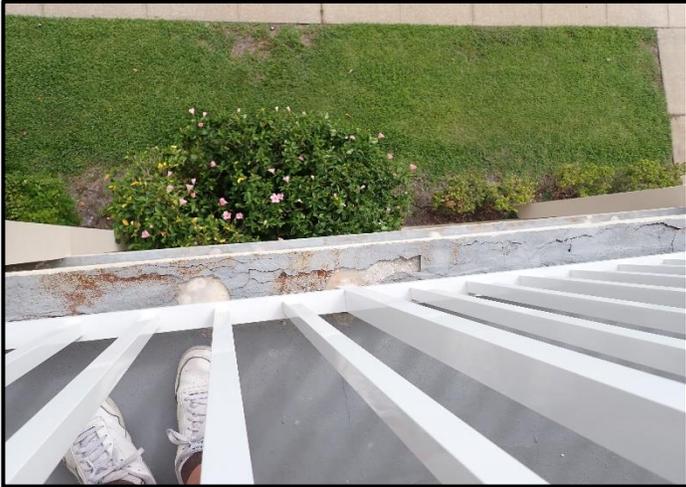
Photograph 05 - View of exterior walkway surface spalling at the outer edge of the walkway on the 3rd floor northwest wing.

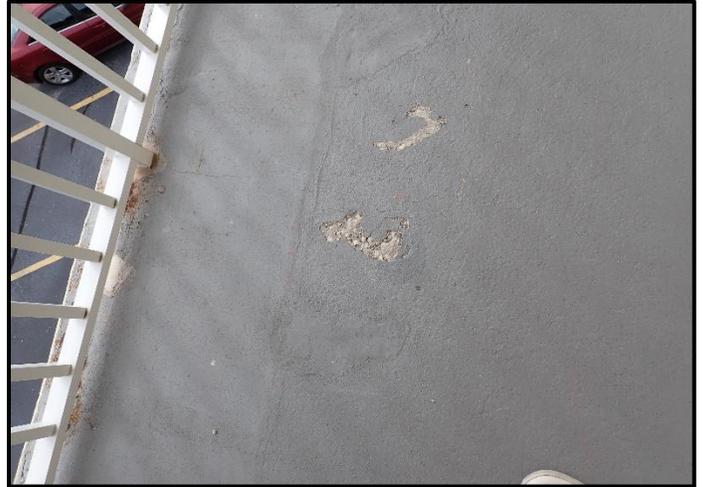
Photograph 06 - View of exterior walkway surface delamination at the front elevation of unit 61.

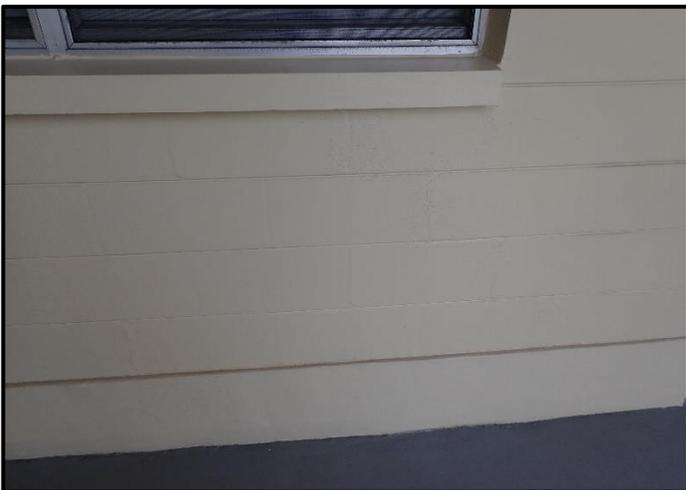
Photograph 07 - View of a previously repaired stair step mortar crack at the front elevation of unit 52.

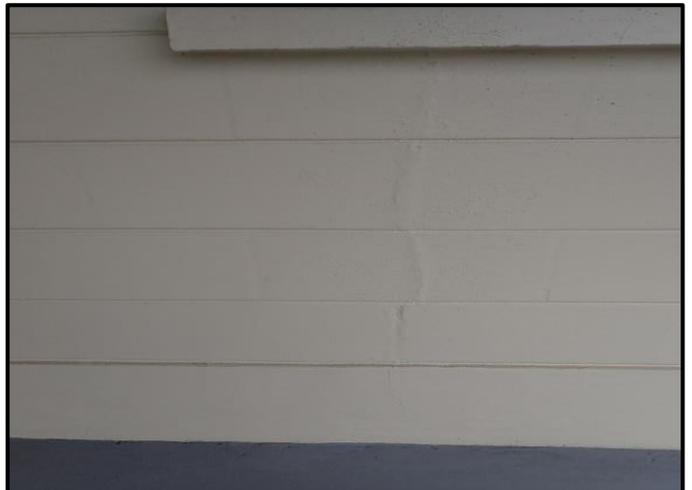
Photograph 08 - View of a previous repair to a vertical crack in the CMU wall at the front elevation of unit 48.

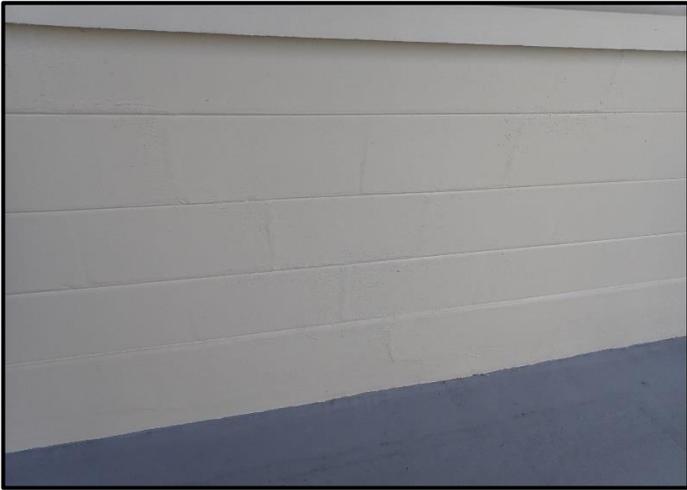
Photograph 09 - View of a previously repaired stair step mortar crack at the front elevation of unit 32.

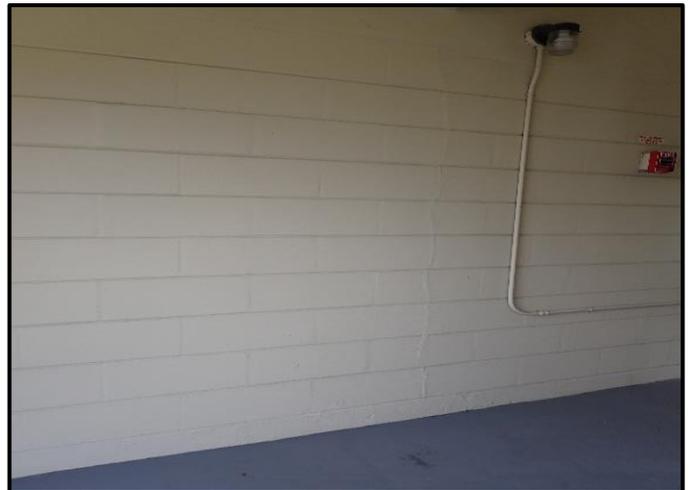
Photograph 10 - View of a previous repair to a vertical crack in the CMU wall at the northeast stair 1st floor.

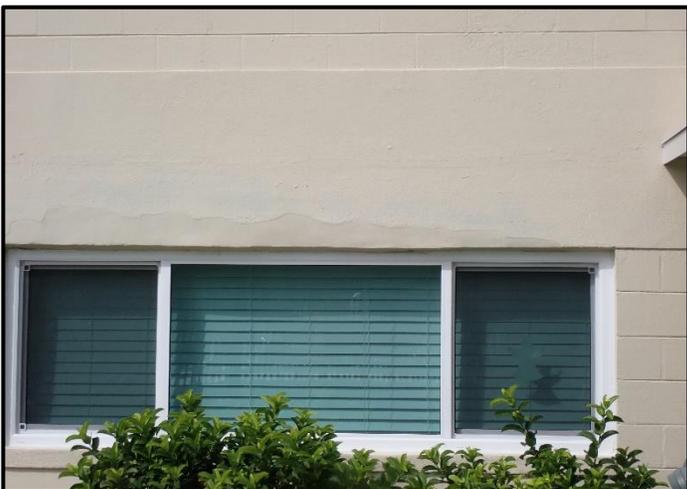
Photograph 11 - View of delaminated stucco cladding above a window at the rear elevation of unit 8.

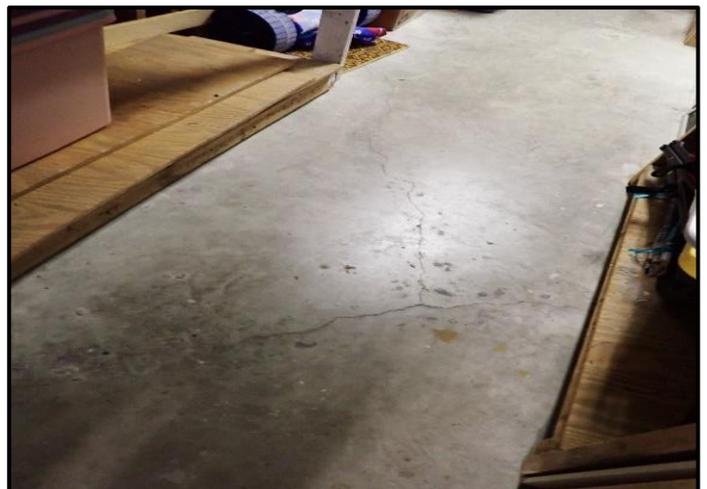
80	Shallow hairline crack in concrete slab.	1st floor storage.	No	No	Y - Localized as noted in the Location column.	No	Seal cracks with high-strength epoxy.	No

Photograph 12 - View of the hairline slab cracks in the 1st floor storage room.

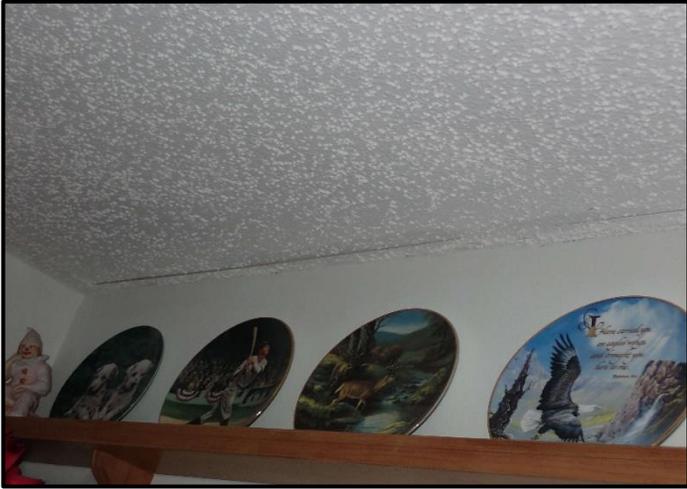
Photograph 13 - Crack at the ceiling in unit 50.

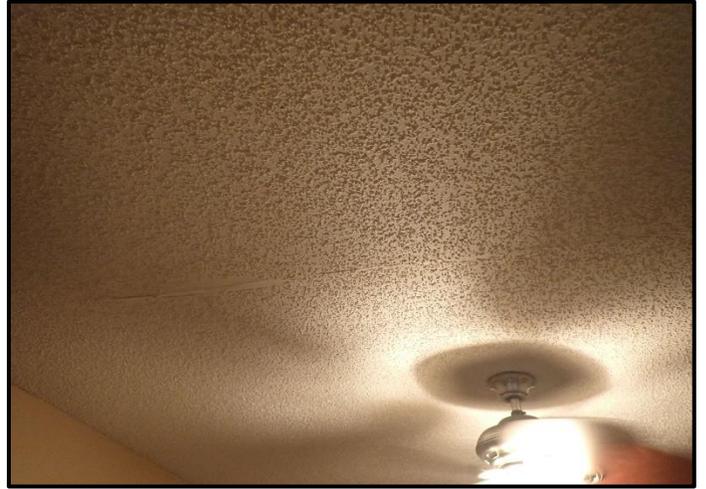
Photograph 14 - Crack at the ceiling in unit 53.

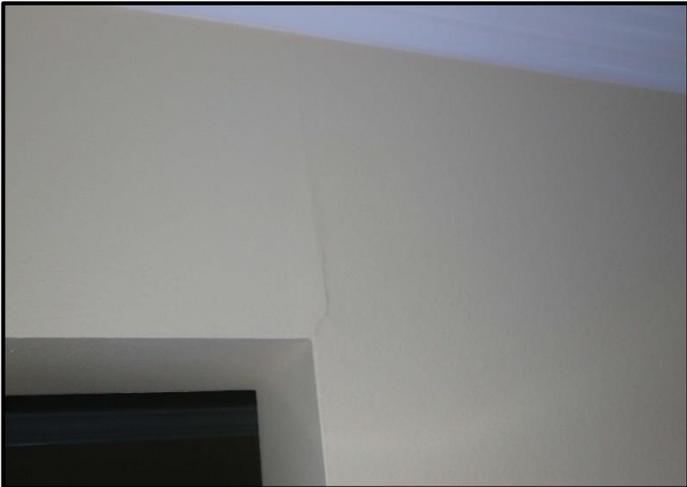
Photograph 15 - Vertical crack on wall in unit 61.
