Phase 1 Milestone Inspection Report

On Top of the World Clearwater

Building 85

ESi Project No: 98508

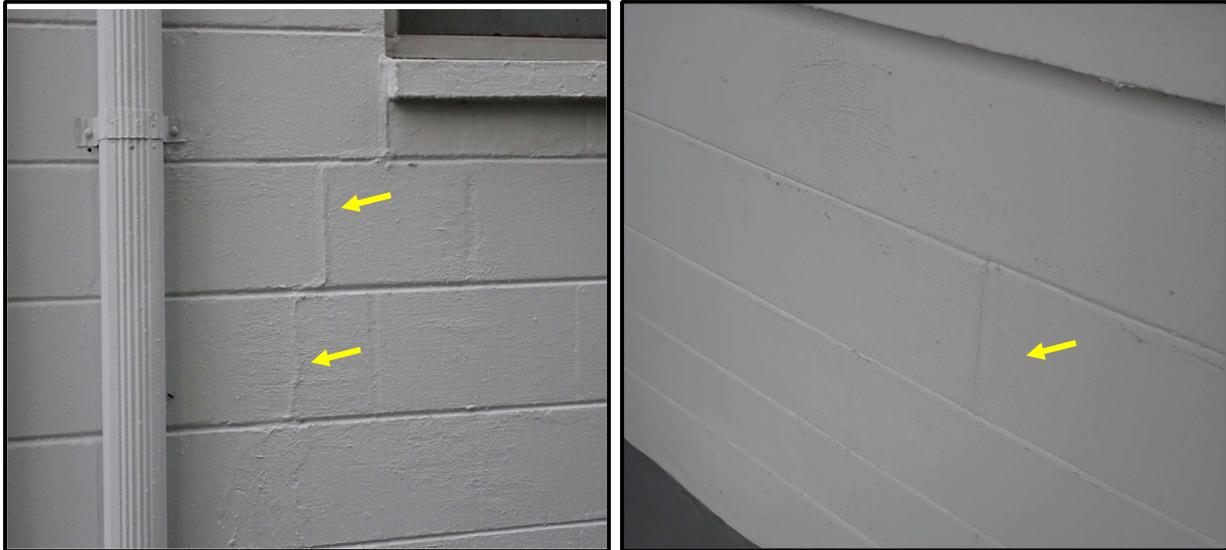
Figure 7. Representative photographs of step stair cracks at CMU walls.

Stairstep cracks, both previously repaired and those appearing to be recent, on the CMU bearing walls of the wings particularly below windows and near the core were typically observed throughout the elevations of the building. Stairstep cracks are cracks in the mortar joints and form due to the movement of the structure, as mortar is a brittle material. The observed width and location of the cracks represent typical movement from a structure (commonly due to soil settlement) and do not appear to be indicative of structural damage. Recommendation for repairs and monitoring of the cracks is provided in Exhibit A. Representative photographs of this observation are shown below in **Figure 7**.

85	Surface patch (previous repair) to stair step crack in CMU wall.	Front elevation of units : 3rd story - 46, 50, 52, 54, 49, 51, 55 and 45. 2nd story - 27, 25, 31, 24, 22 and 21. 1st story - 15, 11, 9, 1, 12, 10, 6, 4 and 2. Rear elevation of units: 3rd story - 51, 55, 39, 41, 45, 47, 48 and 50. 2nd story - 21, 23 and 32.	No	No	Y - Localized as noted in the location column.	No	Monitor.	No

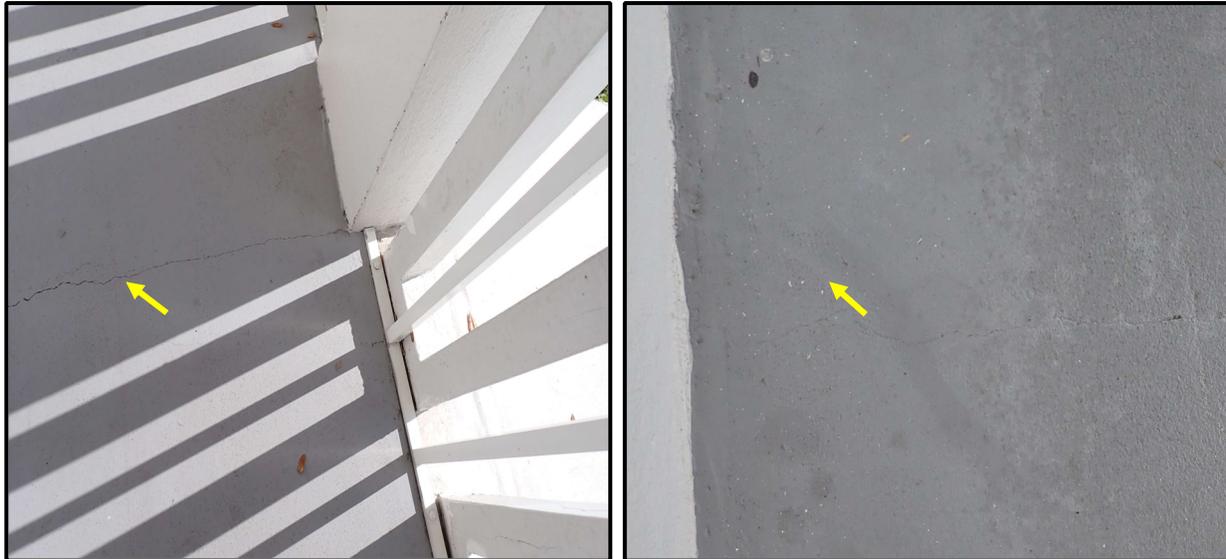
Figure 8. Representative photographs of shallow cracks at top surface of the exterior hallway.

Cracks on the exterior hallway floor slabs were observed perpendicular to the length of the slab and the supporting wall. The observed cracks were typically hairline cracks and shallow. The cracks had weathered edges and dirt on the inside, representing they are historical in nature. The frequency and spacing of these cracks were not uniform. The observed cracks in the subject building are likely due to the expansion and contraction of the materials where control joints were not observed or due to the deflection of the slab at support locations and do not represent a structural damage or substantial deterioration. Recommendation for repairs and monitoring of the cracks is provided in Exhibit A. Representative photographs of this observation are shown below in **Figure 8**.

85	Shallow line cracks at the top face of the concrete slab of the exterior walkway perpendicular to the wall, consistently throughout all walkways. In some locations hairline cracks perpendicular to the walkway observed on the bottom face of the concrete slab.	Exterior walkways in 2nd and 3rd story.	No	No	Y - Perpendicular single cracks throughout the walkways in 2nd and 3rd story.	No	Repair - Seal hairline cracks with high-strength epoxy.	No
85	Stair step mortar crack in exterior face of CMU wall.	Front elevation of units: 3rd story - 42, 40, 53 and 43. 2nd story - 23, 21, 35, 37 and 26.	No	No	Y - Localized as noted in the location column.	No	Repair - Seal hairline cracks with high-strength epoxy.	No

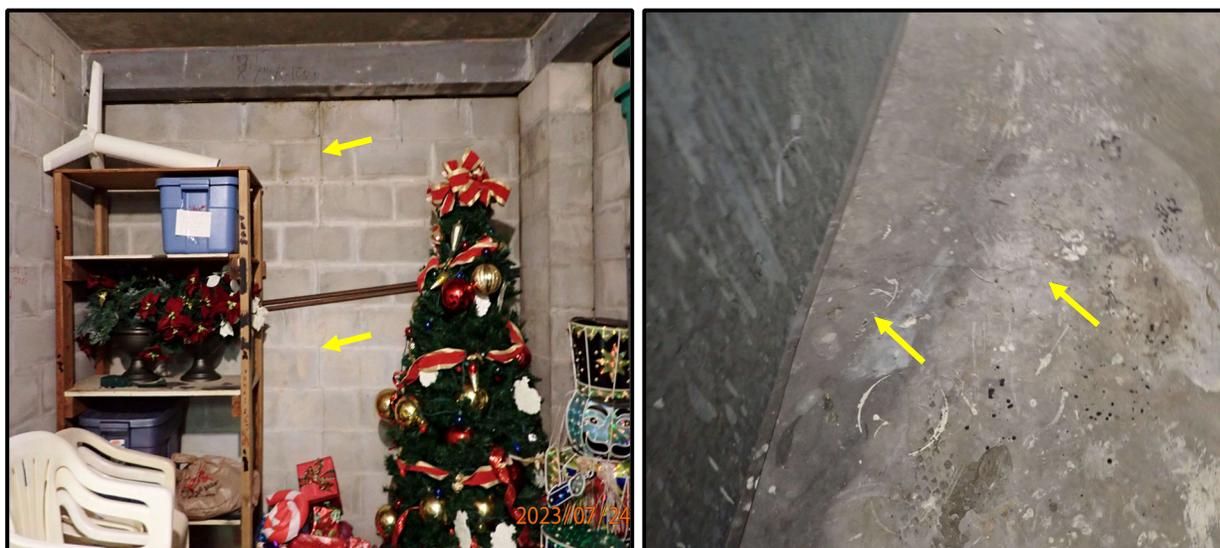
Figure 9. Representative photographs of cracks on CMU walls and concrete slabs at common rooms in Core building.

Vertical and horizontal cracking was observed on the building's core on the CMU walls of the storage rooms. CMU and mortar are brittle materials and are likely to crack when subjected to expansion and contraction and differential movement. The observed cracks are due to the movement of the core throughout its life. Similarly observed, were cracks on the concrete slab on grade on the first-floor electrical and storage rooms. The observed cracks are due to the expansion and contraction of the slab and typical settlement of the soils below the structure. Recommendations for repairs and monitoring of the cracks is provided in Exhibit A. Representative photographs of this observation are shown below in **Figure 9**.

Building Number	Observation	Location	Structural damage (Y/N) If yes - extent	Substantial Structural Damage (Y/N) If yes - extent	Surface imperfection* (Y/N) If yes - extent	Dangerous as defined by the Florida Building Code? (Y/N)	Recommendations (maintenance, repair, replace, or monitor)	Further (Phase 2) inspection required? (Y/N)
85	Stair step mortar crack on the CMU wall.	1st story elevator machine room. Right wall, when standing at the entry door.	No	No	Y - Localized as noted in the location column, crack measuring hairline width.	No	Repair - Seal cracks with high-strength epoxy or mortar.	No
85	Crack on the slab.	1st story elevator machine room, 1st story north storage room, 1st story electrical room, 2nd story north storage room and 2nd story south storage room.	No	No	Y - Localized, cracks measuring hairline width.	No	Repair - Seal cracks with high-strength epoxy.	No

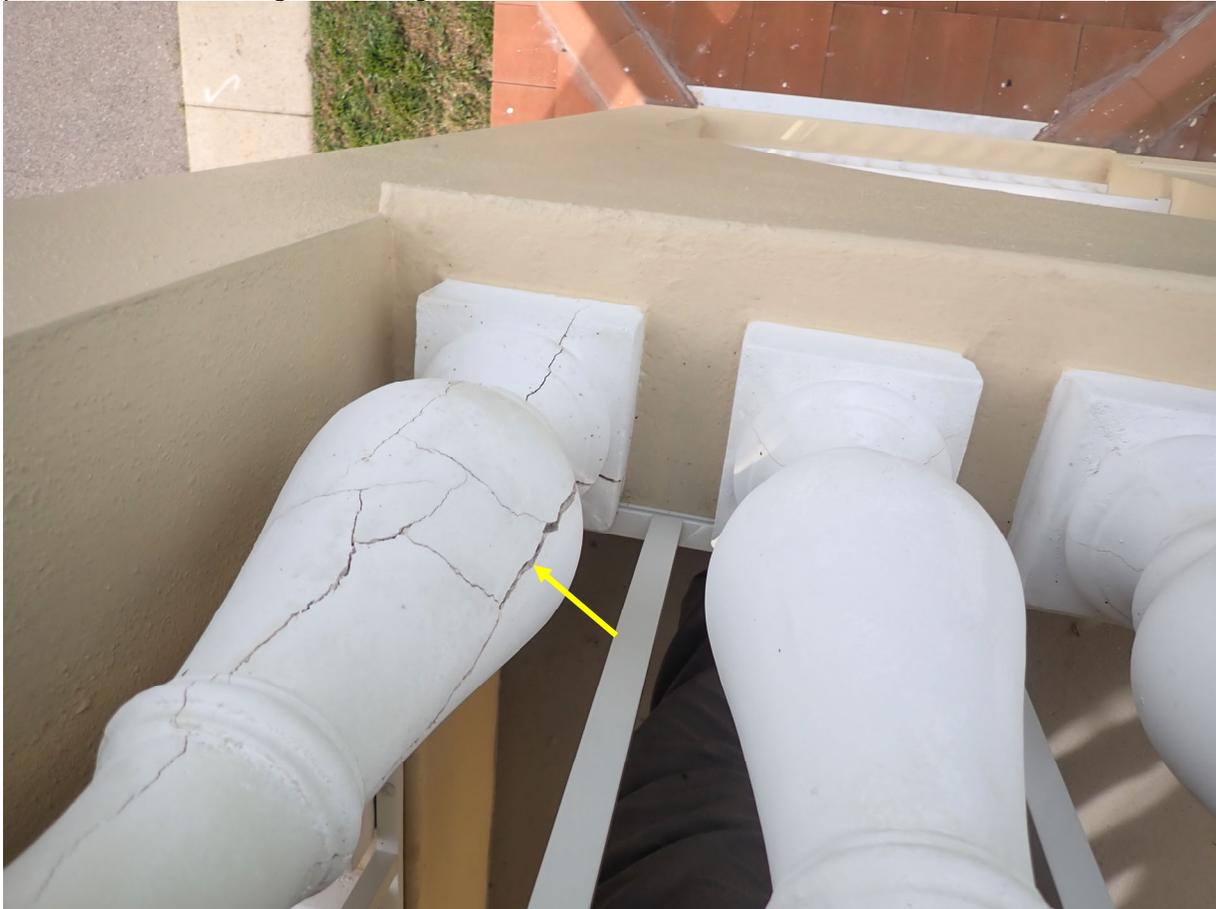
Figure 10. Photograph of cracking of decorative railing

The building's exterior architectural features consisted of a decorative railing with exposed columns which extended from the roof to the slab. The railings and columns were constructed of a painted cementitious material. A secondary metal railing was installed in the interior and on top of the decorative railing, which was in good condition. Evidence of deterioration of the decorative railings in the form of cracking was observed throughout the building (**Figure 10**). This is not structural damage, yet it is recommended that the decorative railing be repaired to prevent spalled pieces from detaching and falling.

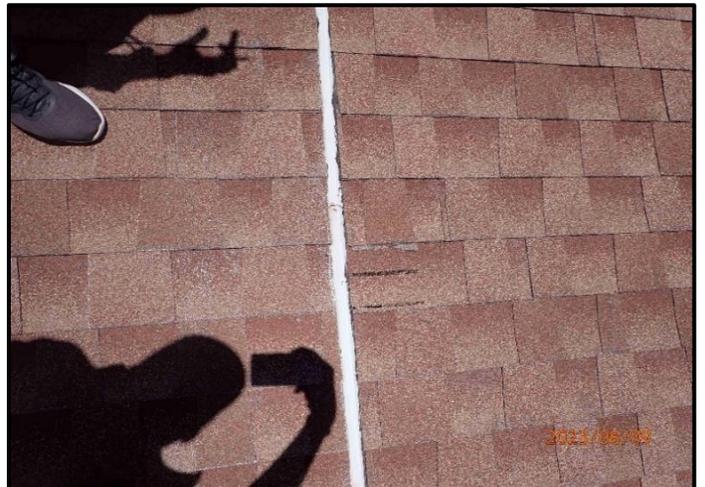
Photograph 04 - View of missing laminate tab in the central portion of roof.

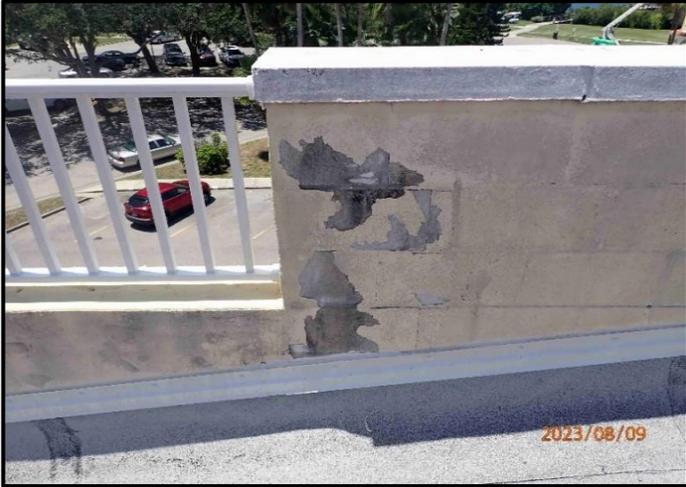
Photograph 05 - View of delaminating paint finish in southeast portion of roof.

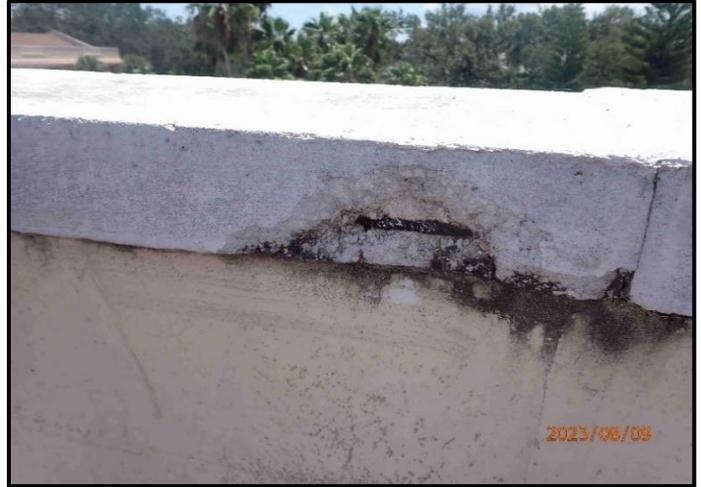
Photograph 06 - View of exposed reinforcement in southwest portion of roof.

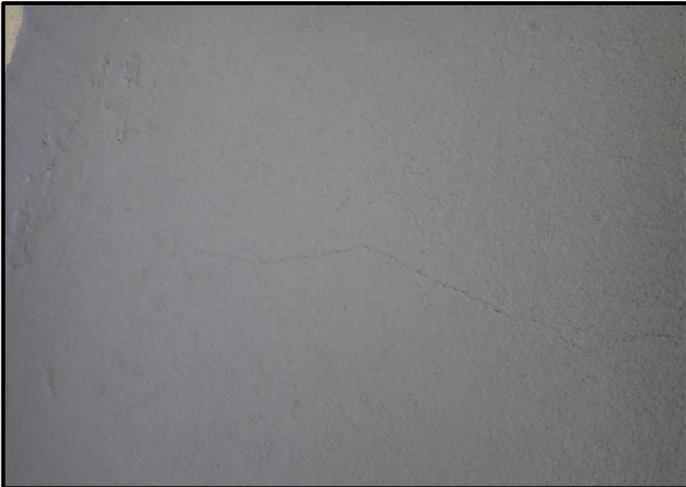
Photograph 07 - View of a crack in the elevated walkway surface perpendicular to the building near unit 48.

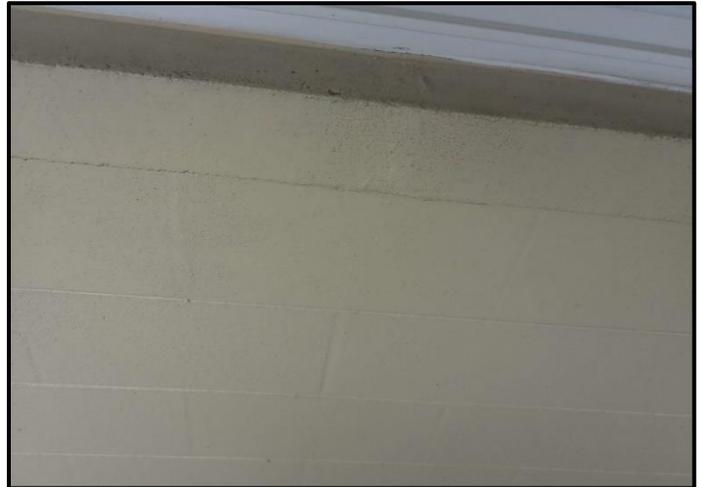
Photograph 08 - View of previous repair to stair step crack near unit 54.

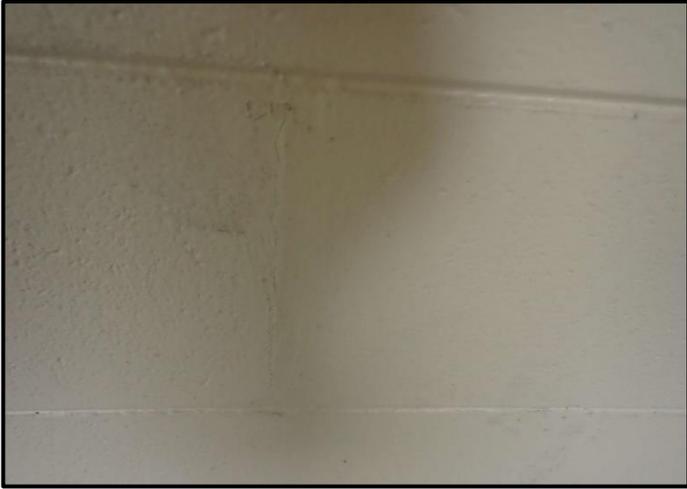
Photograph 09 - View of previous repair to stair step crack with a hairline re-opening near unit 44.

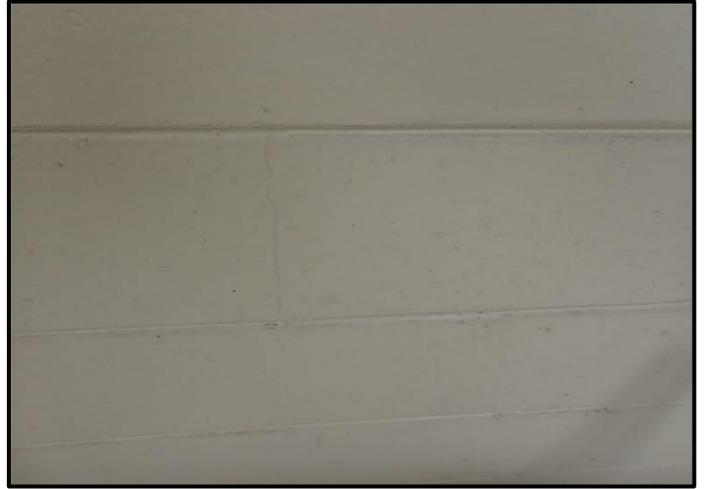
Photograph 10 - View of stair step mortar crack near unit 3.

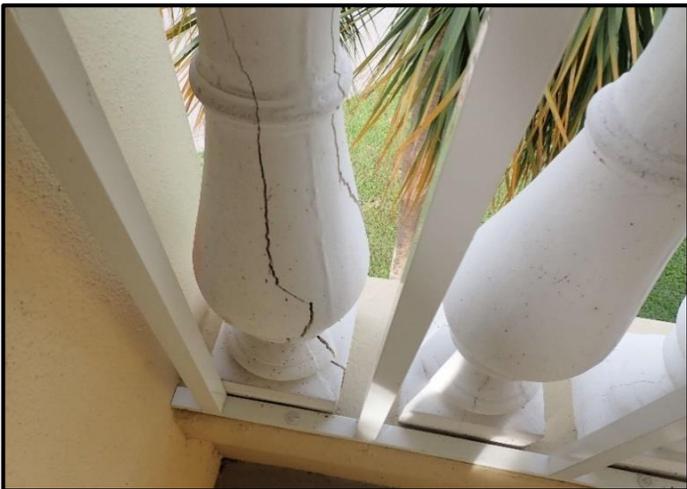
Photograph 11 - View of cracked concrete railing near unit 38.

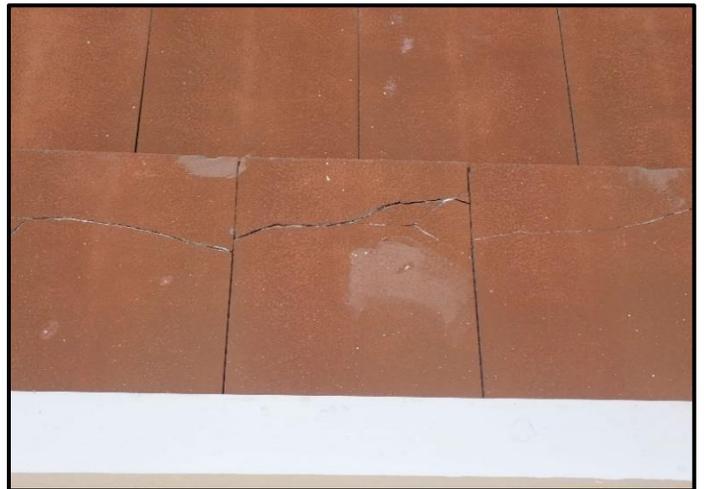
Photograph 12 - View of cracked decorative roof tiles in southwest wing.

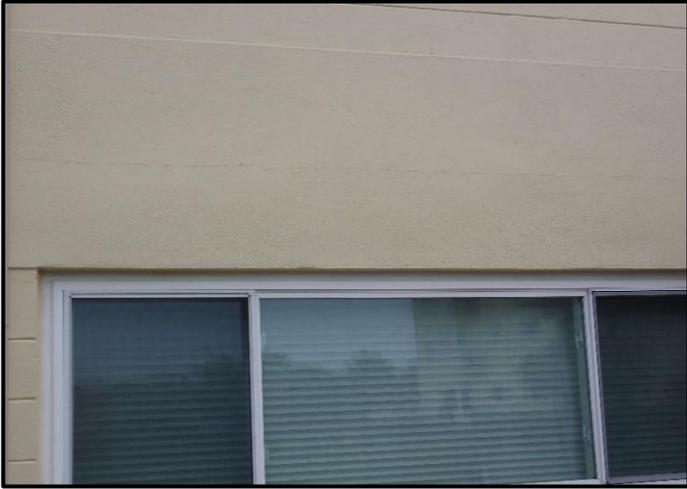
Photograph 13 - View of previous repair to stucco above window in rear elevation of unit 15.

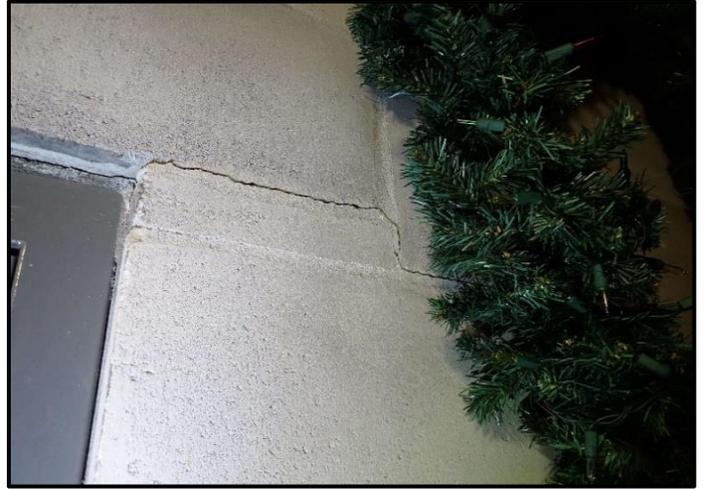
Photograph 14 - View of mortar separation on CMU right wall within 1st story elevator machine room.

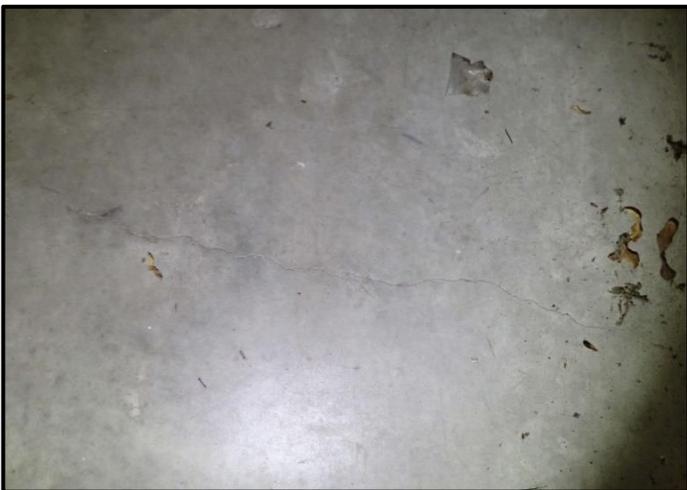
Photograph 15 - View of slab crack in 1st story north storage room.

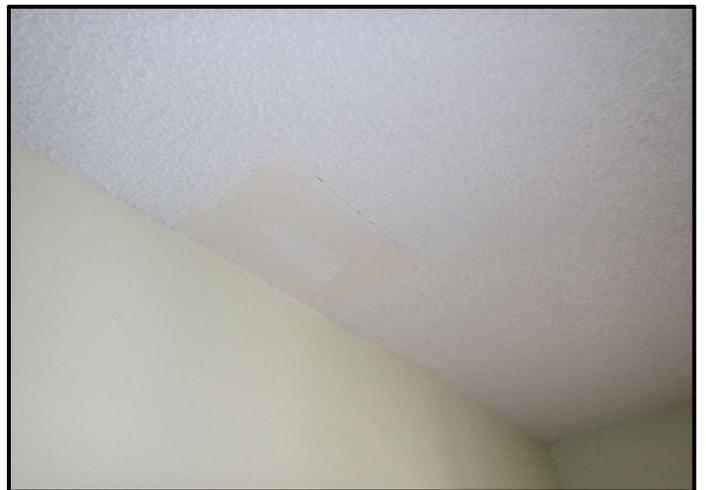
Photograph 16 - View of previously repaired section of ceiling in unit 6.
