Phase 1 Milestone Inspection Report

On Top of the World Clearwater

Building 88

ESi Project No: 98508

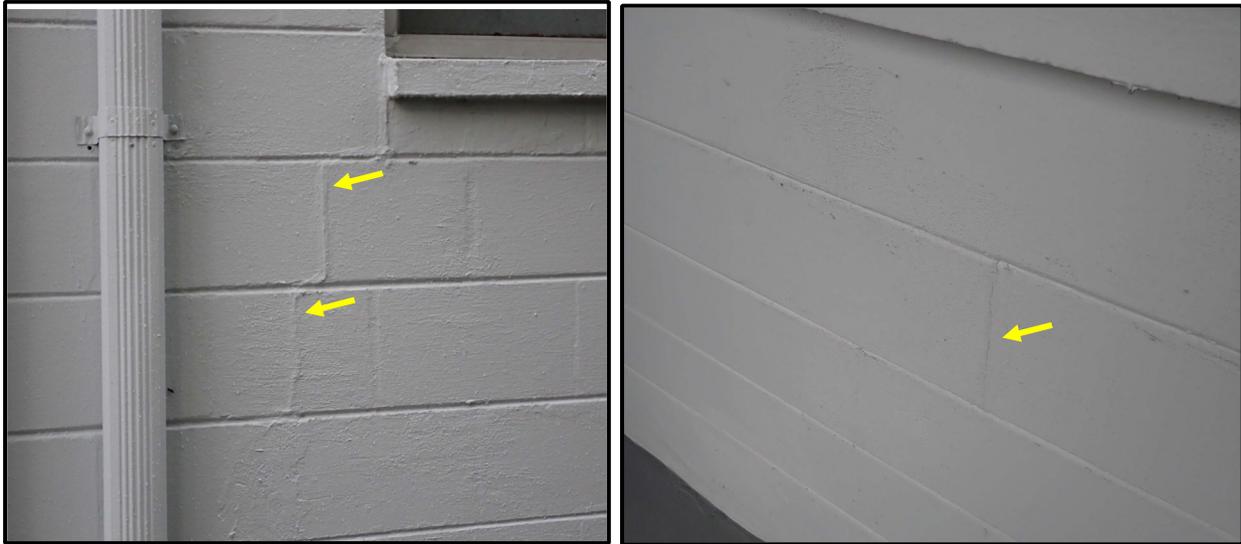
Stairstep cracks, both previously repaired and those appearing to be recent, on the CMU bearing walls of the wings particularly below windows and near the core were typically observed throughout the elevations of the building. Stairstep cracks are cracks in the mortar joints and form due to the movement of the structure, as mortar is a brittle material. The observed width and location of the cracks represent typical movement from a structure (commonly due to soil settlement) and do not appear to be indicative of structural damage. Recommendation for repairs and monitoring of the cracks is provided in Exhibit A. Representative photographs of this observation are shown below in **Figure 7**.

Figure 7. Representative photographs of step stair cracks at CMU walls.

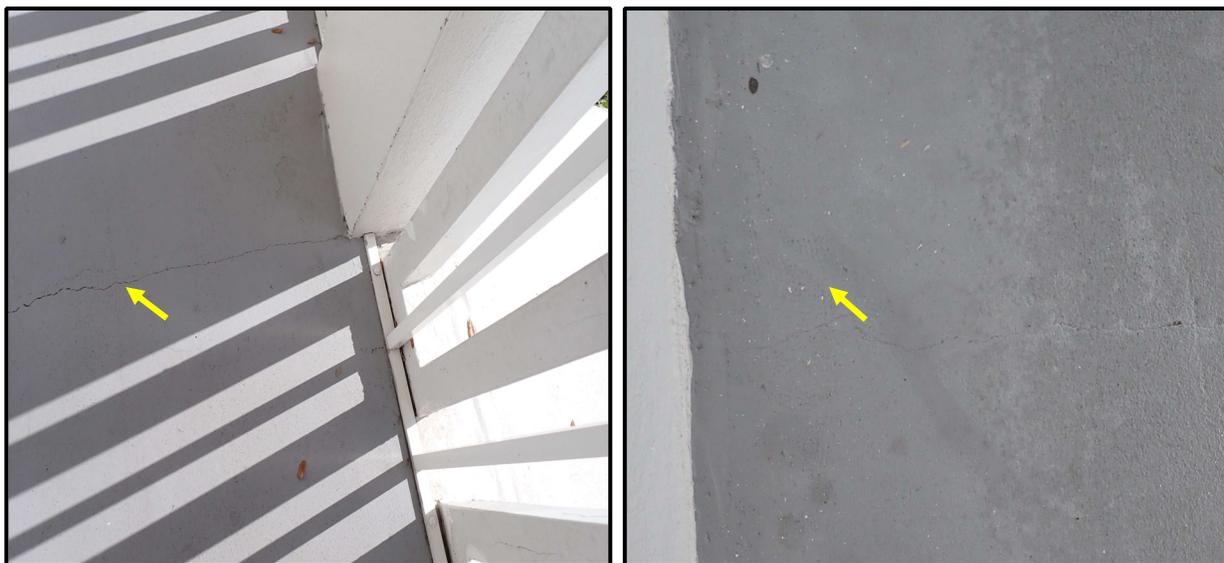
Cracks on the exterior hallway floor slabs were observed perpendicular to the length of the slab and the supporting wall. The observed cracks were typically hairline cracks and shallow. The cracks had weathered edges and dirt on the inside, representing they are historical in nature. The frequency and spacing of these cracks were not uniform. The observed cracks in the subject building are likely due to the expansion and contraction of the materials where control joints were not observed or due to the deflection of the slab at support locations and do not represent a structural damage or substantial deterioration. Recommendation for repairs and monitoring of the cracks is provided in Exhibit A. Representative photographs of this observation are shown below in **Figure 8**.

Figure 8. Representative photographs of shallow cracks at top surface of the exterior hallway.

| Building Number | Observation | Location | Structural damage (Y/N) If yes - extent | Substantial Structural Damage (Y/N) If yes - extent | Surface imperfection* (Y/N) If yes - extent | Dangerous as defined by the Florida Building Code? (Y/N) | Recommendations (maintenance, repair, replace, or monitor) | Further (Phase 2) inspection required? (Y/N) |
|---|--|---|--|--|---|--|--|--|
| 88 | Shallow line cracks at the top face of the concrete slab of the exterior walkway perpendicular to the wall, consistent throughout all walkways. In some locations hairline cracks perpendicular to the walkway observed on the bottom face of the concrete slab. | Exterior walkways. | No | No | Yes / perpendicular single cracks throughout all walkways | No | Seal hairline cracks with high-strength epoxy. | No |

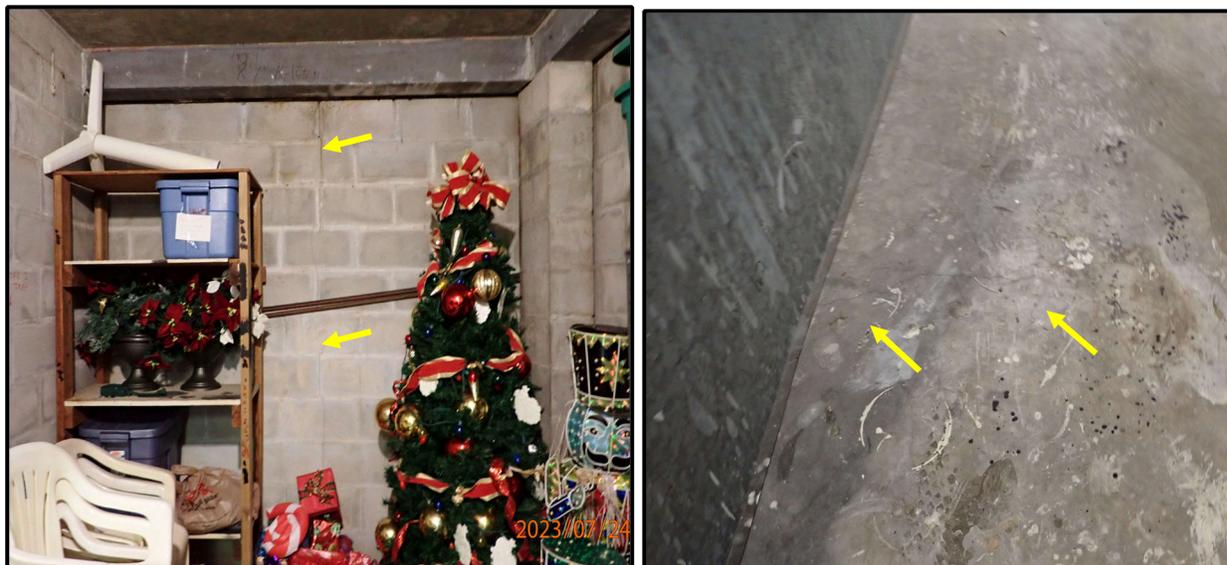
Vertical and horizontal cracking was observed on the building's core on the CMU walls of the storage rooms. CMU and mortar are brittle materials and are likely to crack when subjected to expansion and contraction and differential movement. The observed cracks are due to the movement of the core throughout its life. Similarly observed, were cracks on the concrete slab on grade on the first-floor electrical and storage rooms. The observed cracks are due to the expansion and contraction of the slab and typical settlement of the soils below the structure. Recommendations for repairs and monitoring of the cracks is provided in Exhibit A. Representative photographs of this observation are shown below in **Figure 9**.

Figure 9. Representative photographs of cracks on CMU walls and concrete slabs at common rooms in Core building.

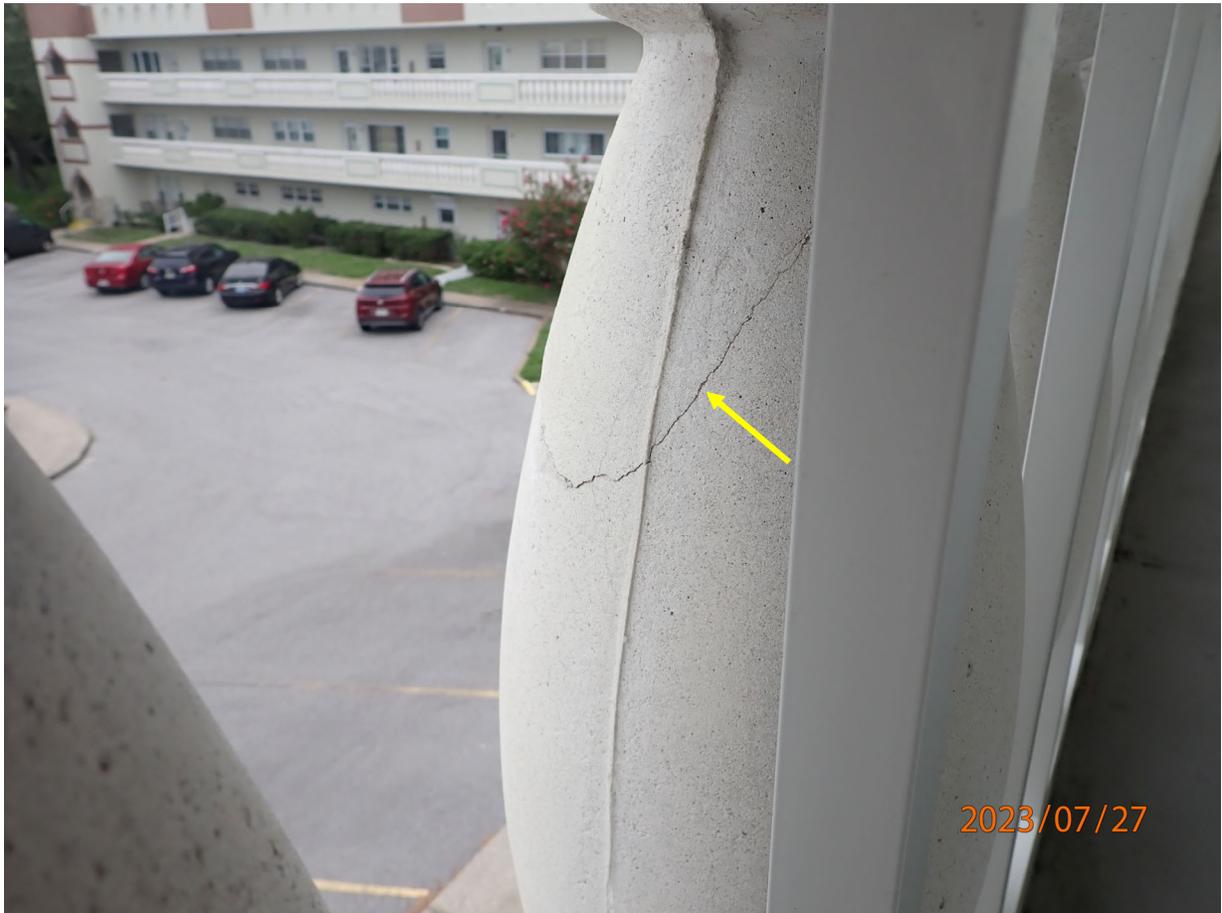
The building's exterior architectural features consisted of a decorative railing with exposed columns which extended from the roof to the slab. The railings and columns were constructed of a painted cementitious material. A secondary metal railing was installed in the interior of the decorative railing, which was in good condition. Evidence of deterioration of the decorative railings in the form of cracking was observed throughout the building (**Figure 10**). This is not structural damage, yet it is recommended that the decorative railing be repaired to prevent spalled pieces from detaching and falling.

Figure 10. Representative photograph of cracking of decorative railing

| Building Number | Observation | Location | Structural damage (Y/N) If yes - extent | Substantial Structural Damage (Y/N) If yes - extent | Surface imperfection* (Y/N) If yes - extent | Dangerous as defined by the Florida Building Code? (Y/N) | Recommendations (maintenance, repair, replace, or monitor) | Further (Phase 2) inspection required? (Y/N) |
|---|--|---|--|--|---|--|--|--|
| 88 | Cracks in exterior walkway railing common, cracks typically horizontal and on the top ledge of the railings, some cracks with previous repairs. | Exterior walkway railings. | No | No | Yes / cracks throughout all walkway railings | Yes | Consider full replacement of decorative concrete railings. Perform temporary spot patches until replacement. | No |

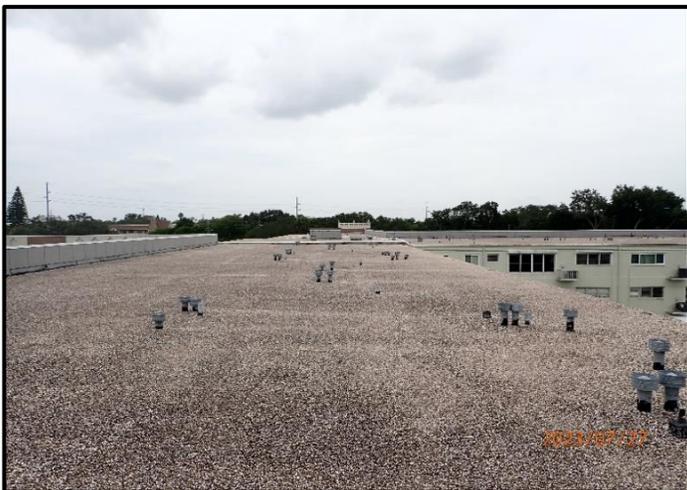
Photograph 03 - Overall view of the roof of the subject building.

| Building Number | Observation | Location | Structural damage (Y/N) If yes - extent | Substantial Structural Damage (Y/N) If yes - extent | Surface imperfection* (Y/N) If yes - extent | Dangerous as defined by the Florida Building Code? (Y/N) | Recommendations (maintenance, repair, replace, or monitor) | Further (Phase 2) inspection required? (Y/N) |
|---|--|---|--|--|---|--|--|--|
| 88 | Several localized areas of missing gravel ballast on built up roof, typically less than 5 SF each. | Roof. | No | No | Y - Localized to less than 5 SF areas | No | Maintenance recommended - add gravel ballast to areas of exposed asphalt. | No |

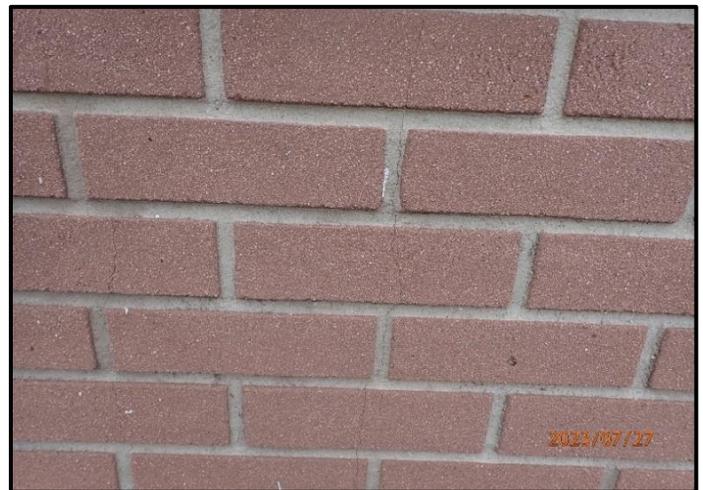
Photograph 04 - Close up view of hairline vertical cracks in the stamped brick texture on the roof turrets.

| Building Number | Observation | Location | Structural damage (Y/N) If yes - extent | Substantial Structural Damage (Y/N) If yes - extent | Surface imperfection* (Y/N) If yes - extent | Dangerous as defined by the Florida Building Code? (Y/N) | Recommendations (maintenance, repair, replace, or monitor) | Further (Phase 2) inspection required? (Y/N) |
|---|--|---|--|--|---|--|--|--|
| 88 | Vertical shallow hairline cracks in stamped brick texture. | Roof turrets. | No | No | Y - Localized as noted in the Location column. | No | Monitor. | No |

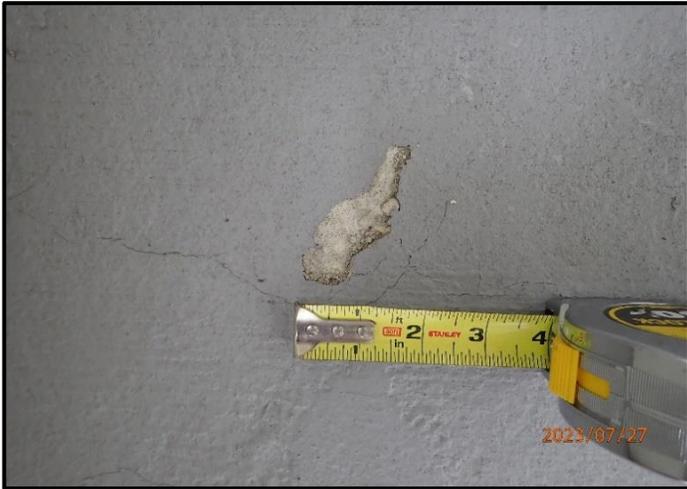
Photograph 05 - View of a spall in the exterior walkway surface at the front elevation of unit 52.

| Building Number | Observation | Location | Structural damage (Y/N) If yes - extent | Substantial Structural Damage (Y/N) If yes - extent | Surface imperfection* (Y/N) If yes - extent | Dangerous as defined by the Florida Building Code? (Y/N) | Recommendations (maintenance, repair, replace, or monitor) | Further (Phase 2) inspection required? (Y/N) |
|---|--|---|--|--|---|--|--|--|
| 88 | Exterior walkway surface chip, spall, or delamination - localized to less than 1 SF area. | Front elevation of units: 52, 27. | No | No | Y - Localized as noted in the Location column. | No | Repair - Remove loose or spalled surface, patch and resurface with resurfacing mixture. | No |

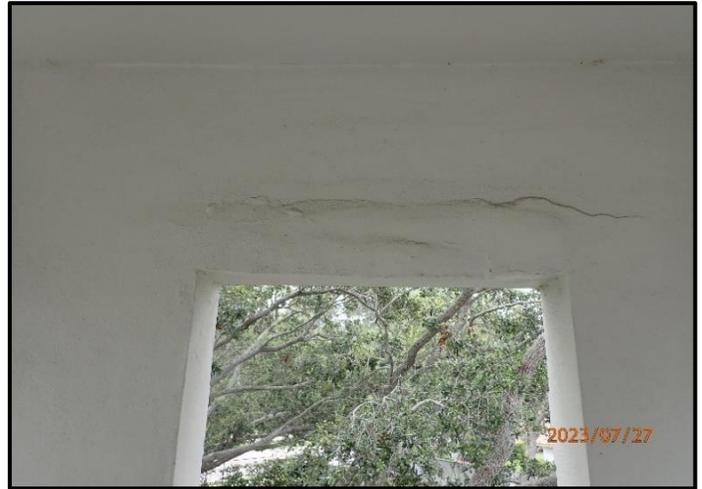
Photograph 06 - View of the typical stucco delamination above the stairway viewports.

| Building Number | Observation | Location | Structural damage (Y/N) If yes - extent | Substantial Structural Damage (Y/N) If yes - extent | Surface imperfection* (Y/N) If yes - extent | Dangerous as defined by the Florida Building Code? (Y/N) | Recommendations (maintenance, repair, replace, or monitor) | Further (Phase 2) inspection required? (Y/N) |
|---|---|---|--|--|--|--|--|--|
| 88 | Stucco delamination - localized to less than 10 SF areas and typically above stair landing viewports. | All stairways each level. | No | No | Y - Localized as noted in the Location column. | No | Repair - Remove loose or delaminated stucco and patch with new stucco wall cladding. | No |

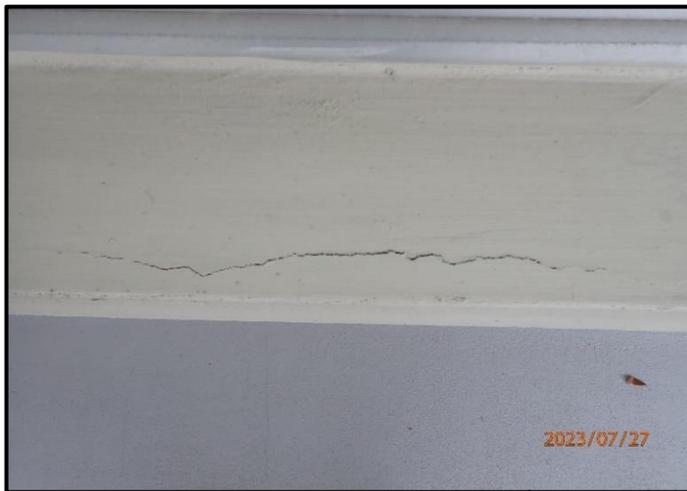
Photograph 07 - View of the horizontal crack in the window sill at the front elevation of unit 23.

| Building Number | Observation | Location | Structural damage (Y/N) If yes - extent | Substantial Structural Damage (Y/N) If yes - extent | Surface imperfection* (Y/N) If yes - extent | Dangerous as defined by the Florida Building Code? (Y/N) | Recommendations (maintenance, repair, replace, or monitor) | Further (Phase 2) inspection required? (Y/N) |
|---|---|---|--|--|--|--|--|--|
| 88 | Horizontal crack at concrete window sill. 0.04" width. | Front elevation of unit: 23. | No | No | Y - Localized as noted in the Location column. | No | Repair - Seal crack with high-strength epoxy or mortar. | No |

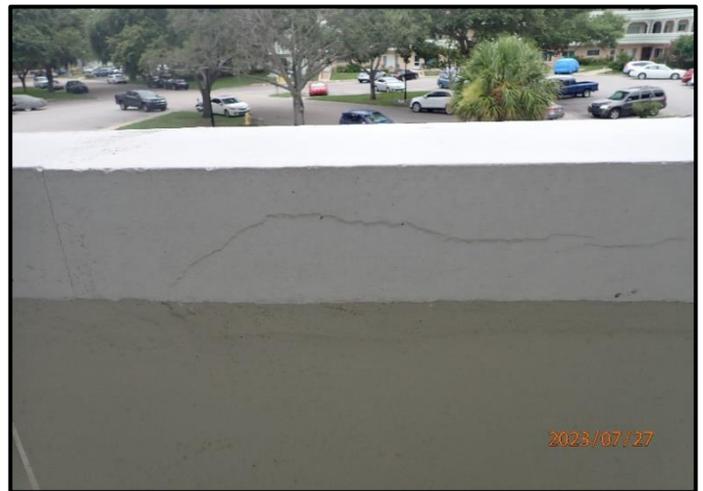
Photograph 08 - Close up view of typical cracks in the top ledge of the exterior walkway railings.

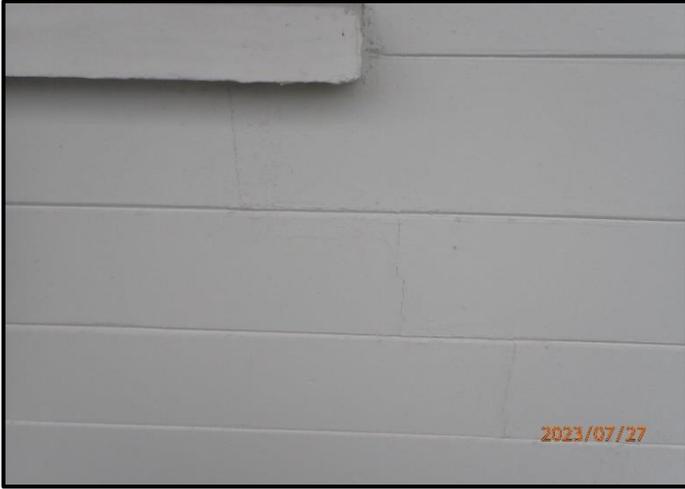
Photograph 09 - View of a stair step crack below a window at the front elevation of unit 24.

| Building Number | Observation | Location | Structural damage (Y/N) If yes - extent | Substantial Structural Damage (Y/N) If yes - extent | Surface imperfection* (Y/N) If yes - extent | Dangerous as defined by the Florida Building Code? (Y/N) | Recommendations (maintenance, repair, replace, or monitor) | Further (Phase 2) inspection required? (Y/N) |
|---|--|--|--|--|--|--|--|--|
| 88 | Stair step mortar shallow hairline crack in CMU wall. | Front elevation of units: 60, 56, 36, 24, 22, 15. 1st floor storage, 3rd floor storage. | No | No | Y - Localized as noted in the Location column. | No | Monitor. | No |

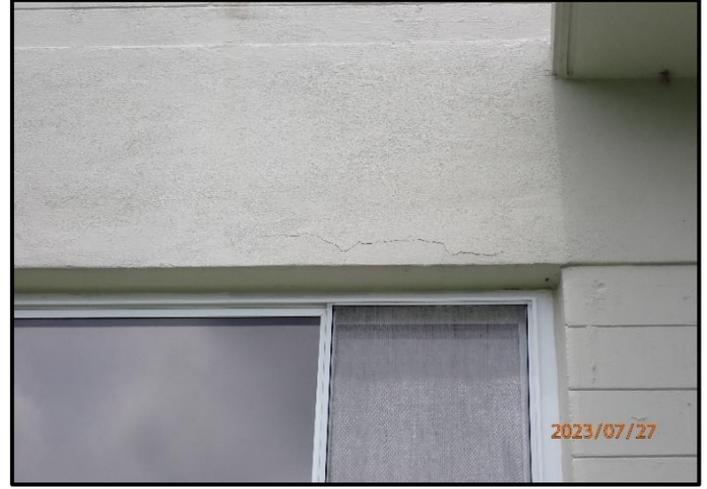
Photograph 10 - View of the typical condition of cracked or delaminated stucco at previous repairs over windows on the rear elevation.

| Building Number | Observation | Location | Structural damage (Y/N) If yes - extent | Substantial Structural Damage (Y/N) If yes - extent | Surface imperfection* (Y/N) If yes - extent | Dangerous as defined by the Florida Building Code? (Y/N) | Recommendations (maintenance, repair, replace, or monitor) | Further (Phase 2) inspection required? (Y/N) |
|---|--|--|--|--|--|--|--|--|
| 88 | Surface patch (Previous repair) to stucco wall cladding common on rear elevation above windows and doors. Cracks and delamination of stucco at previous repair common. | Rear elevation above windows and doors. | No | No | Y - Localized as noted in the Location column. | No | Repair - Remove loose or delaminated stucco and patch with new stucco wall cladding. | No |

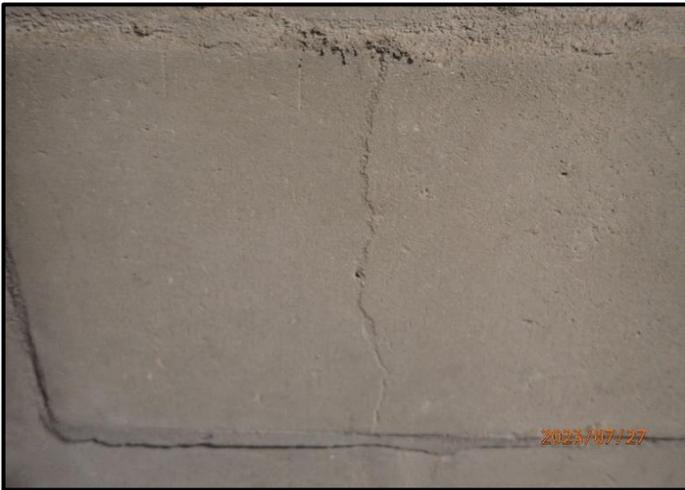
Photograph 11 - Close up view of the cracked CMU block in the elevator machine and bike storage room.

| Building Number | Observation | Location | Structural damage (Y/N) If yes - extent | Substantial Structural Damage (Y/N) If yes - extent | Surface imperfection* (Y/N) If yes - extent | Dangerous as defined by the Florida Building Code? (Y/N) | Recommendations (maintenance, repair, replace, or monitor) | Further (Phase 2) inspection required? (Y/N) |
|---|---|---|--|--|--|--|---|--|
| 88 | Cracked CMU block. | Elevator machine room / bike storage room, 1st floor storage. | Y - Localized CMU | No | Y - Localized as noted in the Location column. | No | Repair - Seal crack with high-strength epoxy or mortar. Locally replace cracked CMUs with in-kind materials if broken full depth. | No |

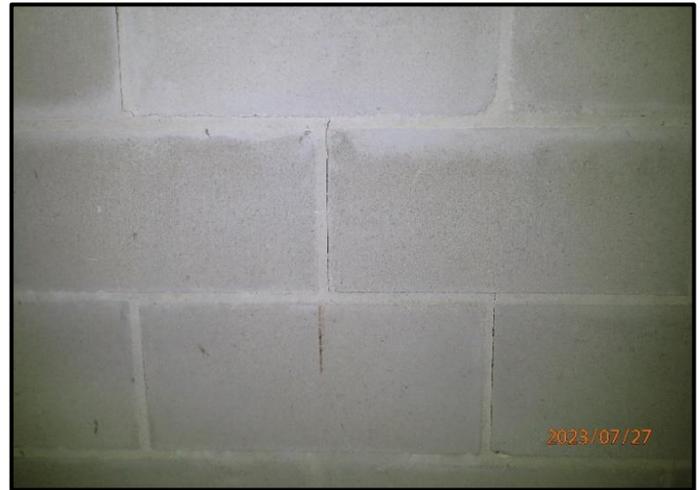
Photograph 12 - Close up view of the stair step mortar crack in the CMU wall in the north storage room.

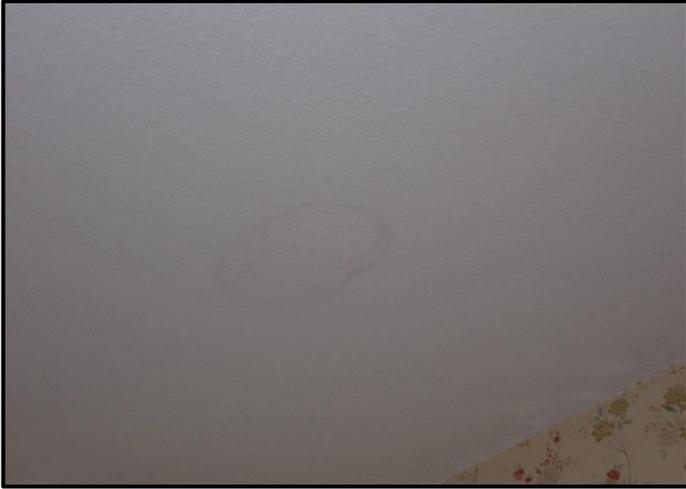
Moisture staining on the finishes was observed in locations noted in Exhibit B. The moisture staining does not represent a structural damage or deterioration. It was also observed that some of these stains were historical, and that the source of the moisture had been repaired. At areas where the moisture source is unknown, it is recommended that the location is investigated and that the source be repaired.

Photograph 13 - Moisture staining on ceiling of unit 14.

| Building Unit | Observations | Substantial Structural Damage (Y/N) If yes - extent | Surface imperfection* (Y/N) If yes - extent | Further (Phase 2) inspection required? (Y/N) | Recommendations (maintenance, repair, replace, or monitor) |
|---|---|--|--|--|--|
| B88:14 | Water stain on ceiling above shower in master bathroom. | No | As noted in observation. | No | Verify if moisture damage is due to active leak and if so, repair damage and source. |
