Phase 1 Milestone Inspection Report

On Top of the World Clearwater

Building 89

ESi Project No: 98508

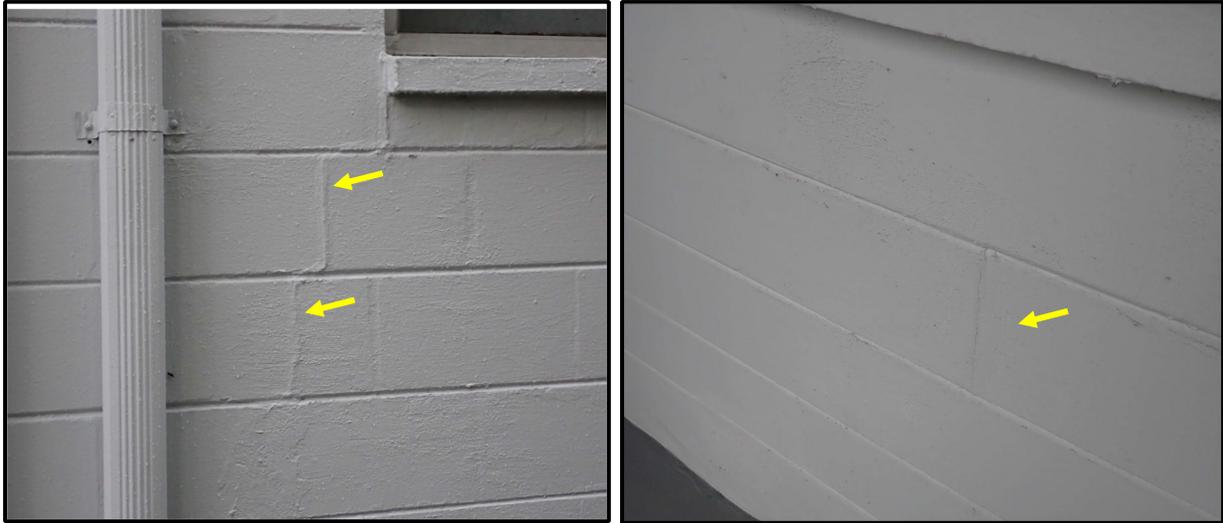
Stairstep cracks, both previously repaired and those appearing to be recent, on the CMU bearing walls of the wings particularly below windows and near the core were typically observed throughout the elevations of the building. Stairstep cracks are cracks in the mortar joints and form due to the movement of the structure, as mortar is a brittle material. The observed width and location of the cracks represent typical movement from a structure (commonly due to soil settlement) and do not appear to be indicative of structural damage. Recommendation for repairs and monitoring of the cracks is provided in Exhibit A. Representative photographs of this observation are shown below in **Figure 7**.

Figure 7. Representative photographs of step stair cracks at CMU walls.

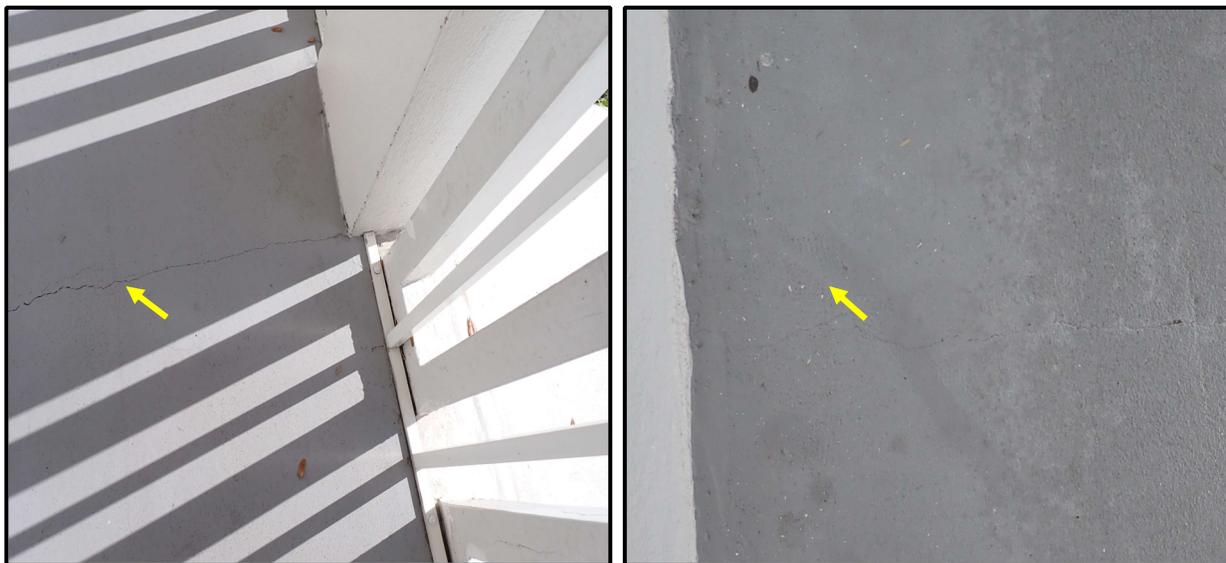
Cracks on the exterior hallway floor slabs were observed perpendicular to the length of the slab and the supporting wall. The observed cracks were typically hairline cracks and shallow. The cracks had weathered edges and dirt on the inside, representing they are historical in nature. The frequency and spacing of these cracks were not uniform. The observed cracks in the subject building are likely due to the expansion and contraction of the materials where control joints were not observed or due to the deflection of the slab at support locations and do not represent a structural damage or substantial deterioration. Recommendation for repairs and monitoring of the cracks is provided in Exhibit A. Representative photographs of this observation are shown below in **Figure 8**.

Figure 8. Representative photographs of shallow cracks at top surface of the exterior hallway.

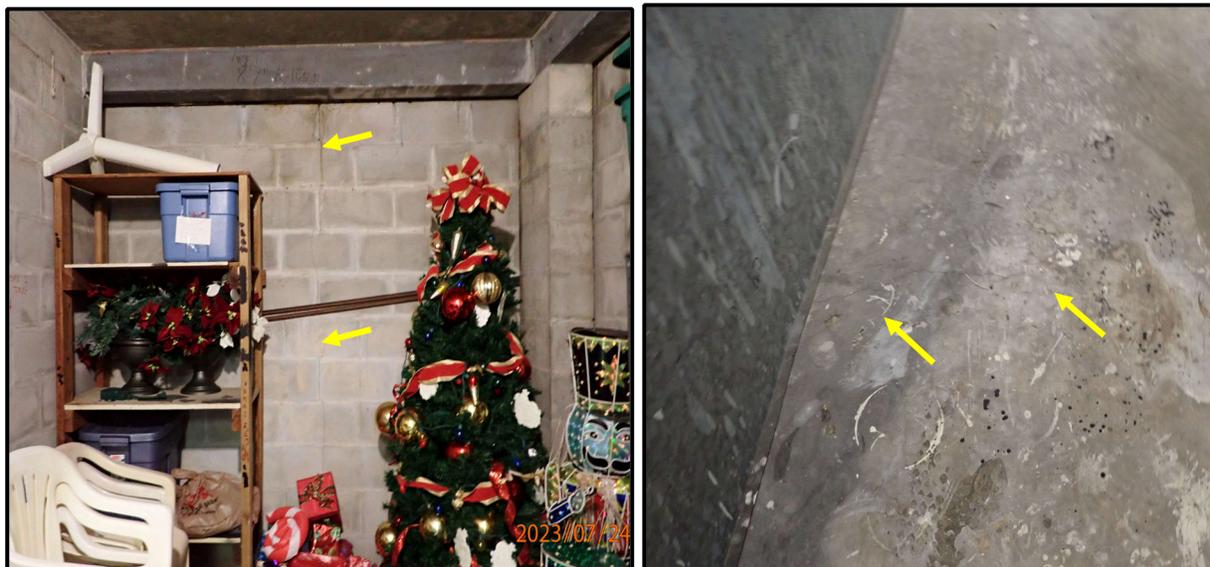
Vertical and horizontal cracking was observed on the building's core on the CMU walls of the storage rooms. CMU and mortar are brittle materials and are likely to crack when subjected to expansion and contraction and differential movement. The observed cracks are due to the movement of the core throughout its life. Similarly observed, were cracks on the concrete slab on grade on the first-floor electrical and storage rooms. The observed cracks are due to the expansion and contraction of the slab and typical settlement of the soils below the structure. Recommendations for repairs and monitoring of the cracks is provided in Exhibit A. Representative photographs of this observation are shown below in **Figure 9**.

Figure 9. Representative photographs of cracks on CMU walls and concrete slabs at common rooms in Core building.

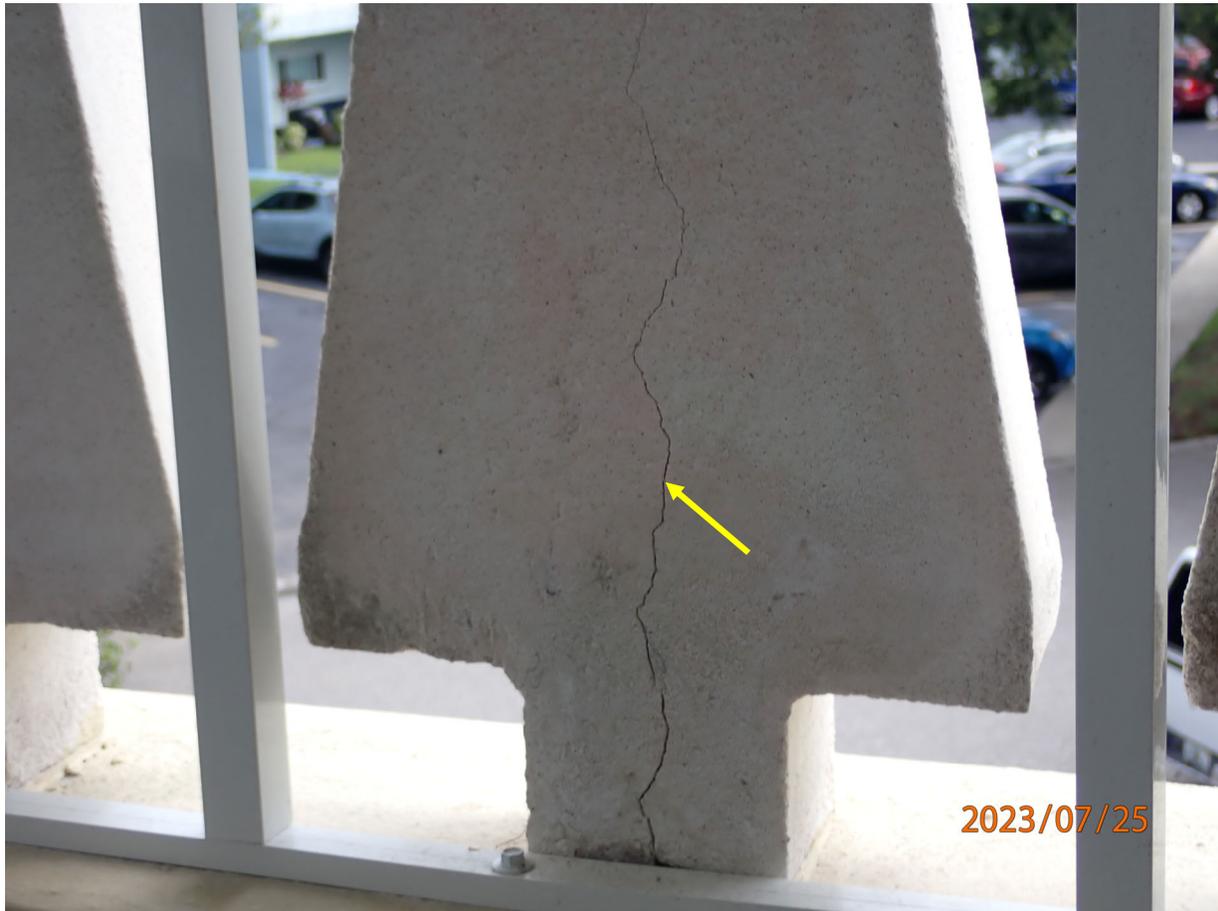
The building's exterior architectural features consisted of a decorative railing with exposed columns which extended from the roof to the slab. The railings and columns were constructed of a painted cementitious material. A secondary metal railing was installed in the interior of the decorative railing, which was in good condition. Evidence of deterioration of the decorative railings in the form of cracking was observed throughout the building (**Figure 10**). This is not structural damage, yet it is recommended that the decorative railing be repaired to prevent spalled pieces from detaching and falling.

Figure 10. Representative photograph of cracking of decorative railing

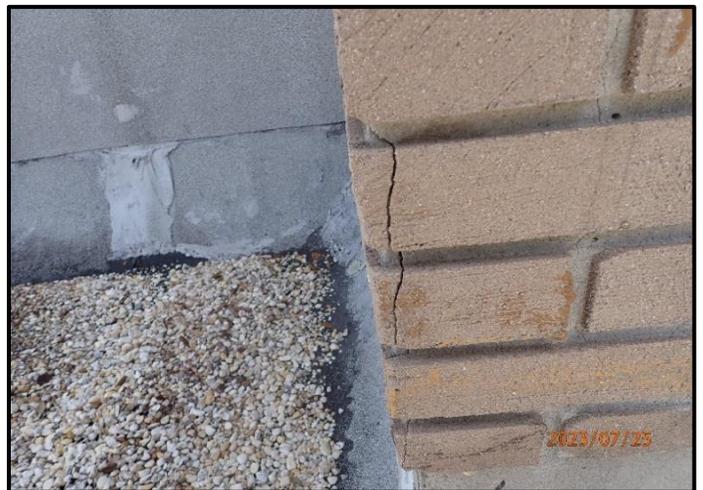
Photograph 04 - Close up view of a vertical crack in stamped brick texture on a roof turret.

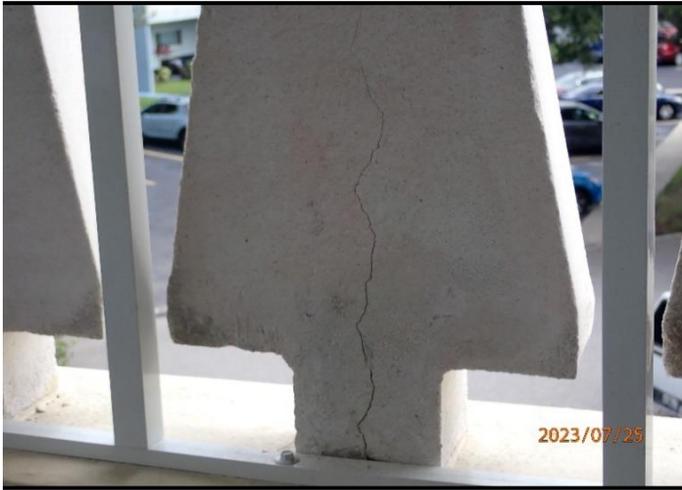
Photograph 05 - View of typical vertical crack at exterior walkway railing baluster.

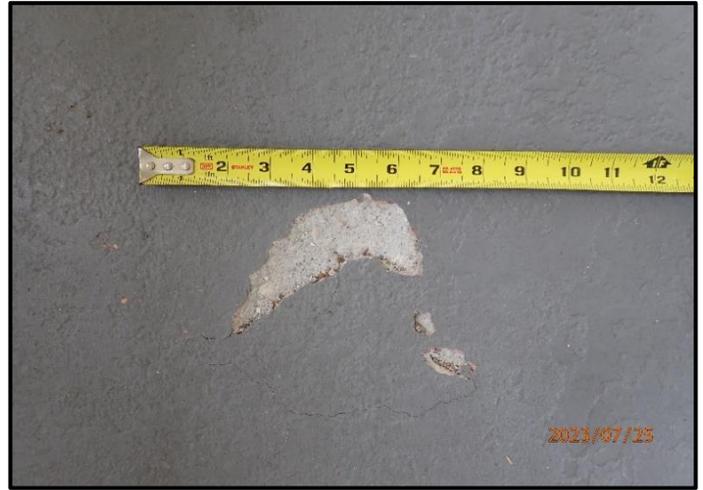
Photograph 06 - View of exterior walkway surface delamination at the front elevation of unit 73.

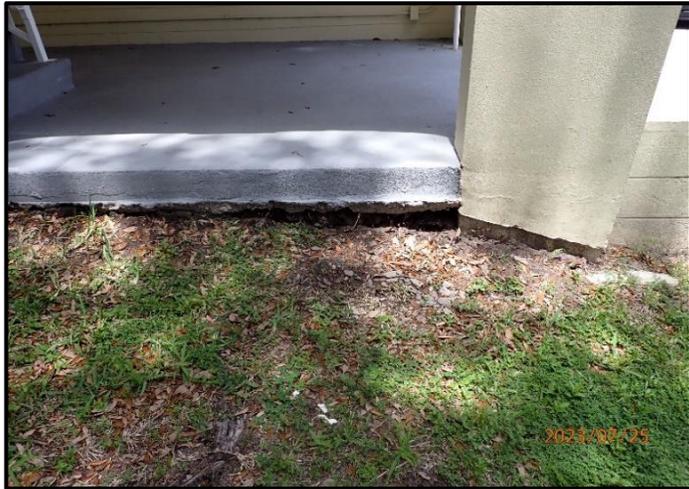
Photograph 07 - View of washout beneath the first floor stair landing at the southwest stair.

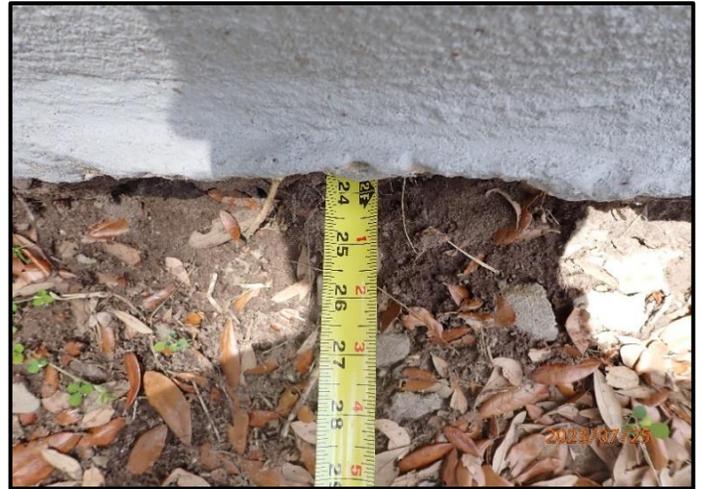
Photograph 08 - Close up view of washout beneath the first floor stair landing at the southwest stair.

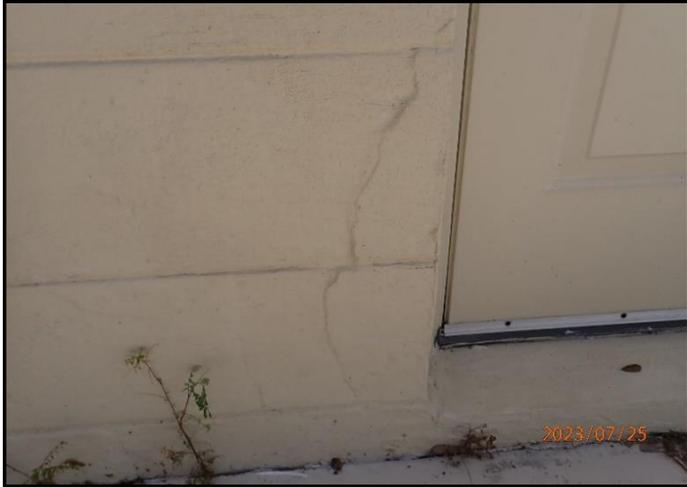
Photograph 09 - View of a previous repair to a vertical crack at the door sill at the rear elevation of unit 11.

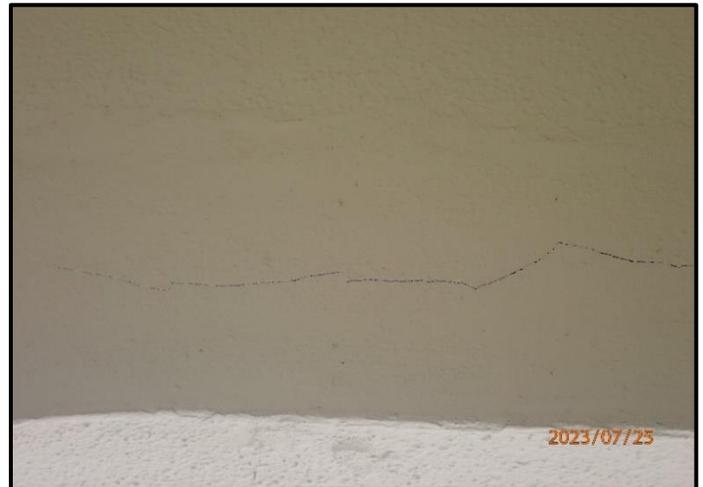
Photograph 10 - Close up view of stucco delamination at the southeast stair 3rd floor.

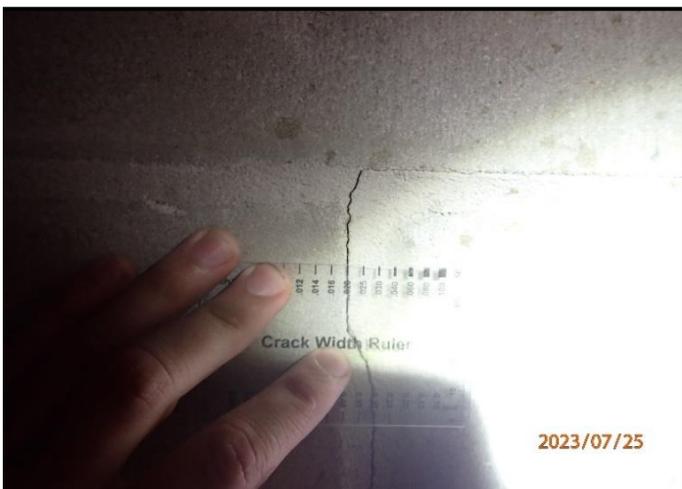
89	Stair step mortar shallow crack in CMU wall. 0.02" width.	1st floor large storage.	No	No	Y - Localized as noted in the Location column.	No	Repair - Seal crack with high-strength epoxy or mortar.	No
89	Horizontal crack in stucco wall cladding over CMU wall.	Northwest stair 3rd floor.	No	No	Y - Localized as noted in the Location column.	No	Repair - Remove loose or delaminated stucco and patch with new stucco wall cladding. Inspect CMU when uncovered and repair damage.	No
89	Surface patch (previous repair) to vertical crack in CMU wall.	Front elevation of units: 73, 57, 72, 62, 36, 38, 49, 37, 1, 7, 12, 8. Rear elevation of units: 11 Southwest stair 1st floor.	No	No	Y - Localized as noted in the Location column.	No	Monitor.	No

Photograph 11 - Close up view of a 0.02 inch width stair step mortar crack in the 1st floor large storage room.

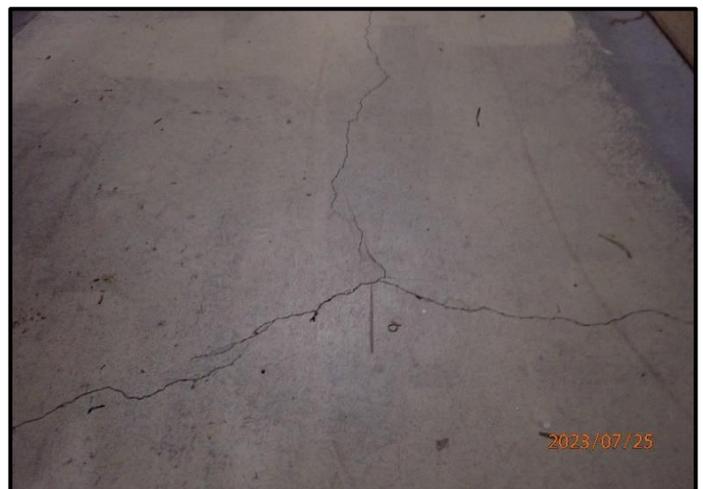
Photograph 12 - Close up view of shallow hairline slab cracks in the 1st floor large storage room.

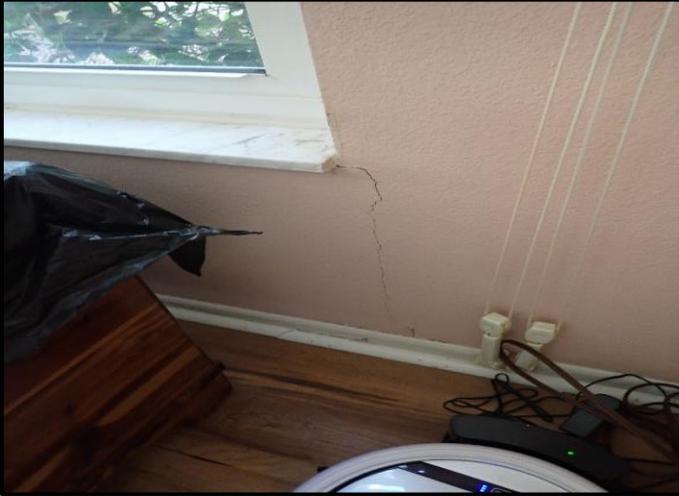
Photograph 13 - Crack on wall in unit 2.

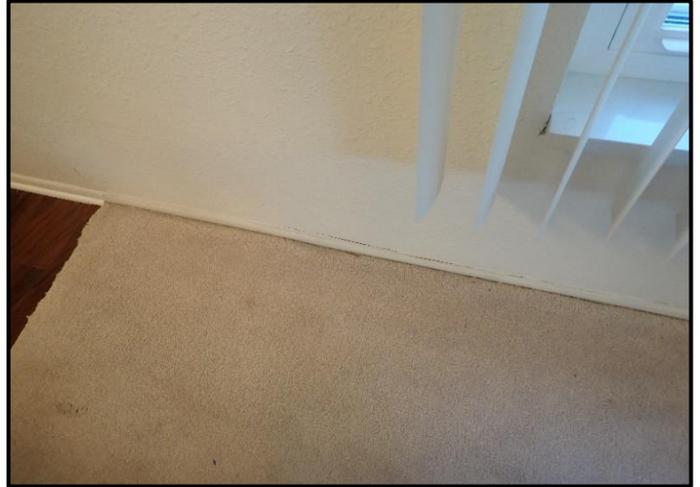
Photograph 14 - Crack along baseboard in unit 49.

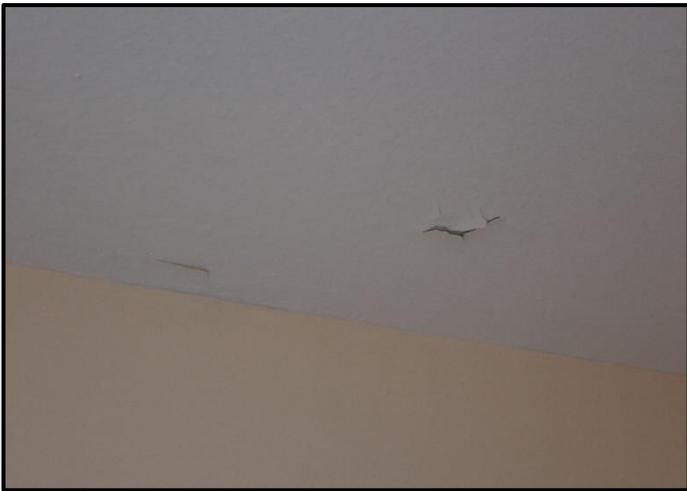
Photograph 15 - Cracks on ceiling in unit 3.
