Phase 1 Milestone Inspection Report

On Top of the World Clearwater

Building 92

ESi Project No: 98508

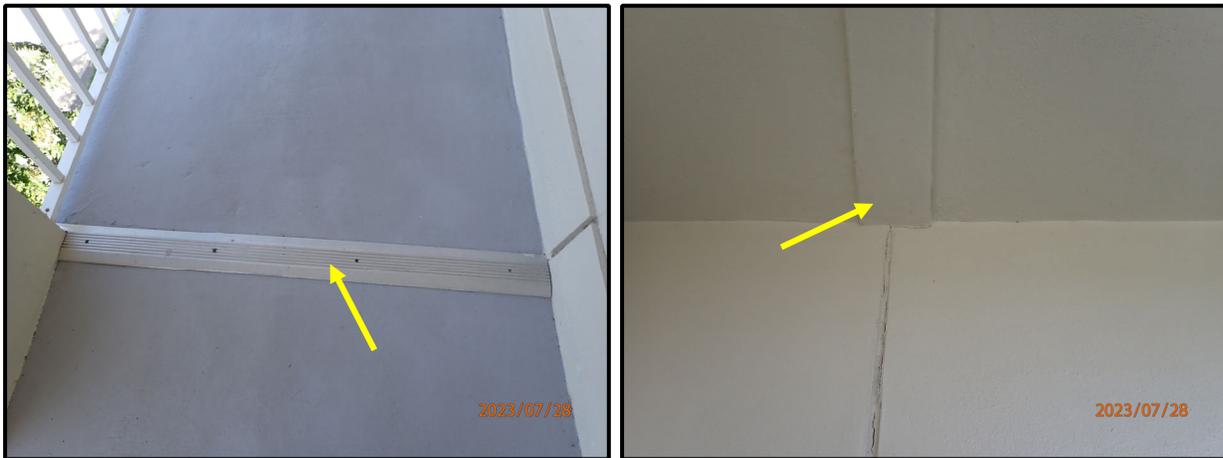
Figure 5. Representative photographs of building expansion joints at exterior corridor at top and bottom of slab.

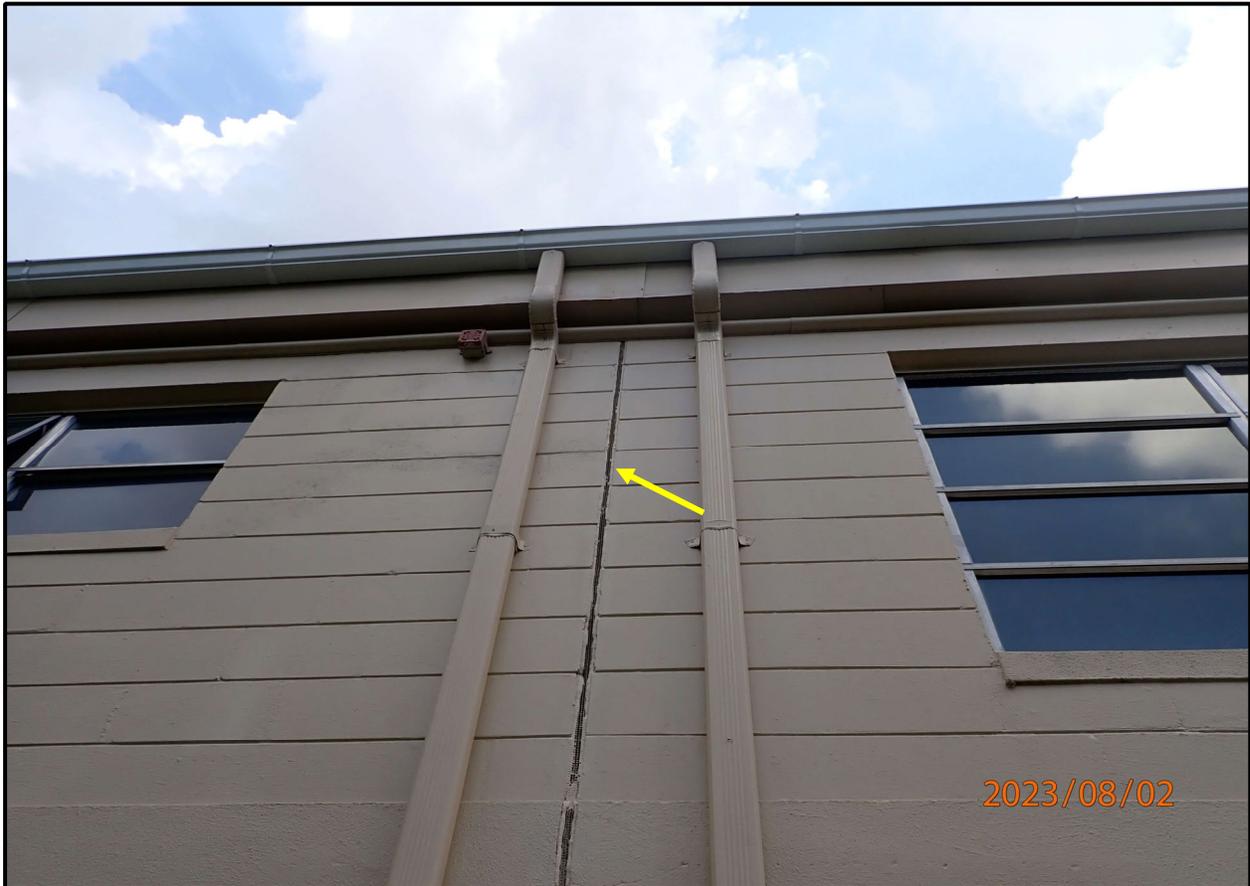
Figure 6. Representative photographs of building expansion joints at rear wall.

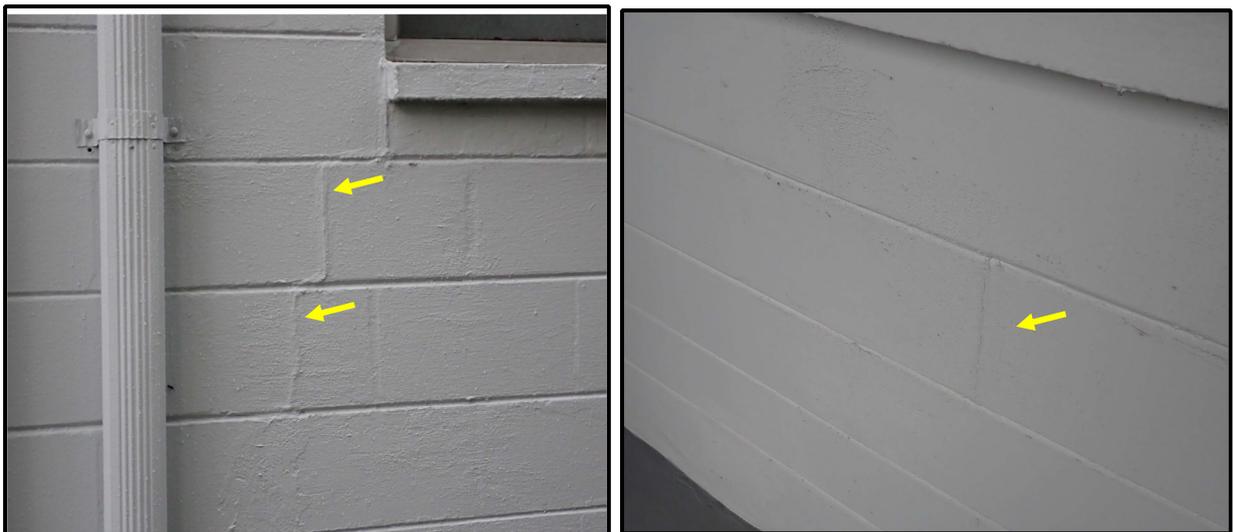
Figure 5. Representative photographs of step stair cracks at CMU walls.

Stairstep cracks, both previously repaired and those appearing to be recent, on the CMU bearing walls of the wings particularly below windows and near the core were typically observed throughout the elevations of the building. Stairstep cracks are cracks in the mortar joints and form due to the movement of the structure, as mortar is a brittle material. The observed width and location of the cracks represent typical movement from a structure (commonly due to soil settlement) and do not appear to be indicative of structural damage. Recommendation for repairs and monitoring of the cracks is provided in Exhibit A. Representative photographs of this observation are shown below in **Figure 5**.

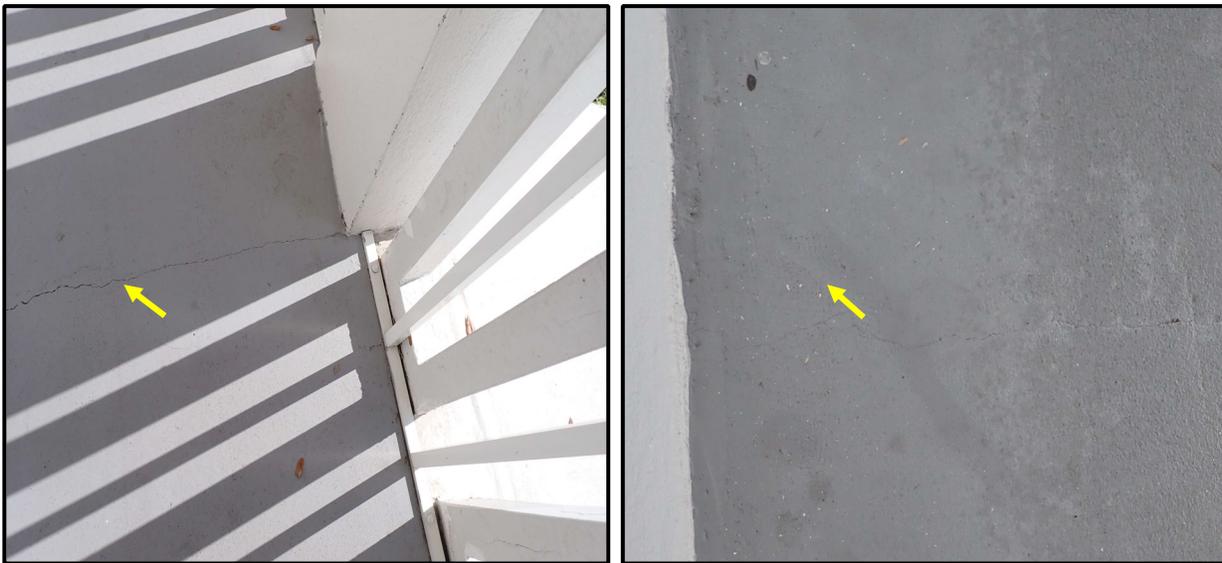
Figure 6. Representative photographs of shallow cracks at top surface of the exterior hallway.

Cracks on the exterior hallway floor slabs were observed perpendicular to the length of the slab and the supporting wall. The observed cracks were typically hairline cracks and shallow. The cracks had weathered edges and dirt on the inside, representing they are historical in nature. The frequency and spacing of these cracks were not uniform. The observed cracks in the subject building are likely due to the expansion and contraction of the materials where control joints were not observed or due to the deflection of the slab at support locations and do not represent a structural damage or substantial deterioration. Recommendation for repairs and monitoring of the cracks is provided in Exhibit A. Representative photographs of this observation are shown below in **Figure 6**.

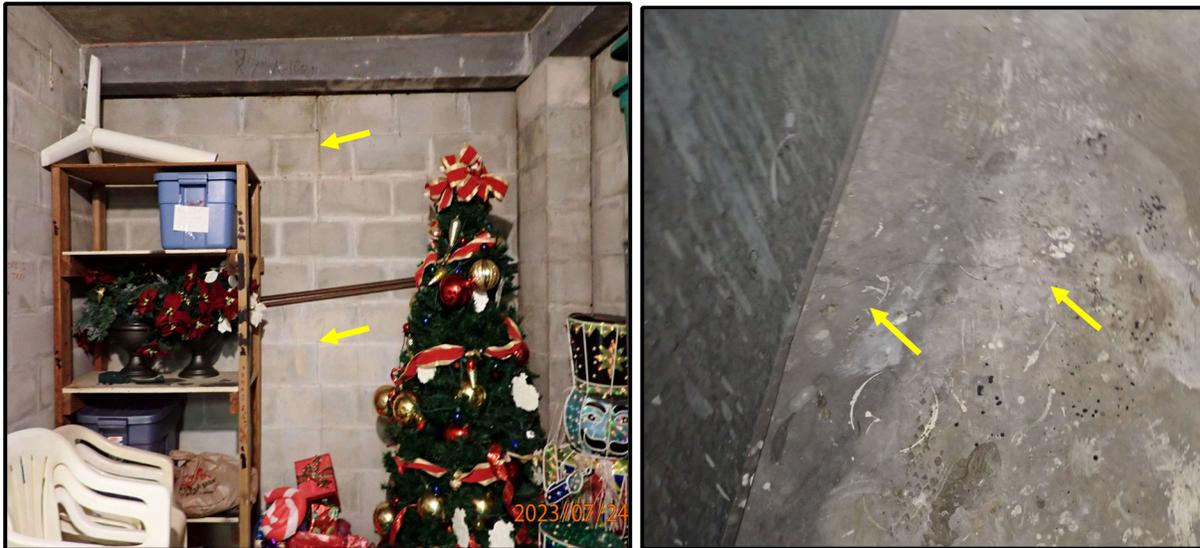
Figure 7. Representative photographs of cracks on CMU walls and concrete slabs at common rooms in Core building.

Vertical and horizontal cracking was observed on the building's core on the CMU walls of the storage rooms. CMU and mortar are brittle materials and are likely to crack when subjected to expansion and contraction and differential movement. The observed cracks are due to the movement of the core throughout its life. Similarly observed, were cracks on the concrete slab on grade on the first-floor electrical and storage rooms. The observed cracks are due to the expansion and contraction of the slab and typical settlement of the soils below the structure. Recommendations for repairs and monitoring of the cracks is provided in Exhibit A. Representative photographs of this observation are shown below in **Figure 7**.

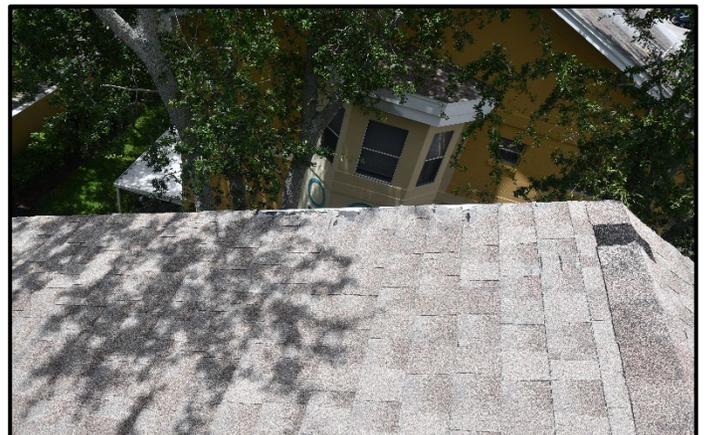
Photograph 04 - View of the asphalt shingles with abrasion damage and missing ridge shingle above unit 301.

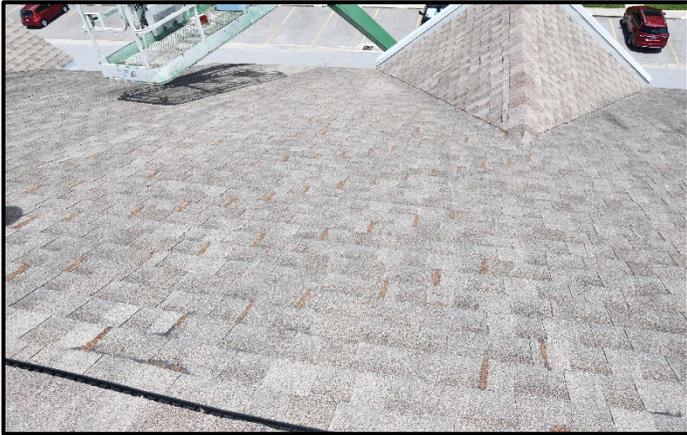
Photograph 05 - View of the previous repairs on the roof above unit 305.

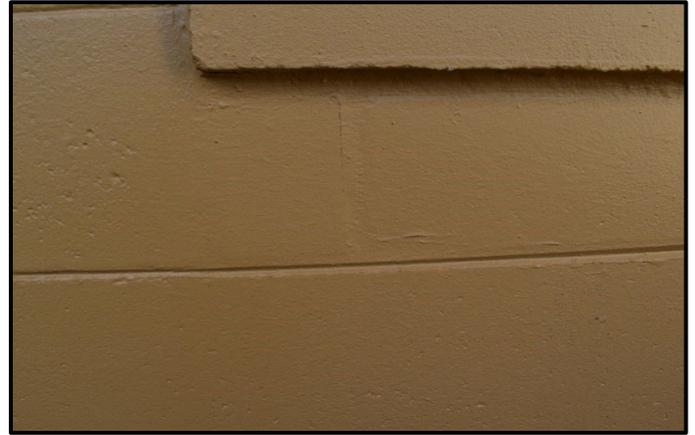
Photograph 06 - Close up view of a hairline start step mortar crack in the CMU wall at the front elevation of unit 103.

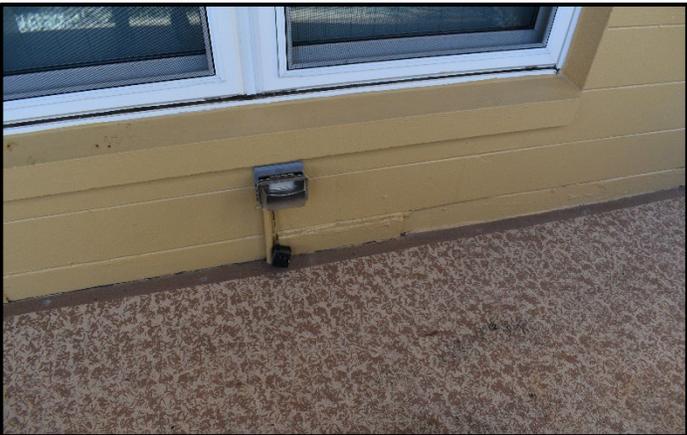
92	Displaced CMU blocks, blocks were displaced when sidewalk was poured, likely an as-built condition.	Front elevation of units: 111.	Y - Localized CMU	No	Y - Localized as noted in the Location column.	No	Repair - Seal any cracks with high-strength epoxy or mortar. Locally replace cracked CMUs with in-kind materials if broken full depth.	No
92	Shallow hairline crack in concrete slab.	3rd floor storage.	No	No	Y - Localized as noted in the Location column.	No	Monitor.	No
92	Shallow crack in concrete slab. 0.02" width.	2nd floor storage.	No	No	Y - Localized as noted in the Location column..	No	Repair - seal crack with high-strength epoxy.	No
92	Crack in concrete slab. 0.06" width.	1st floor elevator.	No	No	Y - Localized as noted in the Location column.	No	Repair - seal crack with high-strength epoxy.	No

Photograph 07 - View of a displaced CMU block at the base of the wall at the front elevation of unit 111.

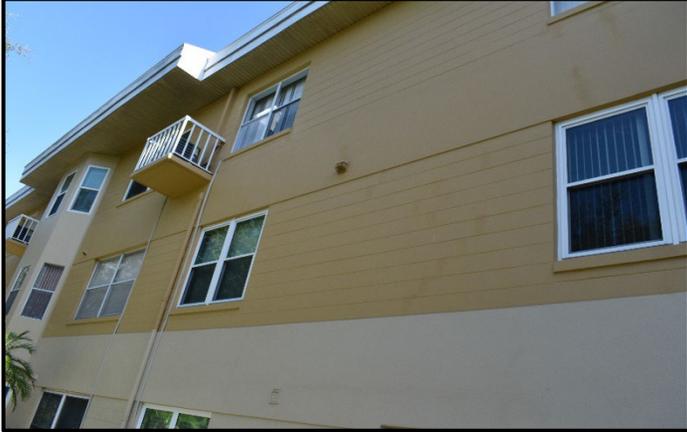
Photograph 09 - View of a previous repair to a stair step mortar crack at the rear elevation of unit 219.

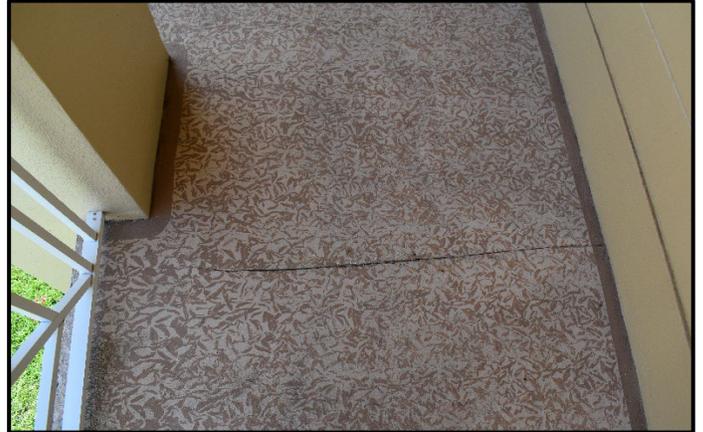
Photograph 10 - View of a typical crack in the exterior walkway surface.

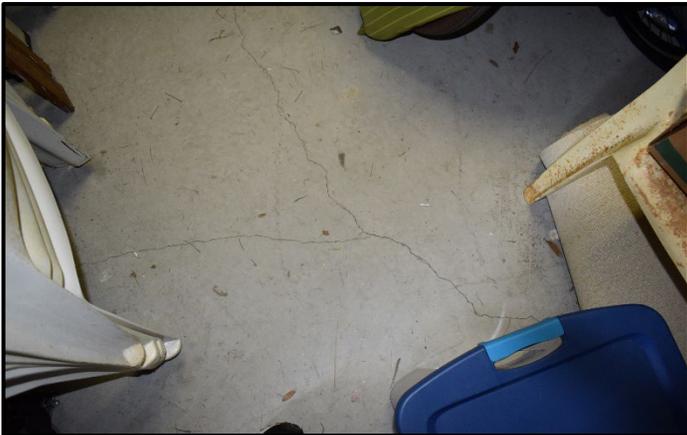
Photograph 11 - View of slab cracks in the 2nd floor storage room.
