Phase 2 Milestone Inspection

**On Top of the World Clearwater
Building 36
2340 Grecian Way and 2341 Haitian Drive
Clearwater, Florida 33763**

ESi Project No: 98508

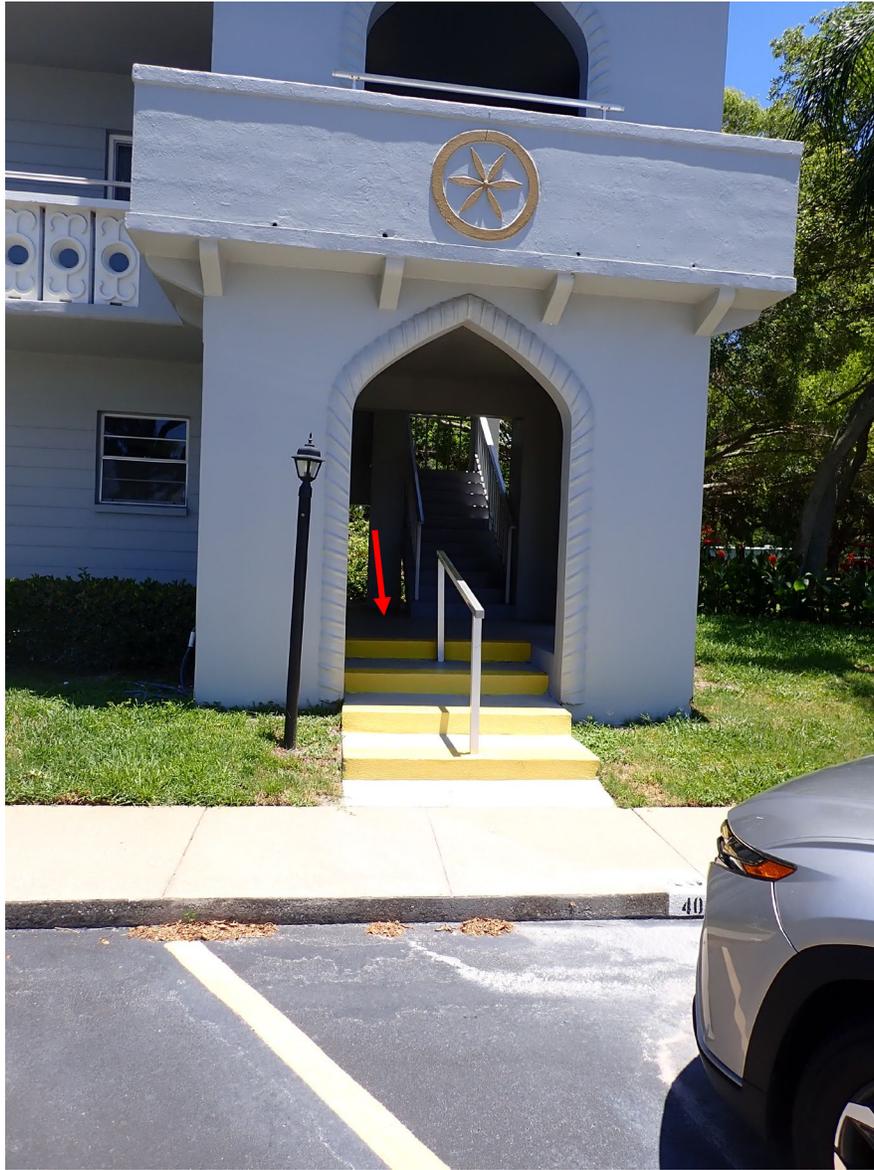
Hammer sounding of the concrete in the stairway adjacent to the first-floor landing did not reveal delaminated areas of the concrete; however, there were separations observed at the stairway to floor slab interface/joint (**Figure 2** and **Figure 3**).

The foundation for the main building is independent from the concrete slab in the first-floor landing and the stairway leading to the first-floor landing. The observed delaminated concrete at the stairways was limited to the first-floor landing and stairs leading to the first-floor landing (**Figure 2** and **Figure 3**). Based on the extent of crack on the face of the slab edge in the first-floor landing (**Figure 4**) and the observed separation at the floor slab to stairway interface/joint, the observed damage was consistent with settlement of the slab as a result of likely subsidence of the near-surface soils underlying the slab. The slab/foundation of the main building was unaffected because of the isolated damage to the first-floor landing slab. The observed cracking and settlement qualifies as a dangerous condition and shall be repaired. No substantial structural deterioration or conditions were identified in this area.

Figure 2: Overview of southeast stair and southeast stair floor slab (annotations by ESi).

It is recommended that soil stabilization via grout injection be completed beneath the subject slab on grade and stairs. Open cracking on the face of the slab edge shall be repaired by sealing the cracks with a high-strength epoxy suitable for concrete repairs and refinishing to match the existing finish in the surrounding areas. It is recommended that the repairs be completed by a contractor(s) licensed to practice in the State of Florida.

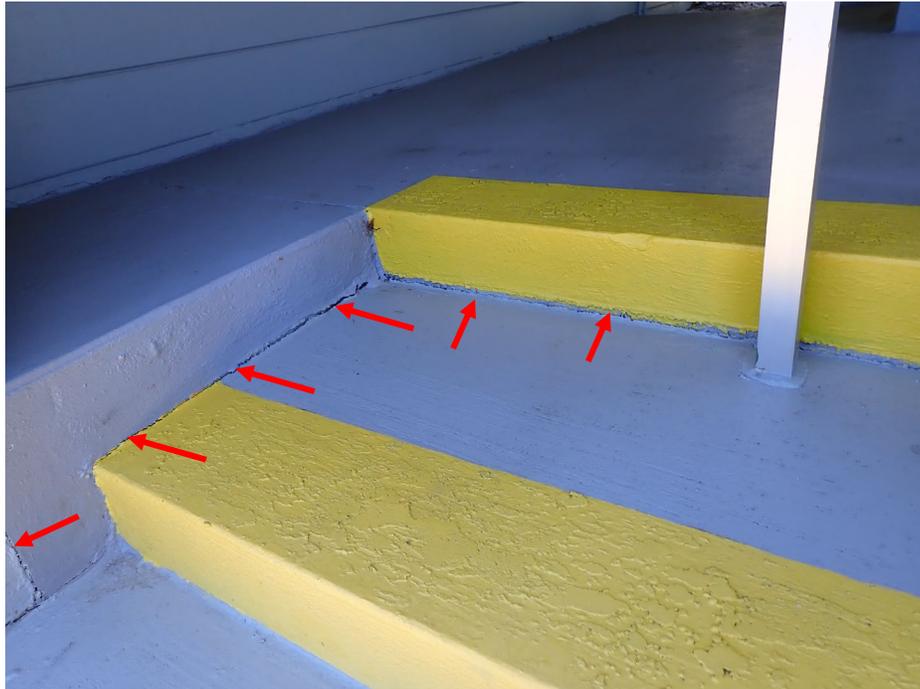
Figure 3: View of crack/separation at the stairway to floor slab interface (annotations by ESi).

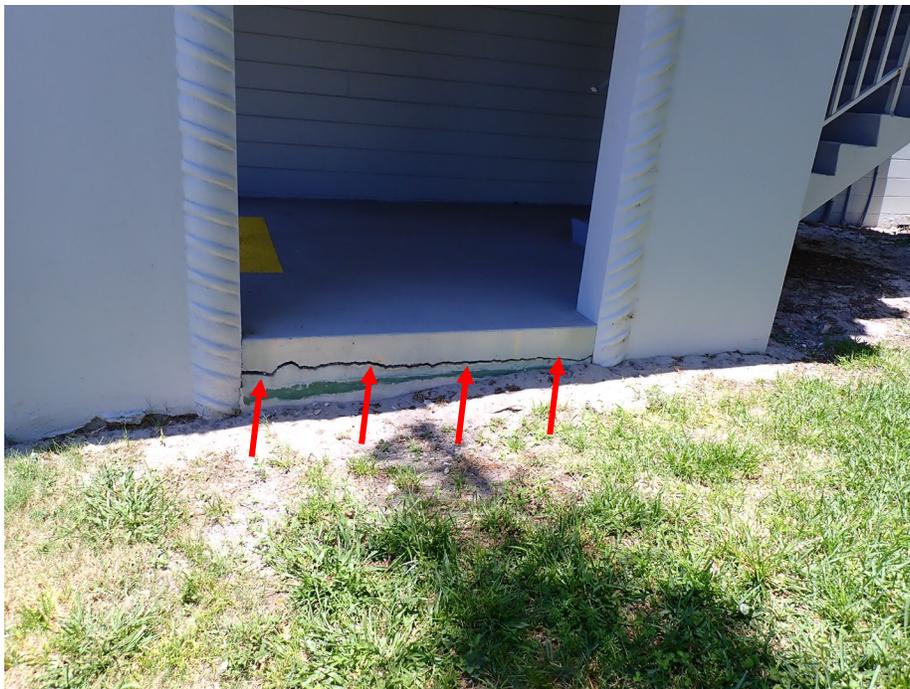
During the Phase 1 Milestone Inspections, a horizontal crack measuring approximately 6 inches deep, 0.5 inches wide and 5 feet 3 inches long was observed on the face of the slab edge of the southeast stair first floor landing. A Phase 2 Milestone Inspection was completed on the southeast first floor landing (**Figure 2**). The Phase 2 inspection consisted of hammer sounding of the slab and stairs in the first-floor landing, and visual observation of the first-floor slab and surrounding stairway for signs of settlement, damage, or displacement.

The concrete slab in the first-floor landing exhibited horizontal cracking on the face of the slab edge. Delaminated concrete was identified isolated directly above the cracked portion of the floor slab in the first-floor landing.

Figure 4: View of horizontal crack on the face of the slab edge (annotations by ESi).
