Phase 2 Milestone Inspection

**On Top of the World Clearwater
Building 57
2436 Rhodesian Drive and 2435 Sumatran Way
Clearwater, Florida 33763**

ESi Project No: 98508

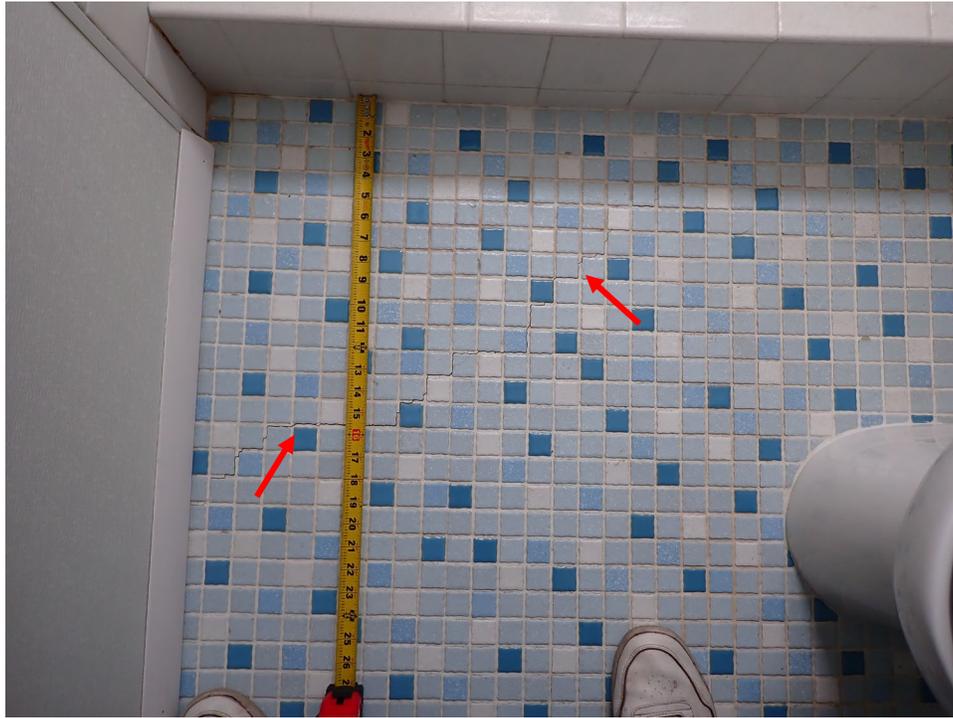
During the Phase 1 Milestone Inspections, cracked ceramic floor tile in the master bathroom floor within unit 9 was observed. Unit 9 is a first-floor unit; therefore, the floor is a slab on grade. The cracked floor tile was adjacent to the unit's demising wall, which are load-bearing concrete masonry unit (CMU) walls. The crack was observed to begin at the wall baseboard but stopped short of the shower curb. A Phase 2 Milestone Inspection was completed of the cracked tile. The Phase 2 inspection consisted of hammer soundings with a rubber mallet and visual observations of the bathroom in general for signs of movement of the structure, damage or displacement.

The soundings returned solid sounds with no tile rattle, no tile or grout movement, and no hollow sounds emanating from under the tile. No difference in height of the tile on either side of the

crack was observed. The floor was observed as being uniformly level. No other cracks or evidence of movement or damage was observed within the bathroom. Per conversation with the owner, the crack was in existence at the time of purchase in 2016. Per owner there has been no increase in the size or extent of the crack since moving in.

It has been determined that the crack was likely caused by movement or typical shrinkage cracking in the concrete slab itself. Cracking of slabs on grade is common, and considering no other signs of substantial movement or damage in the surrounding areas, the cracking is not a sign of substantial deterioration or a structural issue. Tile grout is a brittle material and any movement of the slab or cracking in the slab likely translated through to the floor tile, closely following the grout lines with the tile. No substantial deterioration, or dangerous conditions were identified, and no further action is required at this time.

Figure 2: Extent of crack in floor tile.

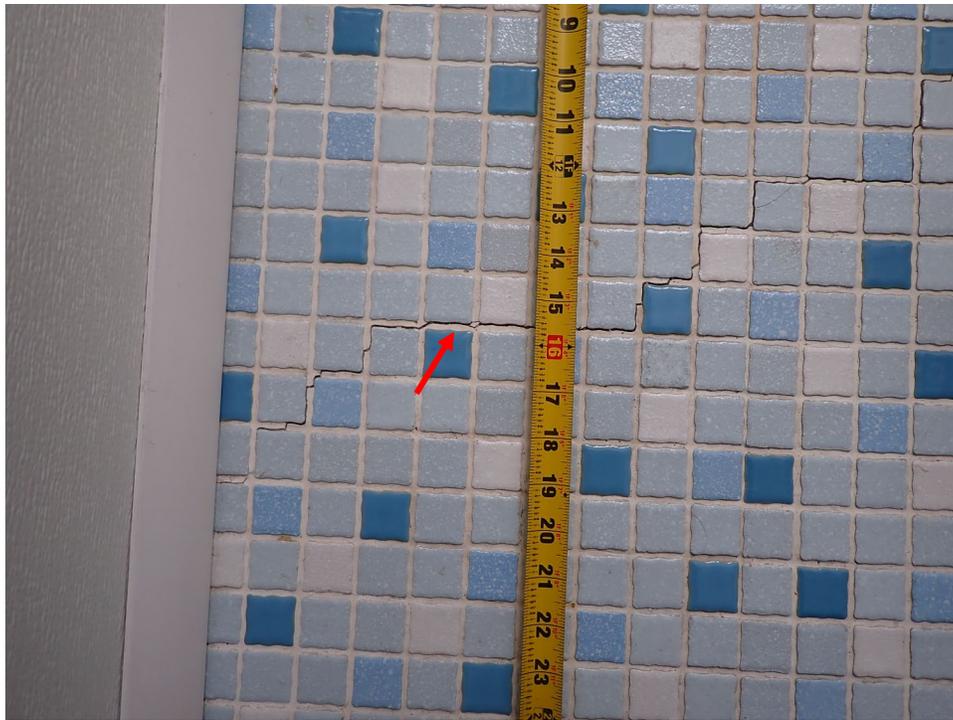
Figure 3: Close-up of crack in floor tile.
