Uniform Mitigation Verification Inspection Form

1. **Building Code:** Was the structure built in compliance with the Florida Building Code (FBC 2001 or later) OR for homes located in the HVHZ (Miami-Dade or Broward counties), South Florida Building Code (SFBC-94)?

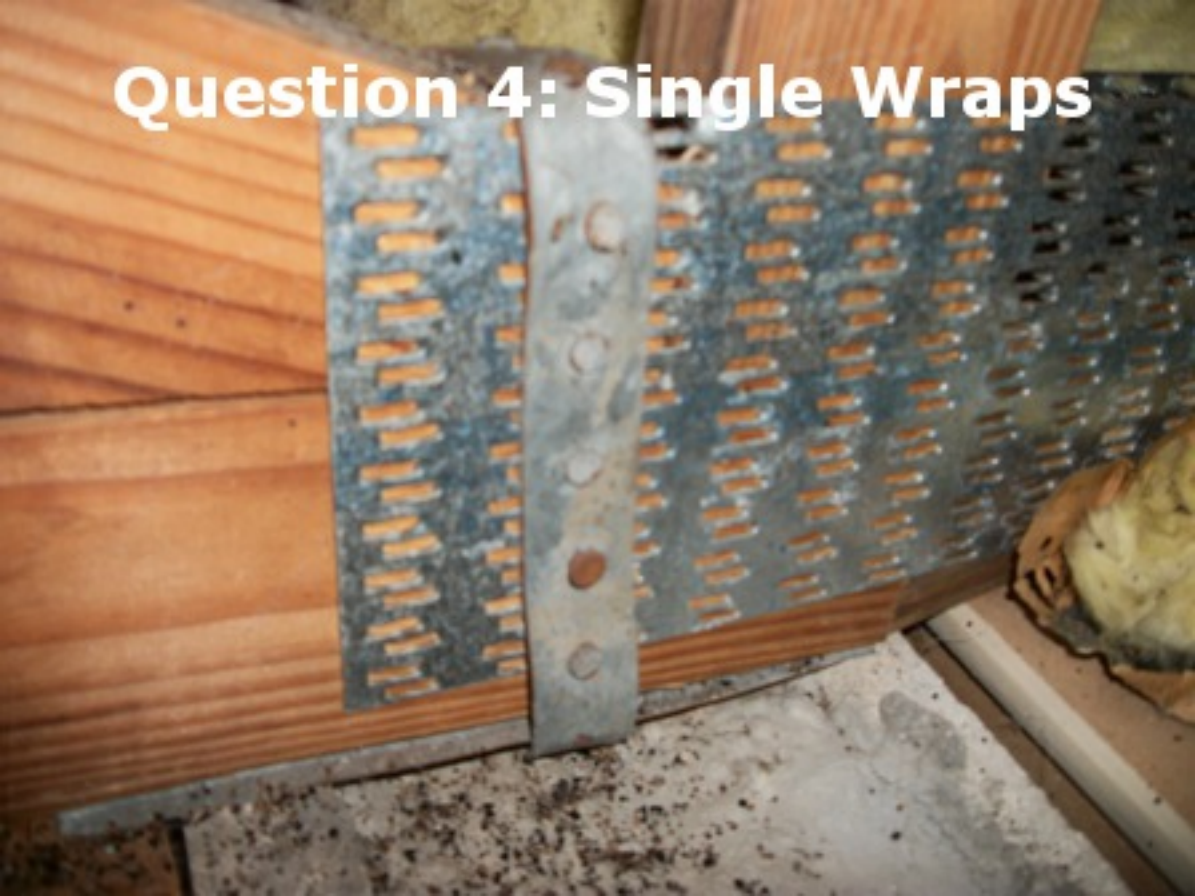
Question 4: Single Wraps

Metal connectors consisting of a single strap that wraps over the top of the truss/rafter and is secured with a minimum of 2 nails on the front side and a minimum of 1 nail on the opposing side.

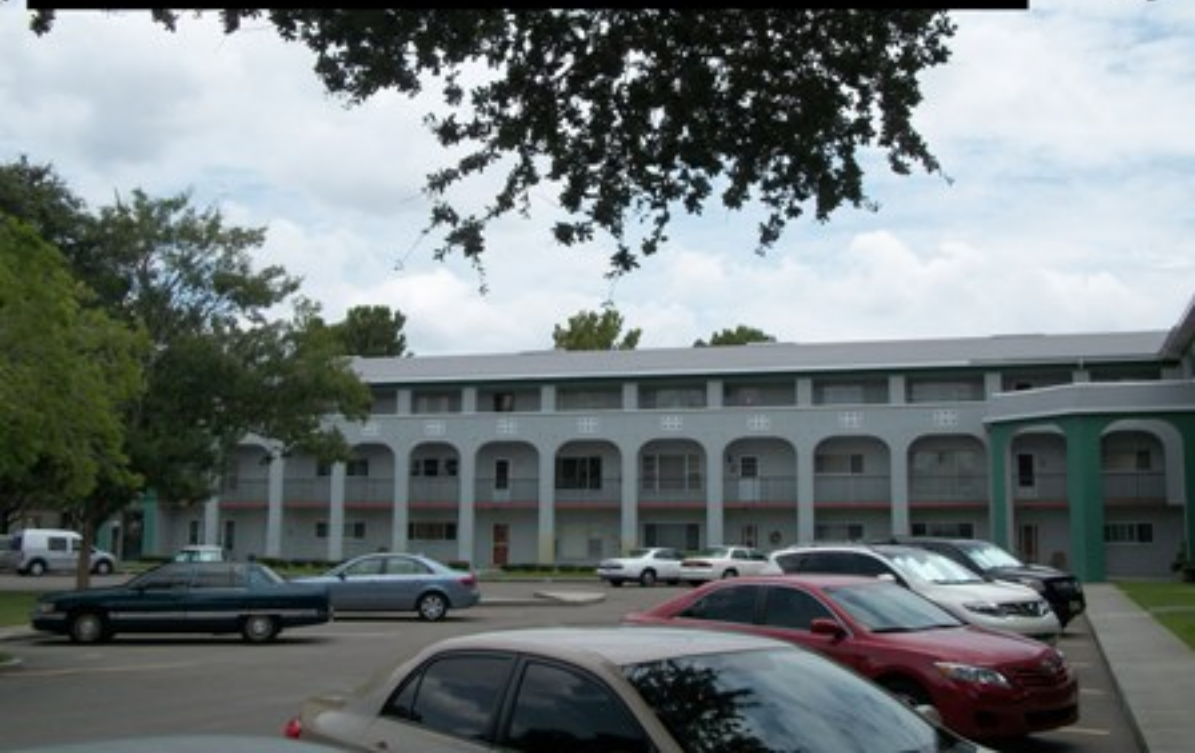
Question 5: Roof Geometry

- ☐ A. Hip Roof Hip roof with no other roof shapes greater than 10% of the total roof system perimeter.
Total length of non-hip features: _____ feet; Total roof system perimeter: _____ feet
- ☐ B. Flat Roof Roof on a building with 5 or more units where at least 90% of the main roof area has a roof slope of less than 2:12. Roof area with slope less than 2:12 _____ sq ft; Total roof area _____ sq ft
- ☐ C. Other Roof Any roof that does not qualify as either (A) or (B) above.
