Uniform Mitigation Verification Inspection Form

QUESTION 4: SINGLE CLIPS

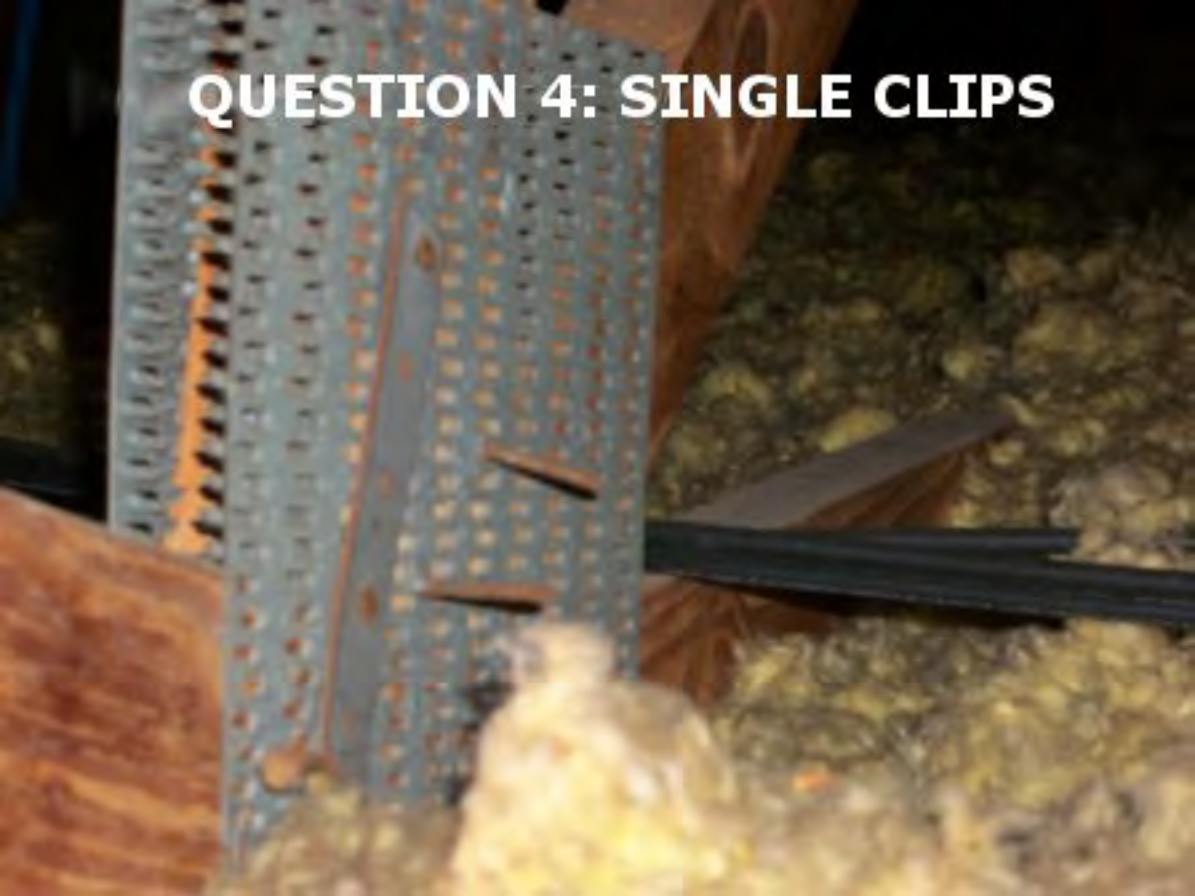
- ☐ B. Clips
 - ☐ Metal connectors that do not wrap over the top of the truss/rafter, **or**
 - ☐ Metal connectors with a minimum of 1 strap that wraps over the top of the truss/rafter and does not meet the nail position requirements of C or D, but is secured with a minimum of 3 nails.

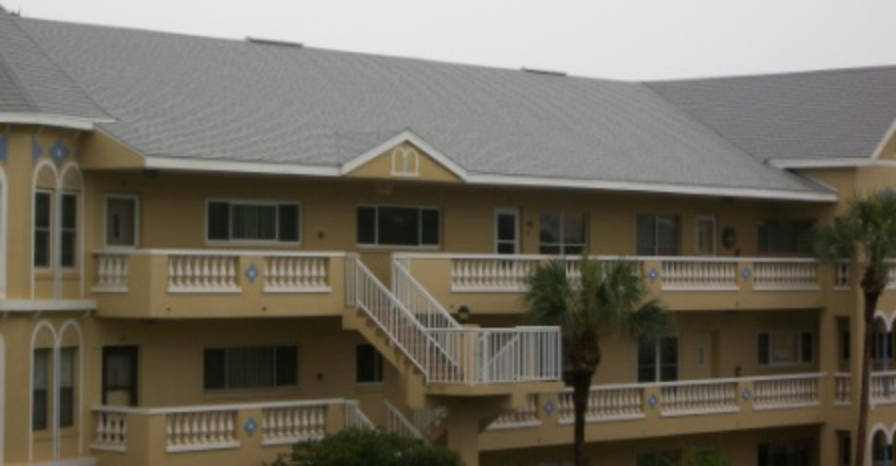
QUESTION 5; BUILDING 90 ROOF GEOMETRY

- ☐ A. Hip Roof Hip roof with no other roof shapes greater than 10% of the total roof system perimeter.
Total length of non-hip features: _____ feet; Total roof system perimeter: _____ feet
- ☐ B. Flat Roof Roof on a building with 5 or more units where at least 90% of the main roof area has a roof slope of less than 2:12. Roof area with slope less than 2:12 _____ sq ft; Total roof area _____ sq ft
- ☐ C. Other Roof Any roof that does not qualify as either (A) or (B) above.
