# Uniform Mitigation Verification Inspection Form

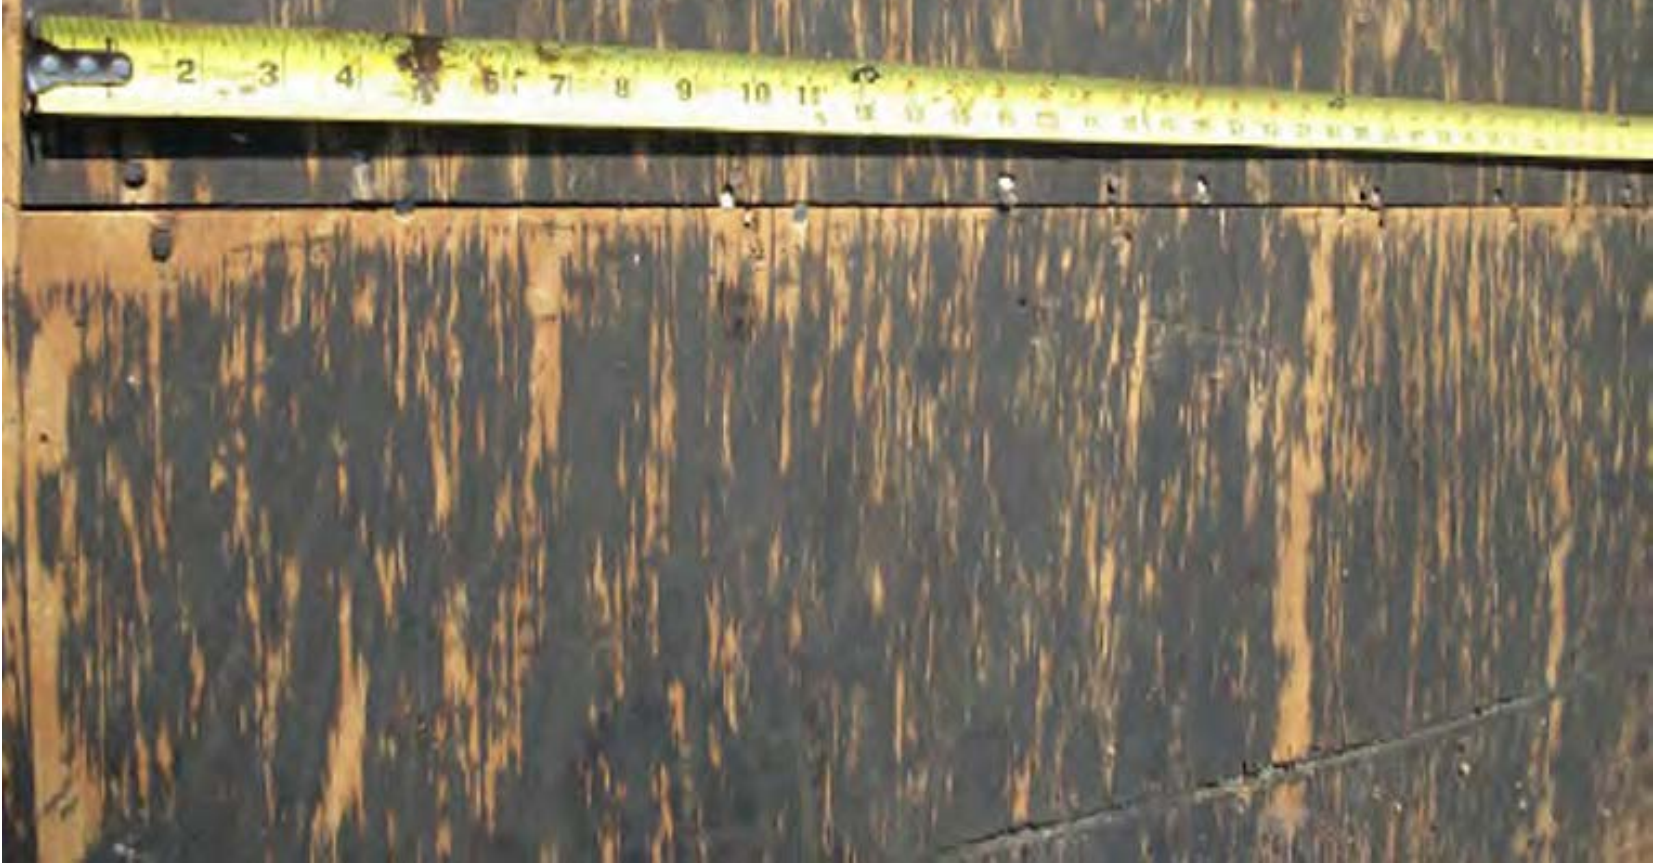
## Question 3: Roof Deck Attachment

3. **Roof Deck Attachment:** What is the weakest form of roof deck attachment?
    - ☐ A. Plywood/Oriented strand board (OSB) roof sheathing attached to the roof truss/rafter (spaced a maximum of 24" inches o.c.) by staples or 6d nails spaced at 6" along the edge and 12" in the field. -OR- Batten decking supporting wood shakes or wood shingles. -OR- Any system of screws, nails, adhesives, other deck fastening system or truss/rafter spacing that has an equivalent mean uplift less than that required for Options B or C below.

- ☐ B. Plywood/OSB roof sheathing with a minimum thickness of 7/16" inch attached to the roof truss/rafter (spaced a maximum of 24" inches o.c.) by 8d common nails spaced a maximum of 12" inches in the field. -OR- Any system of screws, nails, adhesives, other deck fastening system or truss/rafter spacing that is shown to have an equivalent or greater resistance 8d nails spaced a maximum of 12 inches in the field or has a mean uplift resistance of at least 103 psf.

- ☐ C. Plywood/OSB roof sheathing with a minimum thickness of 7/16" inch attached to the roof truss/rafter (spaced a maximum of 24" inches o.c.) by 8d common nails spaced a maximum of 6" inches in the field. -OR- Dimensional lumber/Tongue & Groove decking with a minimum of 2 nails per board (or 1 nail per board if each board is equal to or less than 6 inches in width). -OR- Any system of screws, nails, adhesives, other deck fastening system or truss/rafter spacing that is shown to have an equivalent
