Uniform Mitigation Verification Inspection Form

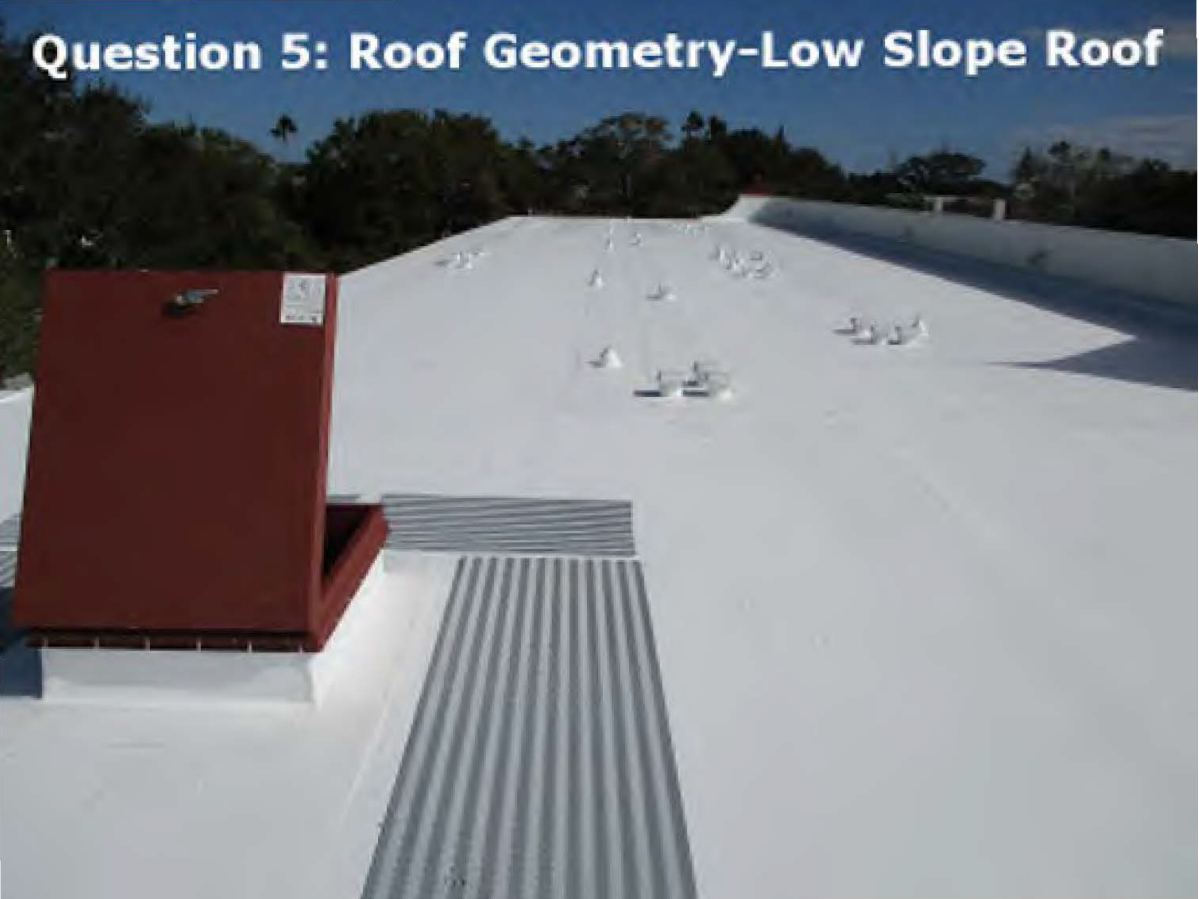
Question 5: Roof Geometry-Low Slope Roof
