Phase 1 Milestone Inspection Report

On Top of the World Clearwater

Building 17

ESi Project No: 98508

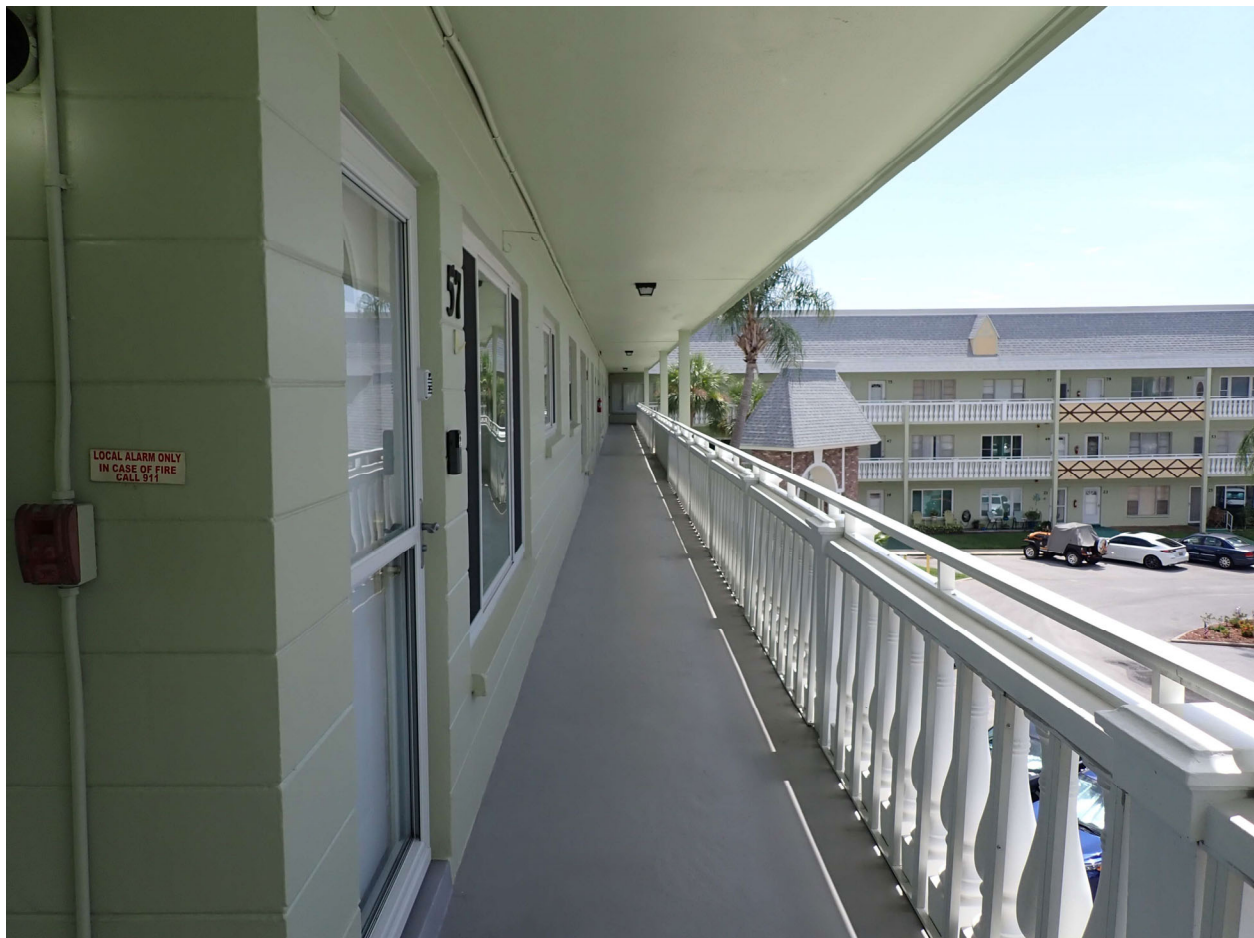
Figure 4. Exterior walkway as constructed.

The front of the units has an exterior walkway which consists of a tapered, cast-in-place, cantilevered concrete slab, and protective metal railings placed in front of the original architectural railings on the exterior edge. The as-built walkway structural support is unknown. The drawings show the walkway being cantilevered from the front CMU bearing building wall. Additionally, there are columns extending from ground level to the bottom of the third level on the exterior side of the walkway on the exterior side of the railing system. Shown in Figure 4 is a photograph of the walkway as constructed.

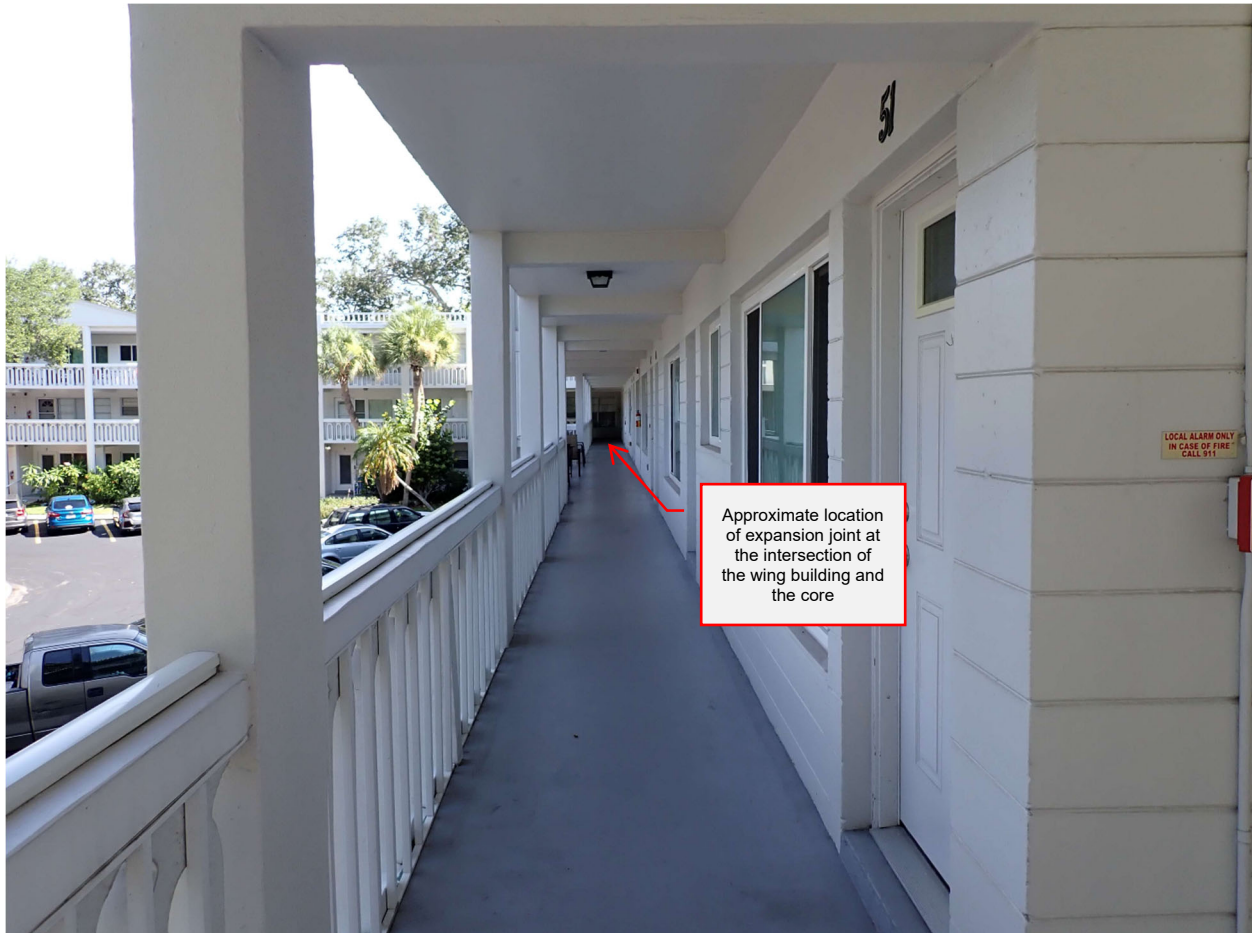
Figure 6. Representative approximate location of expansion joint at wing/core intersection in representative building.

Above grade, the wings and core are structurally independent such that each building is separate and there is a flexible expansion/contraction joint where the structures meet (Figure 5 and Figure 6). Below grade at the foundation level, the walls of the building's wings and the core's columns share a foundation footing.
