Phase 1 Milestone Inspection Report

On Top of the World Clearwater

Building 34

ESi Project No: 98508

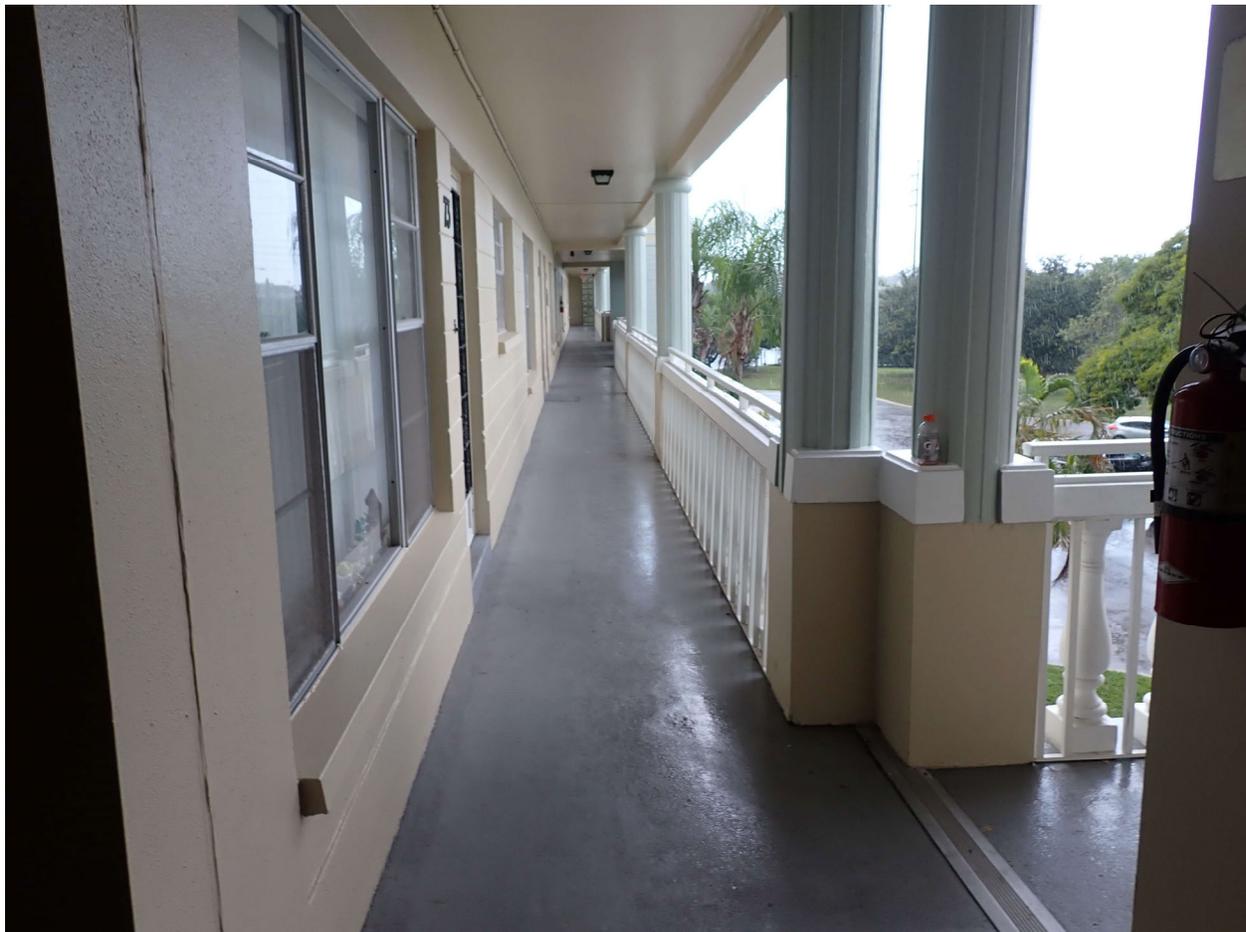
Figure 4. Exterior walkway as constructed.

The front of the units has an exterior walkway which consists of a tapered, cast-in-place, cantilevered concrete slab, and protective metal railings placed in front of the original architectural railings on the exterior edge. The as-built walkway structural support is unknown. The drawings show the walkway being cantilevered from the front CMU bearing building wall. Additionally, there are columns extending from ground level to the bottom of the third level on the exterior side of the walkway in line with the railing system. Shown in Figure 4 is a photograph of the walkway as constructed.
