# **Phase 1 Milestone Inspection Report**

**On Top of the World Clearwater**

**Building 36**

**2340 Grecian Way and 2341 Haitian Drive, Clearwater**

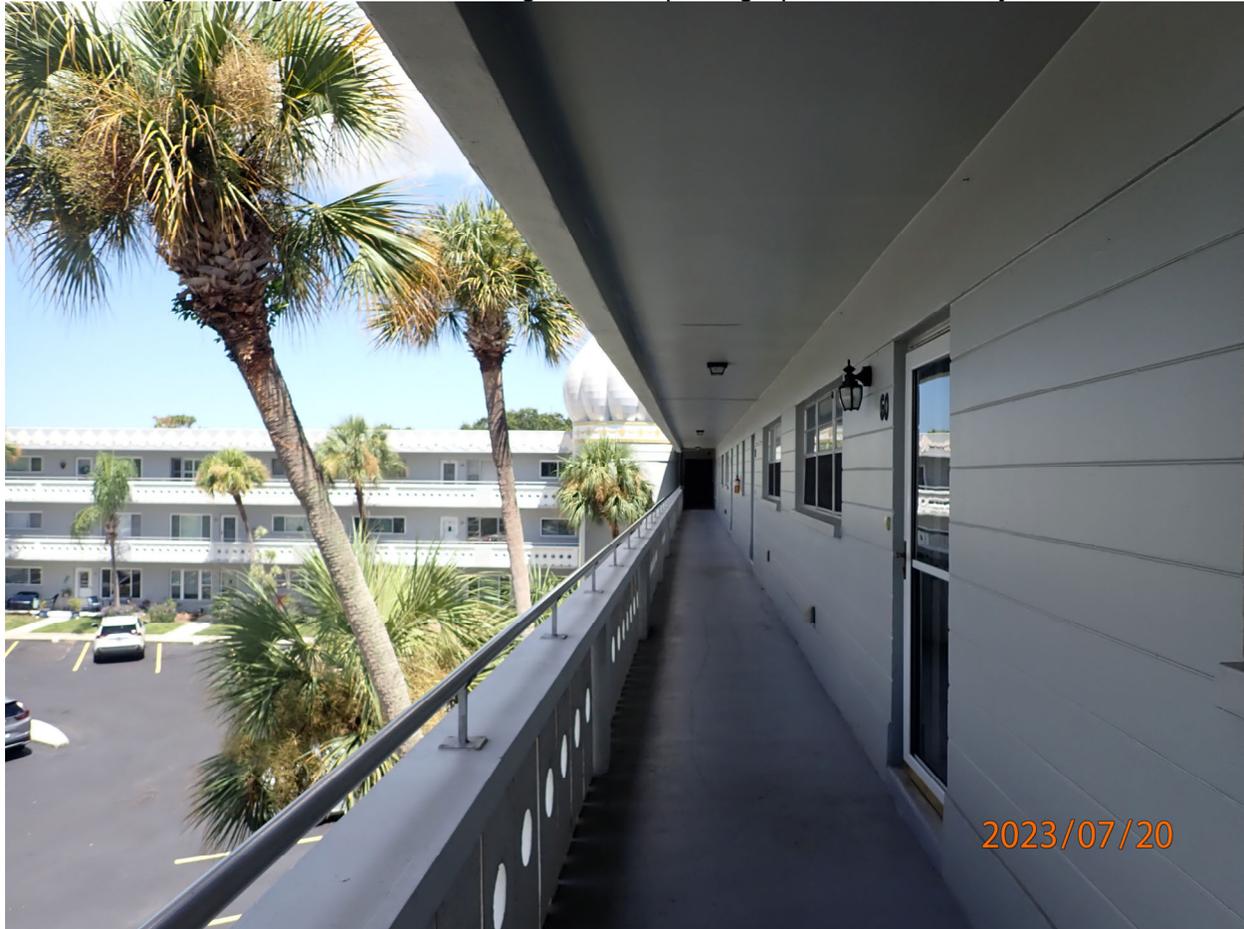
**Figure 4. Exterior walkway as constructed.**

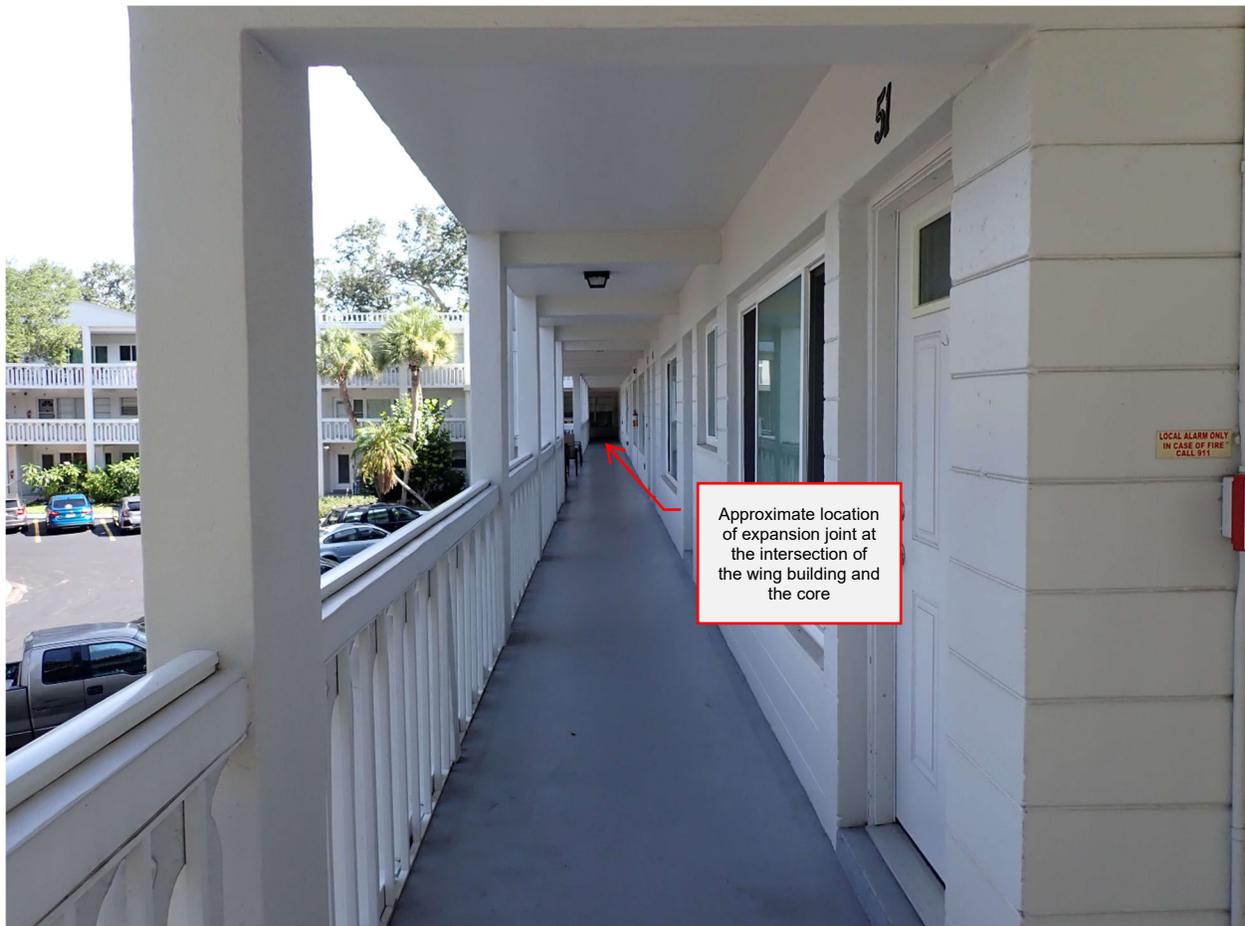
**Figure 6. Representative approximate location of expansion joint at wing/core intersection in representative building.**
