# **Phase 1 Milestone Inspection Report**

**On Top of the World Clearwater**

**Building 46**

**ESi Project No: 98508**

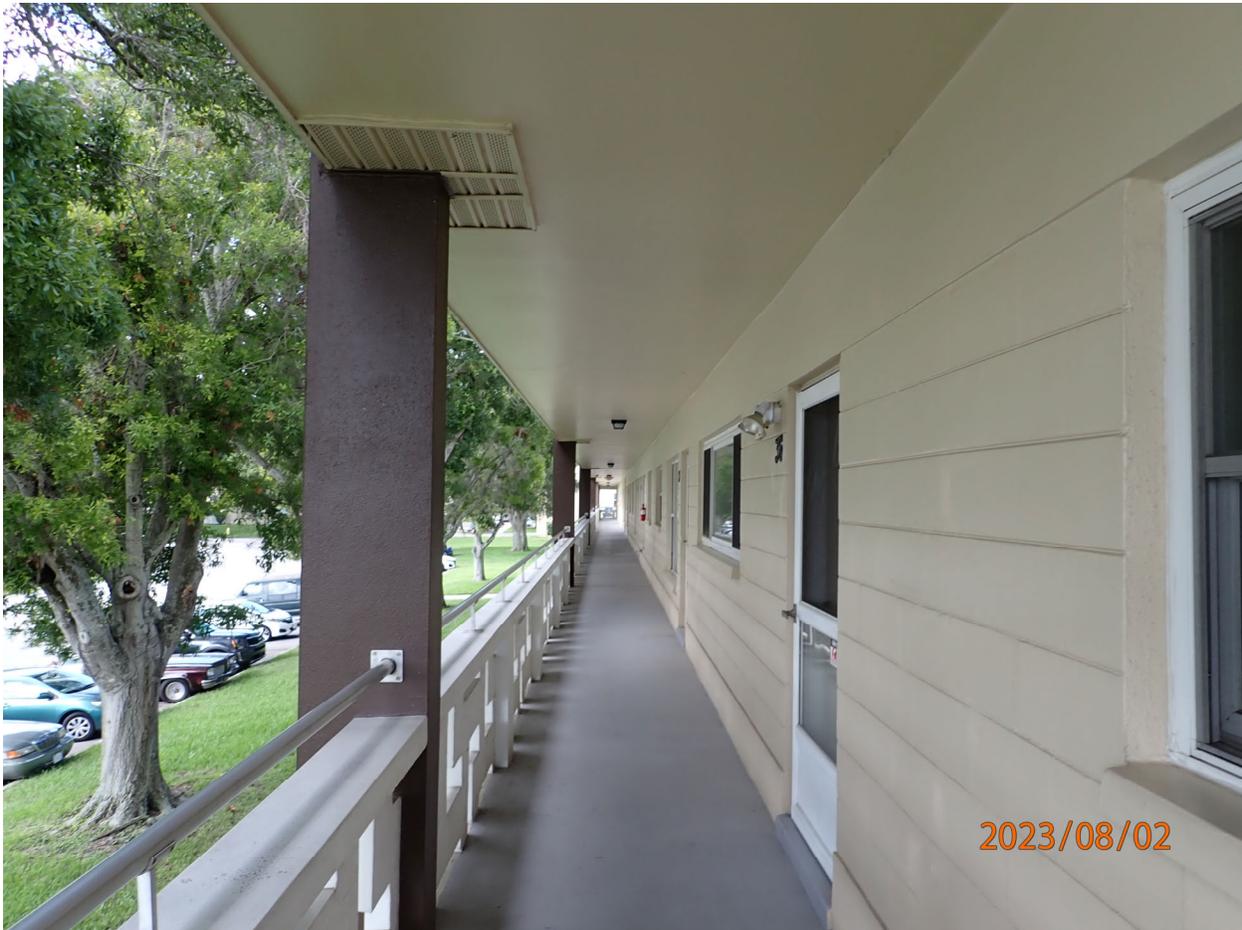
The front of the units has an exterior walkway which consists of a tapered cast-in-place concrete slab, and painted cementitious architectural railings on the exterior edge. The as-built walkway structural support is unknown. The drawings show the walkway being cantilevered from the front CMU bearing building wall. Additionally, there are columns extending from ground level to the bottom of the third level on the exterior side of the walkway in line with the railing system. Shown in **Figure 4** is a photograph of the walkway as constructed.

**Figure 4. Exterior walkway as constructed.**
