Phase 1 Milestone Inspection Report

On Top of the World Clearwater

Building 80

ESi Project No: 98508

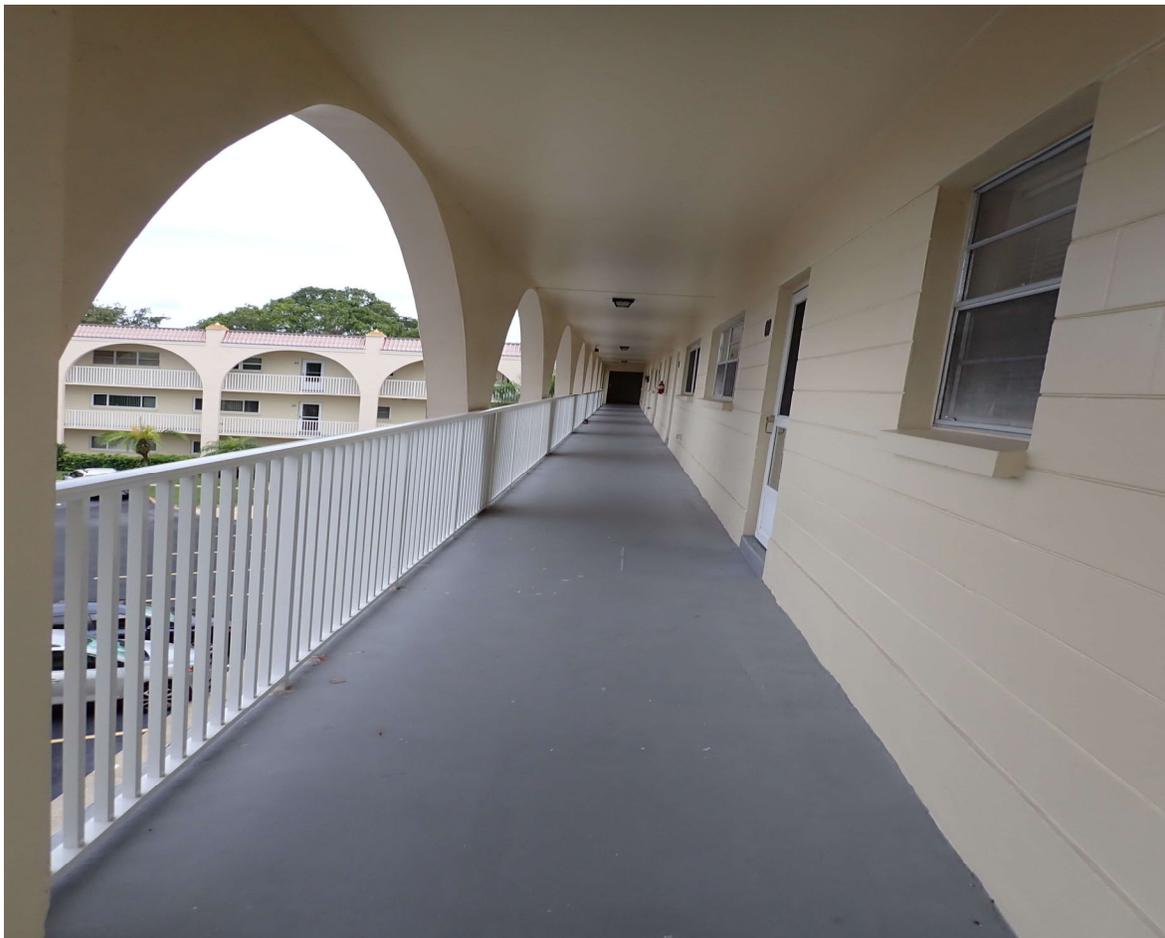
Figure 4. Exterior walkway as constructed.

The front of the units has an exterior walkway which consists of a tapered cast-in-place, cantilevered concrete slab, and protective metal railings on the exterior edge. The drawings show the walkway being cantilevered from the front CMU bearing building wall. Additionally, there are columns extending from ground level to the top level on the exterior side of the walkway in line with the railing system. Shown in **Figure 4** is a photograph of the walkway as constructed.
