Phase 1 Milestone Inspection Report

On Top of the World Clearwater

Building 92

ESi Project No: 98508

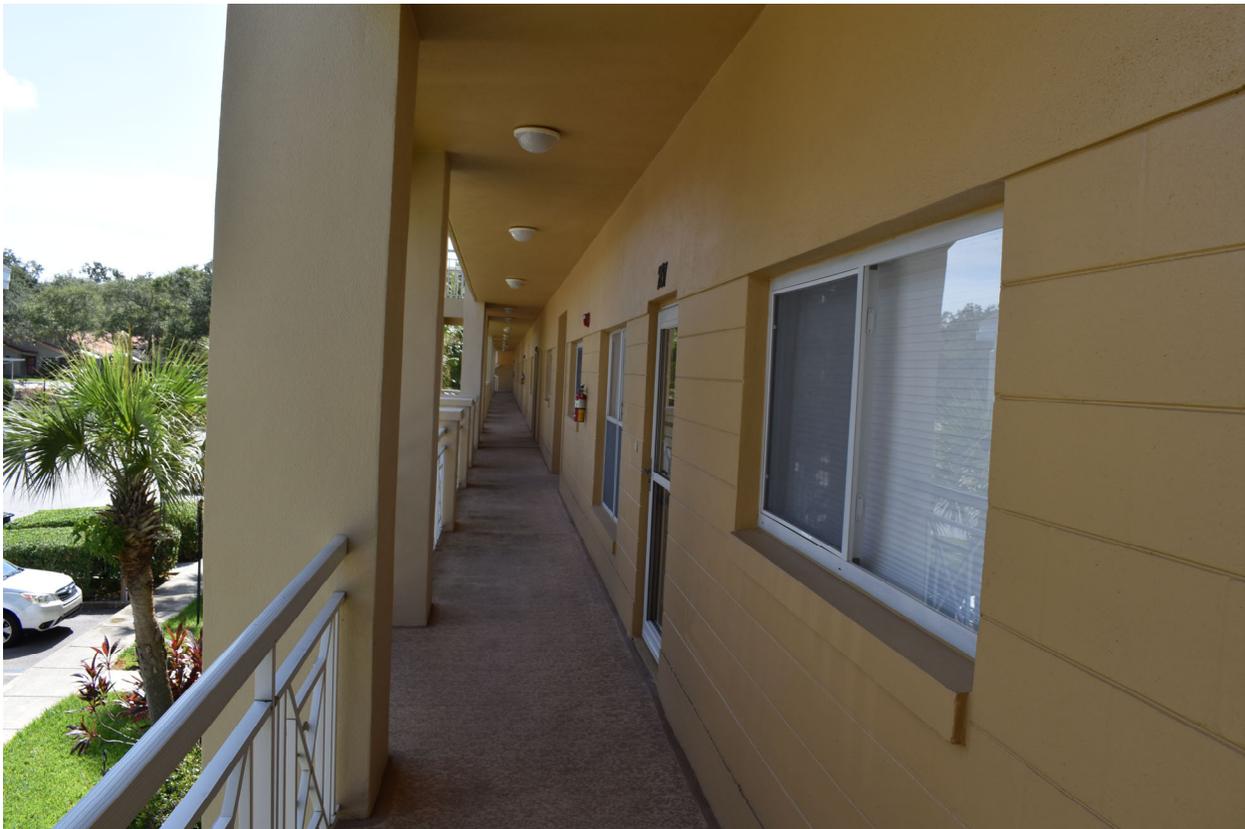
The front of the units has an exterior walkway which consists of a tapered cast-in-place concrete slab, and protective metal railings. The drawings show the walkway being cantilevered from the front CMU bearing building wall. Additionally, there are columns extending from ground level to the second level and to the top level on the exterior side of the walkway in line with the railing system. Shown in **Figure 4** is a photograph of the walkway as constructed.

Figure 4. Exterior walkway as constructed.
